Upper Broad Run Watershed Management Plan

Watershed Partnership Workgroup Meeting #4

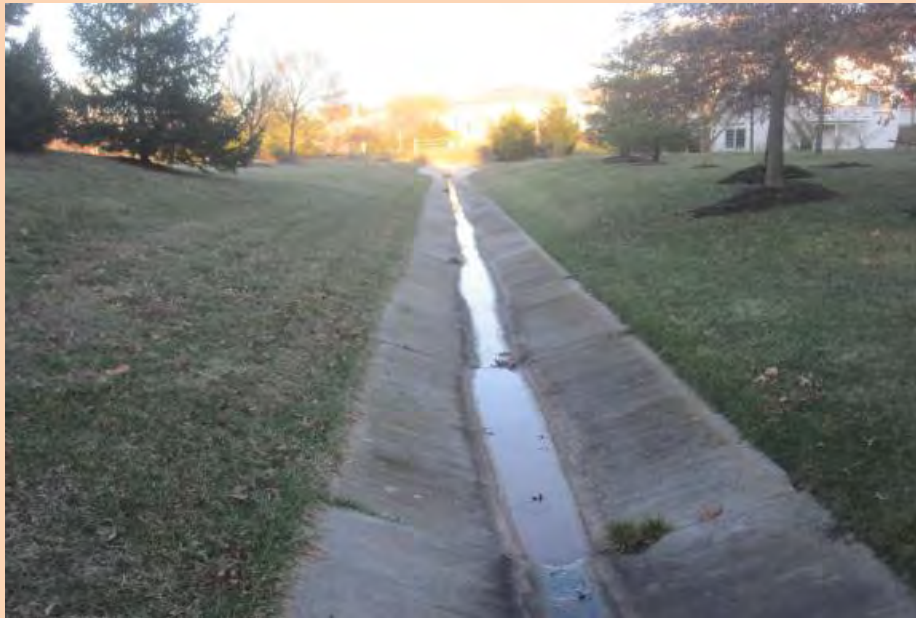
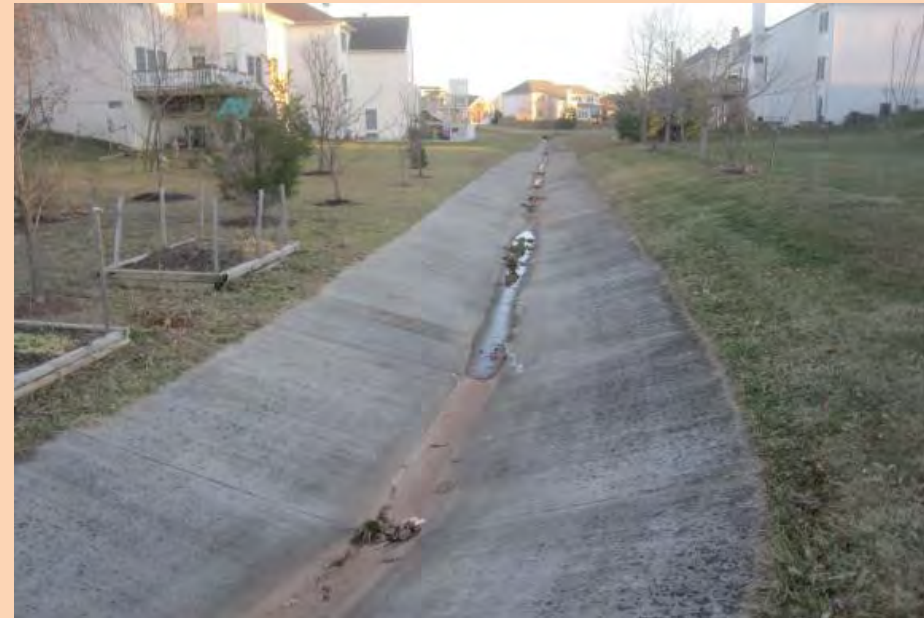
Example: Recommended Stormwater Conveyance Conversion – High Priority

Structure ID: JC4162
Subwatershed: Brambleton
Project Name: Gleedsville Manor Bioswale
Nearest Address: Gleedsville Manor Drive

Project Type: Conversion to Bioswale
Restoration Priority: High
Drainage Area: 7.78 acres

Proposed Action: Convert concrete channel stormwater conveyance to a bioswale
Benefits: Improve stormwater quality controls, public education, improve aesthetics
Key Issues for Implementation: Engage residents, promote bioswale benefits; no apparent utility conflicts
Planning Level Cost Estimate: TBD

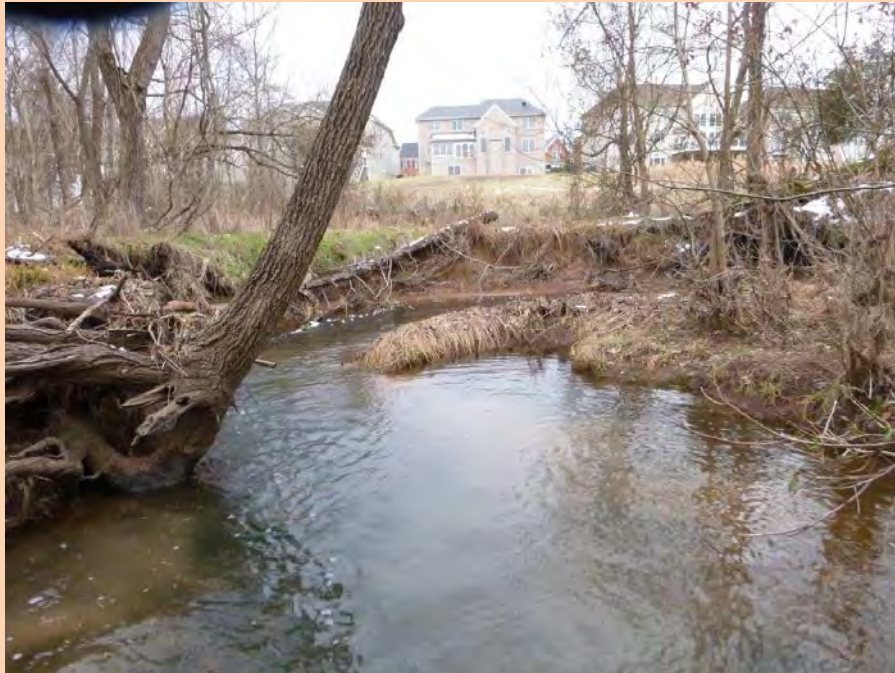
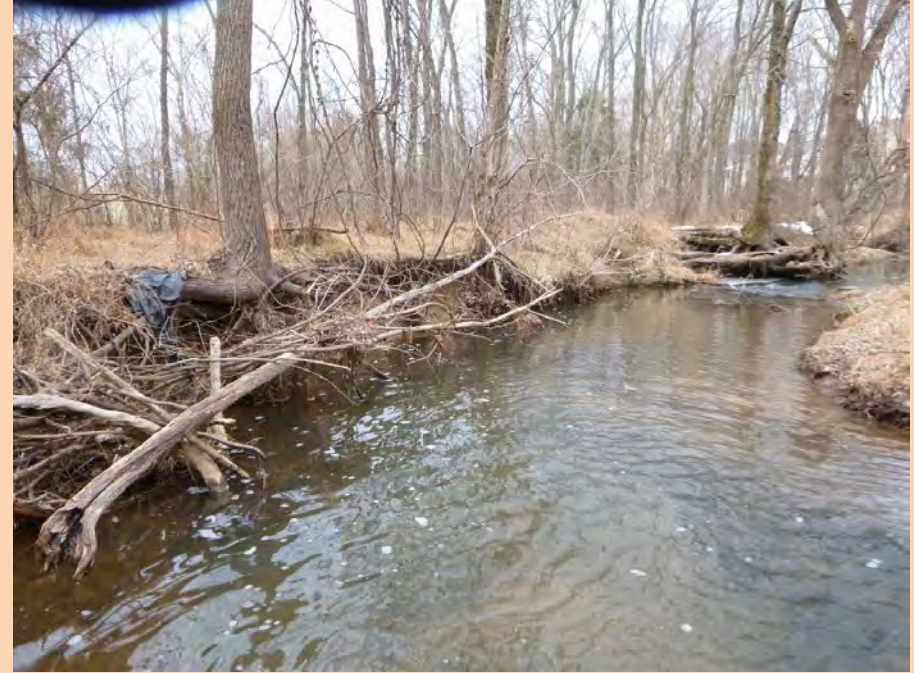
Example: Stream Restoration Site – High Priority

Project ID: BRAM-ES-059-2014
Subwatershed: Brambleton
Project Type: Stream Restoration
Nearest Address: Addlestone Place

Restoration Priority: High
Erosion Length: 90 feet
Erosion Height: 2.5 feet

Proposed Action: Stabilize stream banks and reconnect stream with floodplain
Benefits: Improve stream stability, erosion, and instream habitat, etc.
Key Issues for Implementation: Manage upstream flows; no apparent utility conflicts, check prior to restoration
Planning Level Cost Estimate: TBD

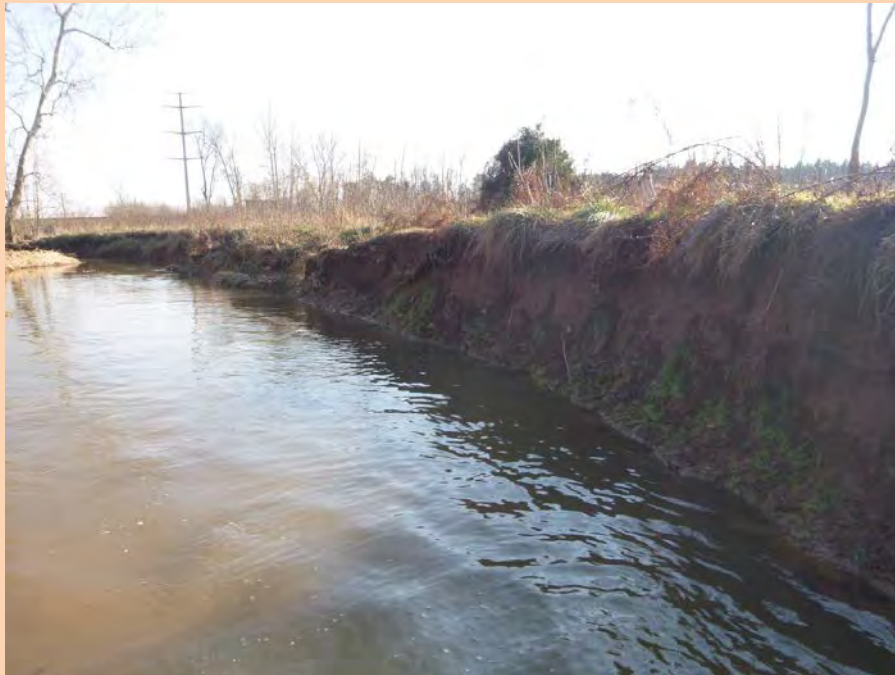
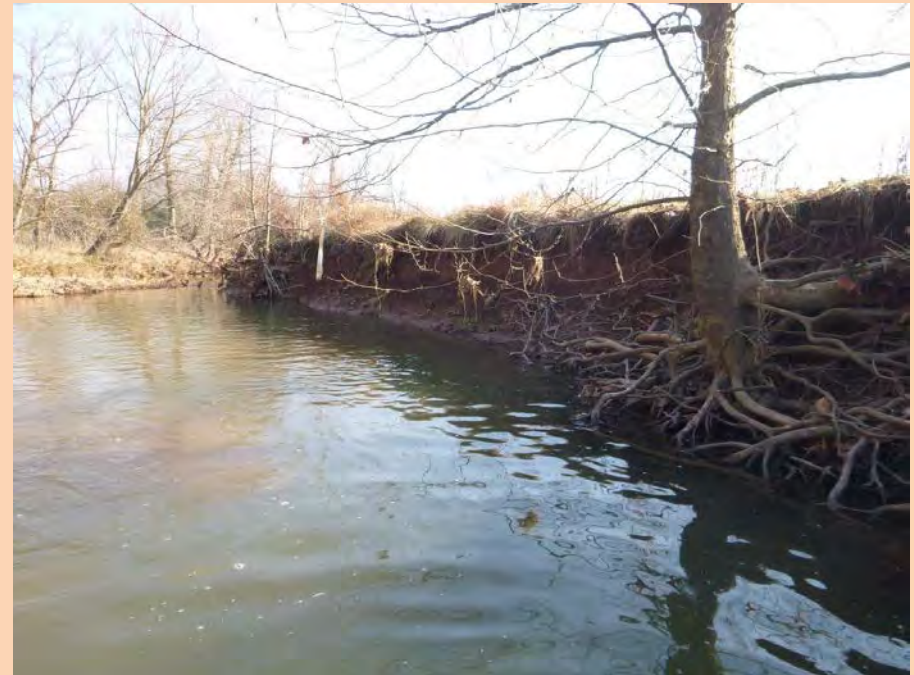
Example: Stream Restoration Site – Medium Priority

Project ID: LNF-ES-114-2014
Subwatershed: Lower North Fork
Project Type: Stream Restoration
Nearest Address: Belmont Ridge Rd. and Evergreens Mill Rd.

Restoration Priority: Medium
Erosion Length: 750 feet
Erosion Height: 4.25 feet

Proposed Action: Stabilize stream banks and reconnect stream with floodplain
Benefits: Improve stream stability, erosion, and instream habitat, etc.
Key Issues for Implementation: Manage upstream flows; adjacent to Transmission line ROW
Planning Level Cost Estimate: TBD
