WESTERN HILLS WATERSHED MANAGEMENT PLAN

**Loudoun County
Department of
Building and Development
1 Harrison St.
Leesburg, VA 20175**

**Tetra Tech, Inc.
10711 Red Run Blvd., Suite 105
Owings Mills, MD 21117**

May 12, 2020

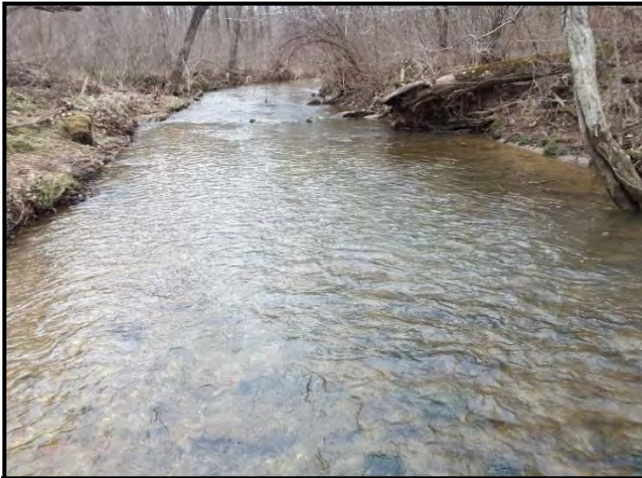
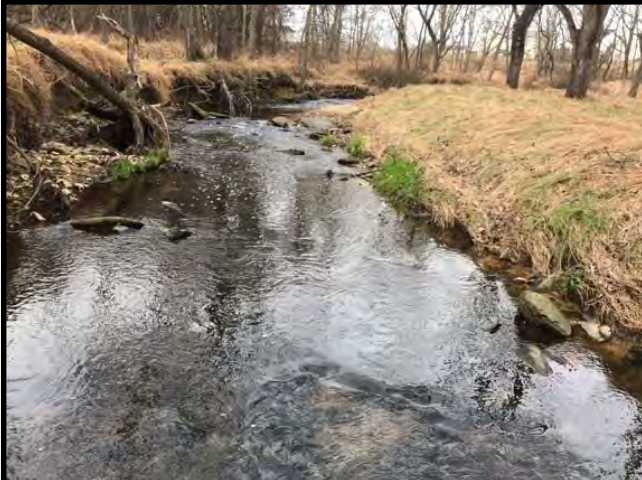
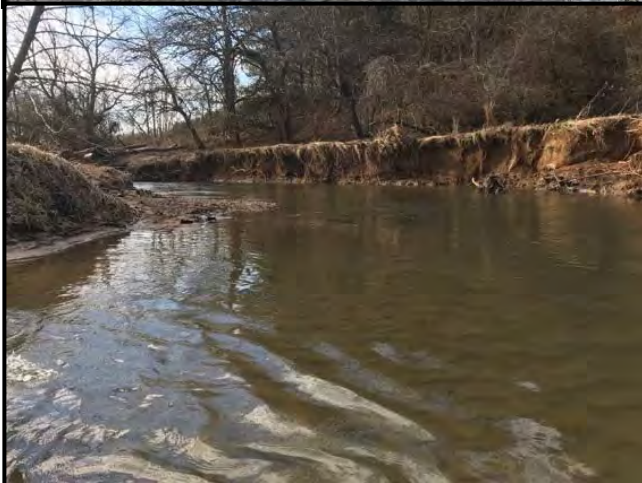
Figure 4-4: Three Western Hills Habitat Sites with Three Different Habitat Ratings

Locations and overall habitat score ratings for the 2018-2019 SCA representative habitat assessment sites, are shown in Figure 4-2. Figure 4-3 shows these scores, along with habitat assessment ratings from the 2009 Loudoun County Stream Assessment (Roth et al. 2009). Figure 4-4 depicts three example habitat sites with different ratings for overall habitat score.

Stream reach with an optimal habitat rating

Stream reach with a suboptimal habitat rating

Stream reach with a marginal habitat rating

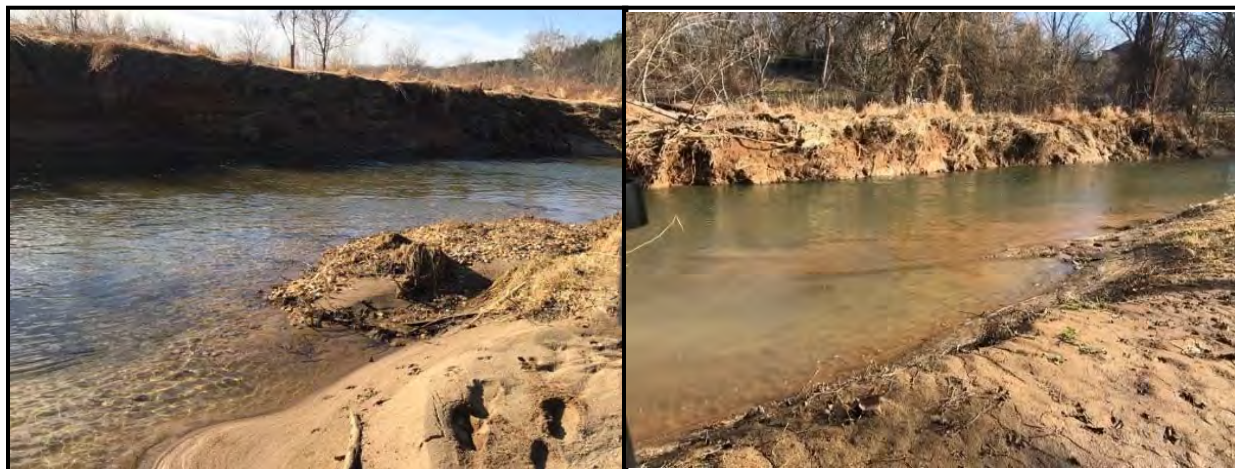
Figure 4-6: Examples of Sites with Severe Erosion, ES031 and ES033

Approximately 66 percent of the documented erosion sites were rated as either moderate, low, or minor severity. Overall, 5 sites were rated as exhibiting very severe erosion and 31 were rated as severe erosion. Lower South Fork Catoctin Creek had the greatest proportion of erosion sites rated as very severe to severe. Figure 4-6 depicts examples of erosion sites documented within the watershed that were assigned a rating of severe.

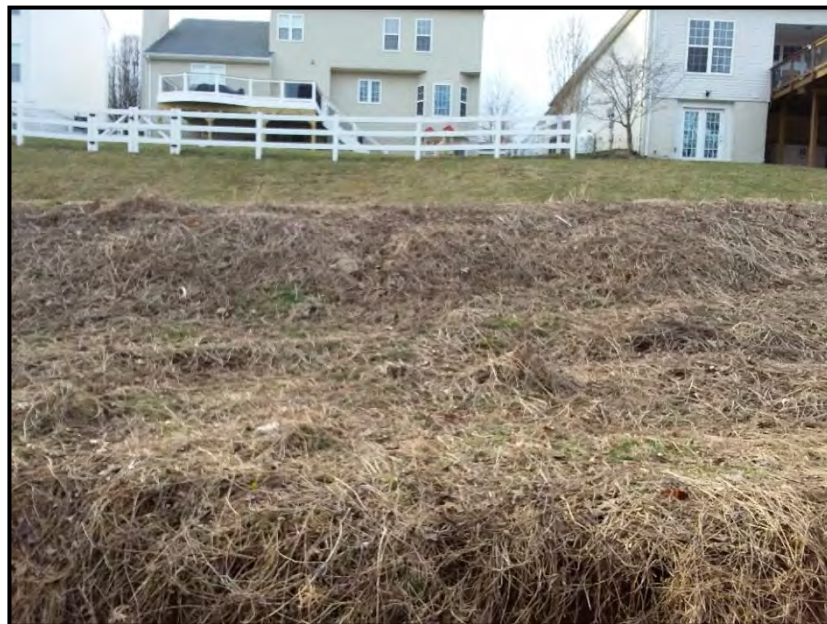
Figure 4-7: Example of Inadequate Buffer Site Rated as Severe, IB204

The severity of inadequate stream buffers was rated according to length and width. Figure 4-7 depicts one typical site that was rated as possessing a severe inadequate buffer. A few sites represented potential opportunities for stream buffer reforestation, but these were in some cases limited because of the presence of the County sewer line Right-of-Way (ROW) within the stream corridor.

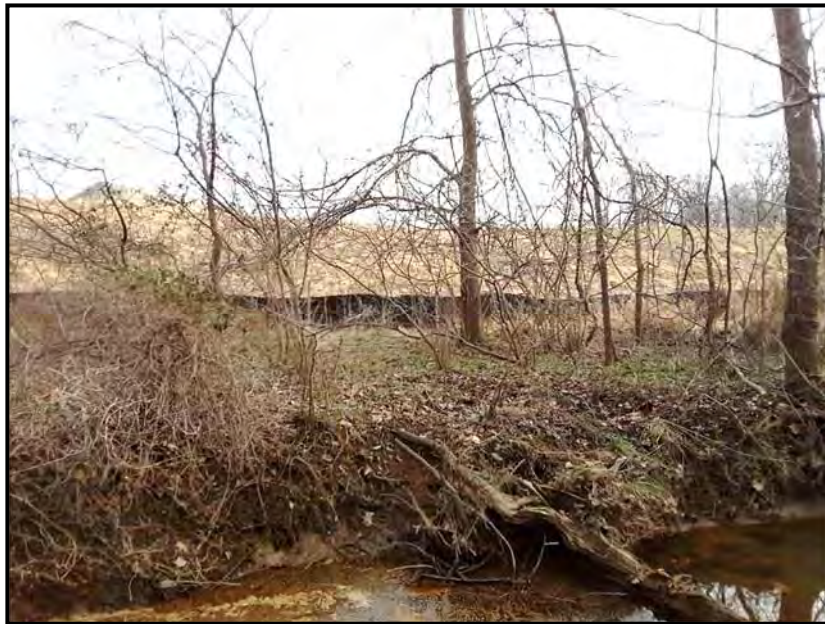
Figure 4-8: Near Stream Construction with Super Silt Fence

There was only a single site (Upper South Fork Catoctin Creek) where construction was observed in or near the stream (Figure 4-8). The field team noted the presence of sediment control measures (silt fence and grading) and looked for possible signs of construction-related pollution, particularly sediment, but none were observed. This site was rated as Minor in severity and impacted zero feet of stream.

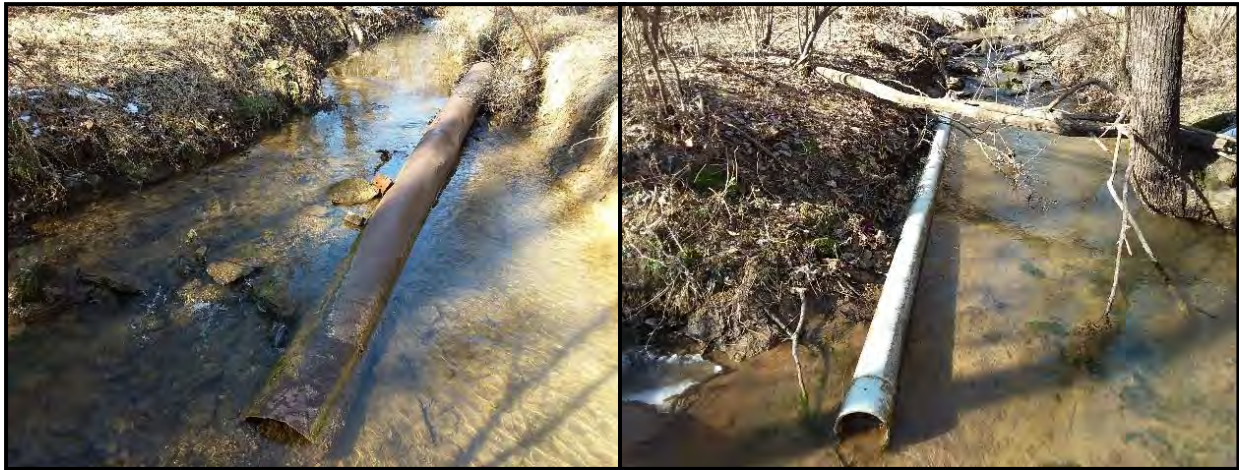
Figure 4-13: Examples of Two Low Severity Trash Dumping Sites

A total of only two trash dumping sites were documented as part of the Western Hills SCA survey, both within the Upper North Fork Goose Creek subwatershed (Figure 4-12 and Figure 4-13). The severity of both these trash dumping sites was rated low, according to the amount and type of trash present, their location, and whether cleaning up the trash would present problems (access and safety). Both trash sites were classified as construction debris. Low severity and minor trash dumping sites are those with easy access and typically where there is potential for a volunteer cleanup. The amount of trash was estimated in terms of number of pick-up truck loads for completely clearing the site. Both sites were estimated to contain a single pick-up truck load of material. One trash pile consisted of PVC piping, and the other site consisted of steel pipes and a manhole cover. Both of these sites were considered as possible volunteer projects.

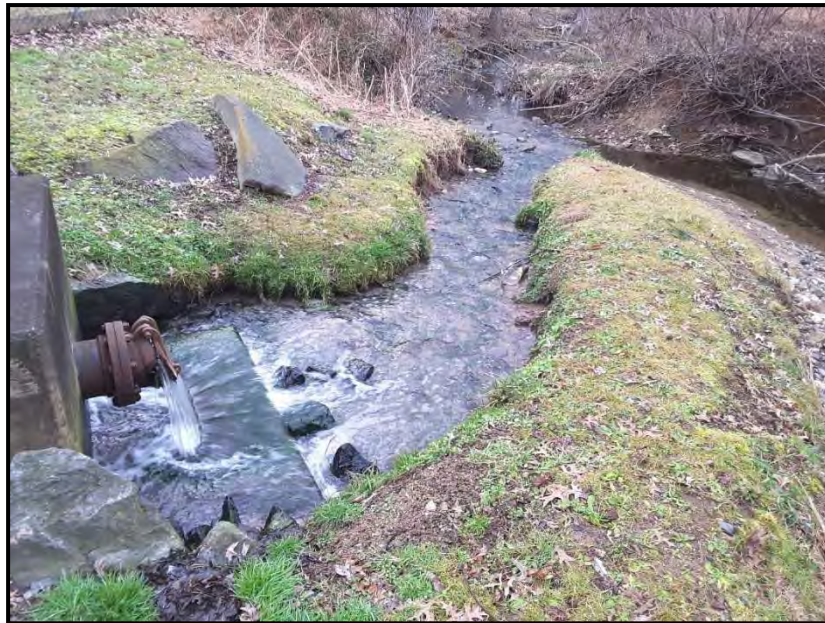
Figure 4-14: Photo of a Moderate Severity Pipe Outfall Site

A total of seventeen pipe outfalls were identified during the Western Hills SCA survey. Of these, most were stormwater outfalls. One non-stormwater pipe (Lower South Fork Catoctin Creek) appeared to be sewage and was rated at moderate severity. No outfalls were noted in the Crooked Run portion of the survey. Access and correctability were rated as best for both of the minor outfalls, and correctability was rated best at the sewage pipe outfall. Figure 4-12 shows the location of outfalls noted during SCA surveys. Figure 4-14 depicts the moderate severity Pipe Outfall site that drains to a tributary of the Lower South Fork Catoctin Creek.

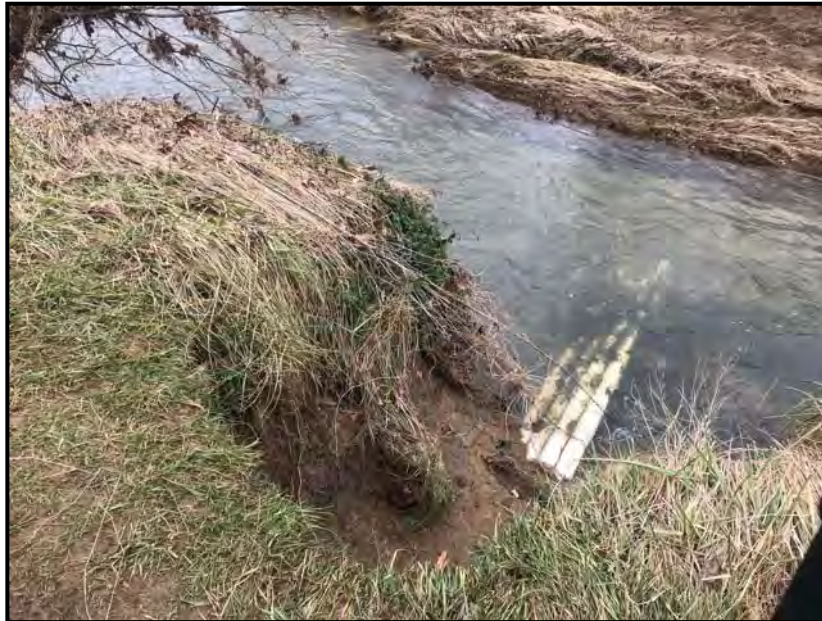
Figure 4-15: Exposed Pipe within the Stream, within Lower South Fork Catoctin Creek

A total of only one exposed pipe site, rated as moderate severity, was identified during the Western Hills SCA survey. It consisted of a 4-inch PVC pipe of unknown function. It was a 7 foot long exposure in Lower South Fork Catoctin Creek. Correctability was listed as unknown, primarily because the function of the pipe was indeterminate. However, access was rated as best and could be considered for action. Figure 4-12 shows the location of the exposed pipe. Figure 4-15 depicts the exposed pipe within the streambed.

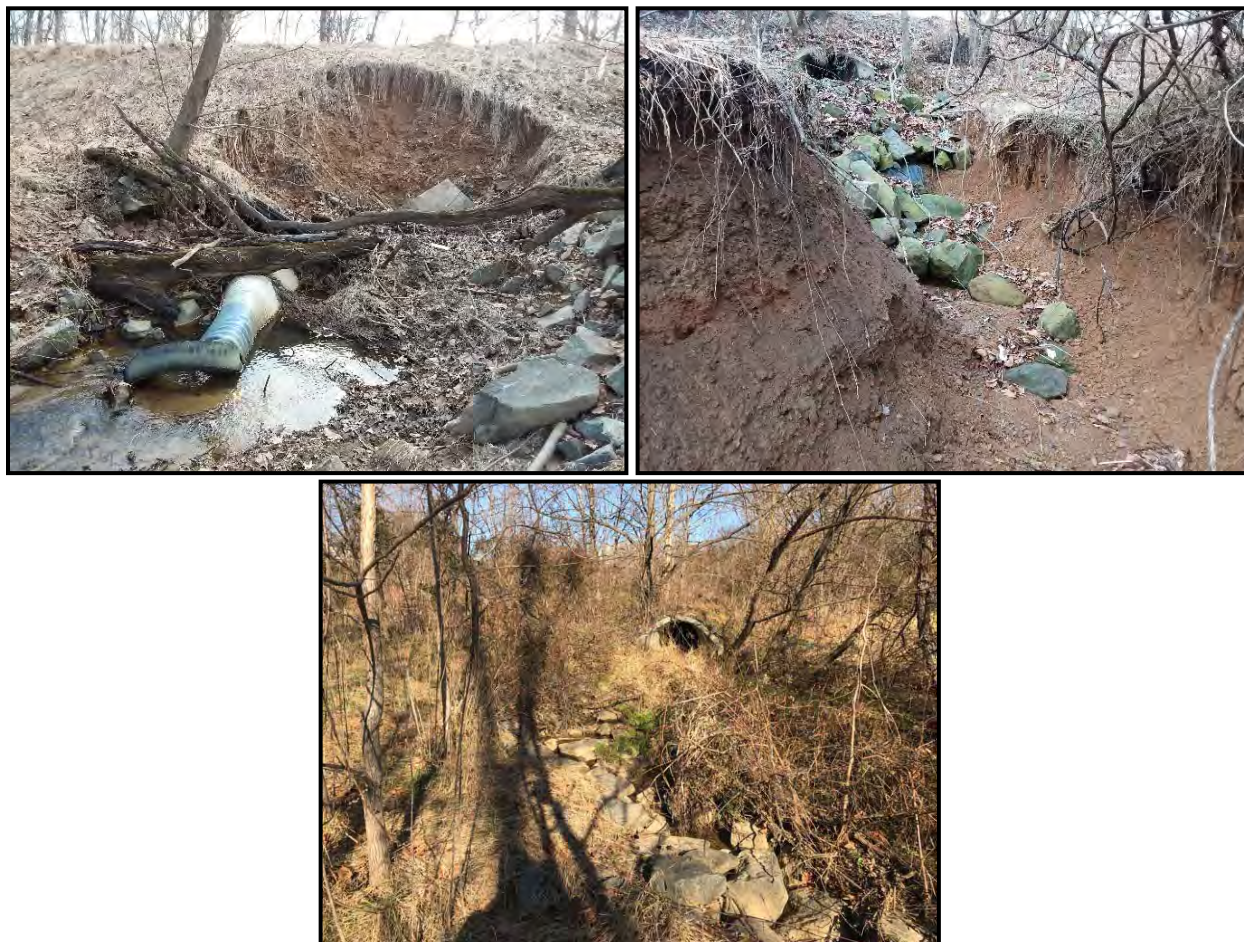
Figure 4-17: Examples of Unusual Conditions Encountered During SCA Surveys.

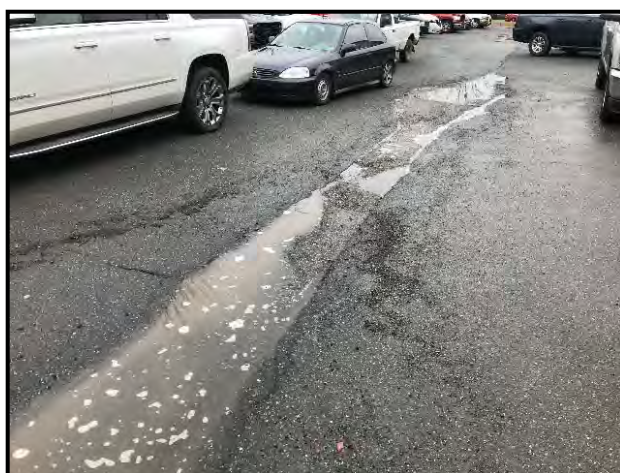
Outdoor vehicle activities such as maintenance, fueling, and washing, without benefit of canopy cover or garaging, were found at four of the sites investigated. Outdoor vehicle activities were found at two commercial businesses dedicated to automotive maintenance, for example an auto body shop where outdoor washing was observed (Figure 4-29). The other two sites were municipal facilities, for example a recycling, maintenance, and bus yard where outdoor fueling was observed (Figure 4-30) and maintenance occurs regularly.

Figure 4-29: Outside Maintenance of a Vehicle at HSI08

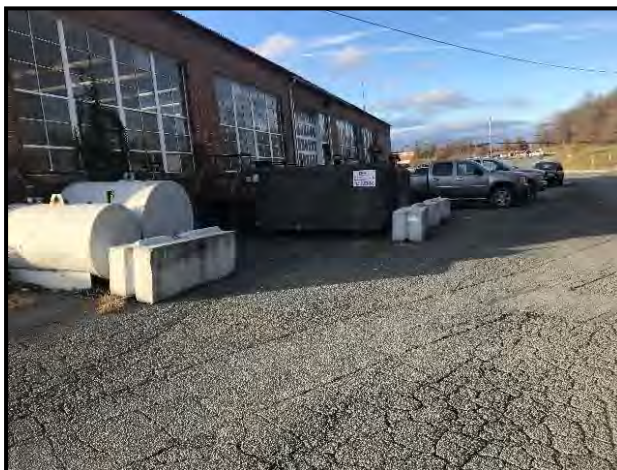
Figure 4-30: Uncovered Fueling Station at HSI01.

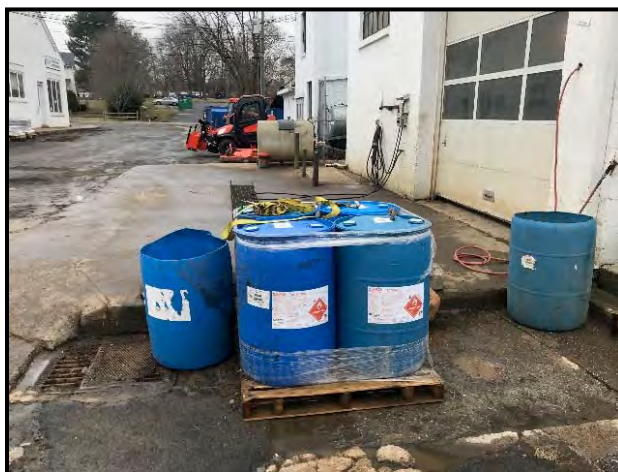
Materials were found stored outside and uncovered at seven locations. If uncovered, such material can leach pollutants or suspended solids to the storm drain system and eventually make its way to surface waters. Material stored outside was mostly found on impervious areas (i.e., concrete or asphalt), such as a maintenance yard. At a maintenance yard, barrels labeled gas and oil were found without secondary containment (Figure 4-31). Other bulk material storage included construction materials, junked equipment parts, and merchandise. In some instances, material was found near storm drain inlets, providing a direct pathway for pollutants to be transferred to surface streams via stormwater runoff. Uncovered loading/unloading operations were found at five locations.

Figure 4-31: Outside storage of liquid materials without an overhead cover or secondary containment at HSI10.

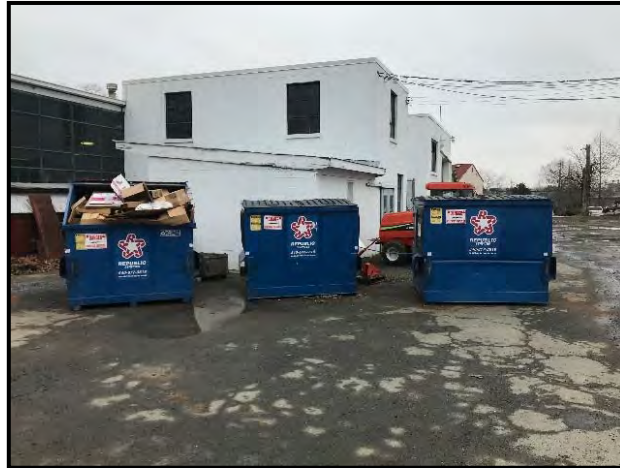
Uncovered and overflowing dumpsters were found at six businesses. Open dumpsters were the most frequently found potential pollution source during hotspot investigations. (Figure 4-32). At one auto body business, discarded car engine parts were placed on the gravel parking area near the dumpster, presumably awaiting disposal.

Figure 4-32: Overflowing Dumpster at HSI10.

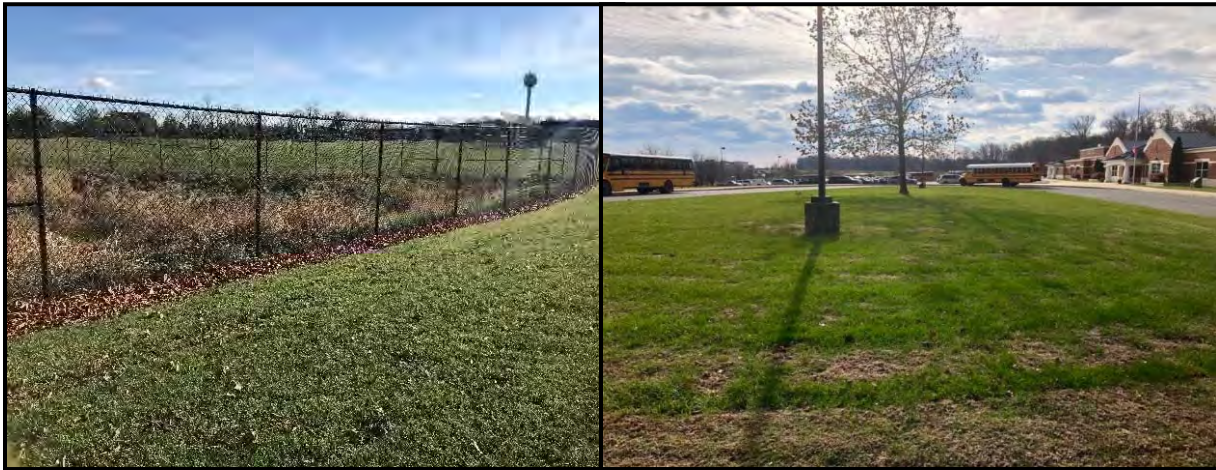
An estimated 7,070 trees were recommended to be planted at institutions within the Western Hills Watershed. Trees were recommended for seven institutions assessed. During field assessments, tree planting areas were identified in the field and drawn on field maps. Small quantities of trees (i.e., less than 10) were recommended for smaller-acreage institutions such as the Loudoun Valley Community Center while a greater number of trees were noted as appropriate for public schools, which tend to have larger available acreage in which to plant. For example, at Culbert Elementary School, a sloping area behind the baseball field that drains to the dry pond on site is currently maintained turf. The slope could be planted in forest cover to help slow overland flow to the facility and improve water quality. In another example, at Mountain View Elementary School, the maintained turf bus circle could be planted with additional trees. These examples are shown in Figure 4-35.

Figure 4-35: Potential Tree Planting Areas at ISI04 (left) and at ISI17 (right)

For planning purposes, the number of trees was estimated based on a density of 200 trees per acre, as noted above. Planning-level estimates presented in Table 4-18 can be refined during follow-up site evaluations.

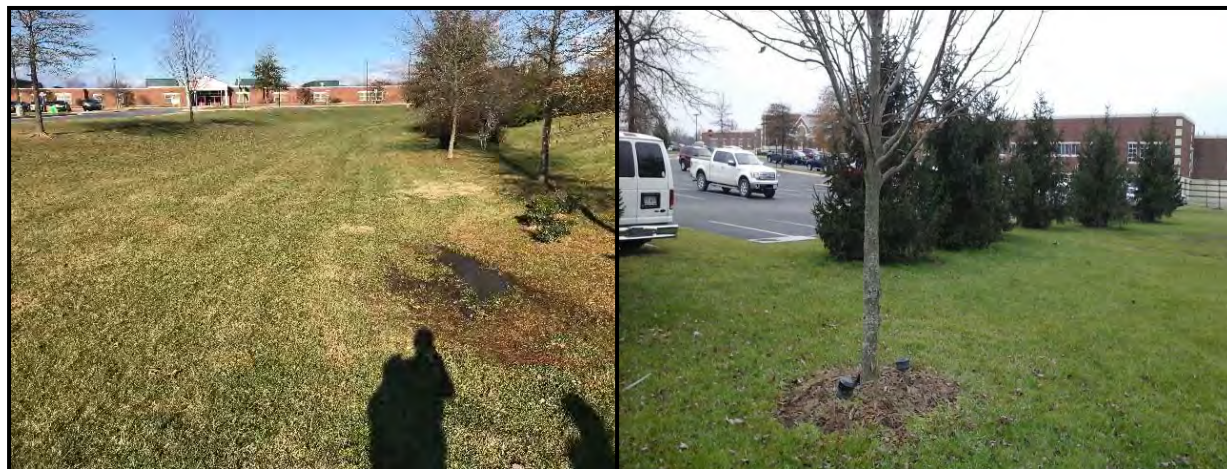
Bioretention treatment utilizes grasses, trees, and shrubs in a planted area to capture, treat, and infiltrate stormwater runoff. At the several public schools that field staff visited, opportunities were found to augment existing stormwater controls. For example, at Culbert Elementary School, an existing grassy swale south of the bus circle could be converted to bioretention to improve stormwater treatment prior to entry into the storm sewer system (Figure 4-36). At Woodgrove High School, installation of bioretention would improve stormwater treatment prior to entry into the storm sewer system. These actions also present an opportunity to educate students and the community at large about the connection between the schools' storm drain systems and the downstream water bodies they flow into.

Figure 4-36: Opportunities for Bioretention at ISI04 (left) and at ISI17 (right)

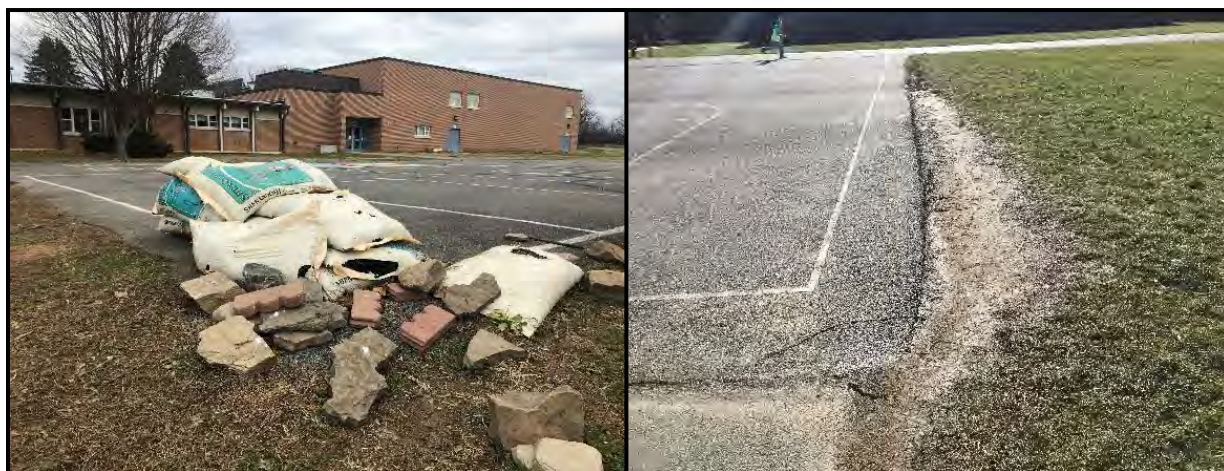
The potential for impervious cover removal was noted at four of the twenty institutions investigated, all at Loudoun County Public School owned sites. Two examples include impervious play areas at Hamilton Elementary School and Culbert Elementary School (Figure 4-37). The removal and replacement of these impervious surfaces was recommended, to be replaced with pervious pavement.

Figure 4-37: Play Area Impervious Cover at ISI10 (left) and ISI04 (right)

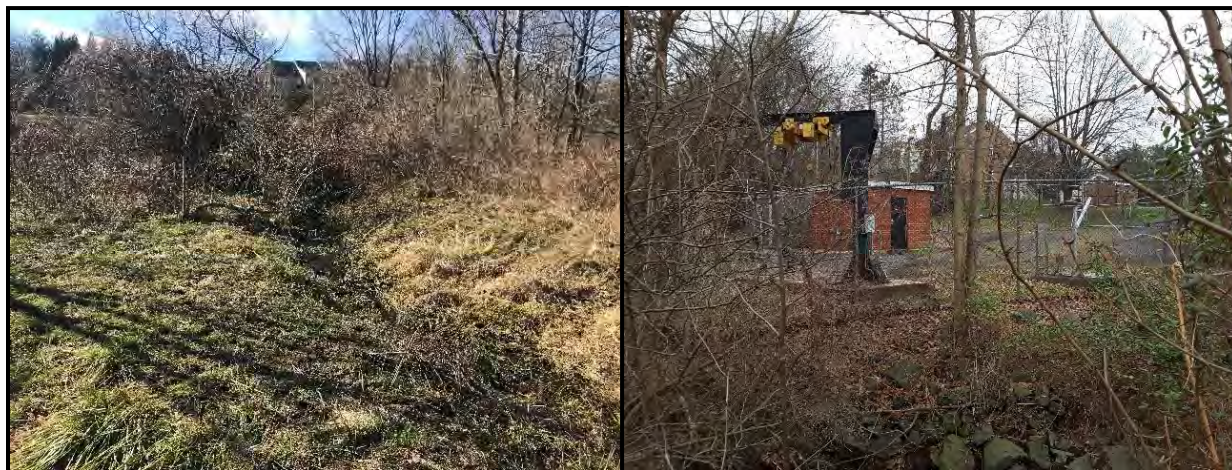
Figure 4-38: Potential Stream Buffer Restoration at ISI16 (left) and ISI11 (right)

Streams were noted on five of the institutions and two were found to lacking adequate buffers. Field teams noted two buffer improvement opportunities. In one case, buffer encroachment has occurred as a result of sanitary sewer installation in stream valleys in order to accommodate new residential and commercial construction in the watershed. Field teams noted that efforts had been made to replant buffers along some streams. An ideal buffer has at least 100 feet of native vegetation along each bank and some previous efforts did not meet this threshold; therefore, opportunities exist at the following areas to improve the buffers: Purcellville Well Head and South Fork Catoclin Creek Conservation Easement. In addition, near the South Fork Catoclin Creek Conservation Easement (Figure 4-38), both banks of a stream near a sanitary sewer right of way would benefit from buffer augmentation.

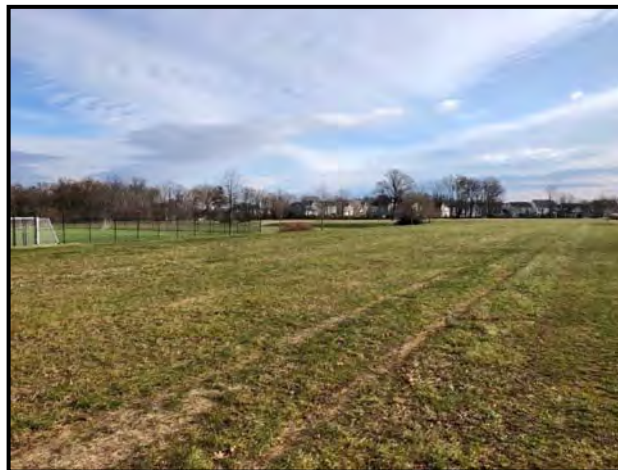
Figure 4-41: Photo of Woodgrove High School (1) potential site for tree planting

The first Woodgrove High School site is located off Alder School Road (Figure 4-41). It is owned and maintained by Loudoun County Public Schools, and the site is easily accessible by foot, vehicle, or heavy equipment. The entire parcel includes two school buildings and many sports fields. The first site is south of Woodgrove High School, is fully covered by maintained turf (100 percent), and it receives full sun exposure. The location identified for tree planting is a large, flat open area that appears ideal for planting. Planting of this site, however, requires verification that it would not interfere with the current school uses of the site, future planning needs, and school safety concerns, and that the tree planting could be a potential community project.

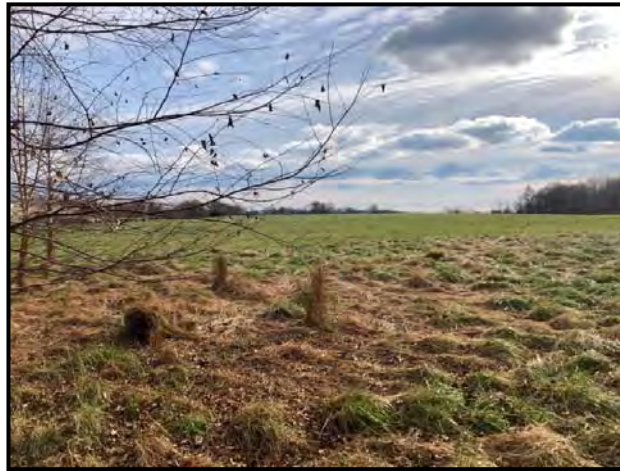
Figure 4-42: Photo of Woodgrove High School (2) potential site for tree planting

The second Woodgrove High School site is located off Alder School Road (Figure 4-42). It is owned and maintained by Loudoun County Public Schools, and the site is easily accessible by foot, vehicle, or heavy equipment. The second site is southeast of Woodgrove High School, is covered primarily by maintained turf (70 percent), and it receives partial sun exposure. The location identified for tree planting is a low-lying area next to a small pond that connects to a stream on the edge of the woods and appears ideal for streamside planting. Tree planting could be a potential community project.

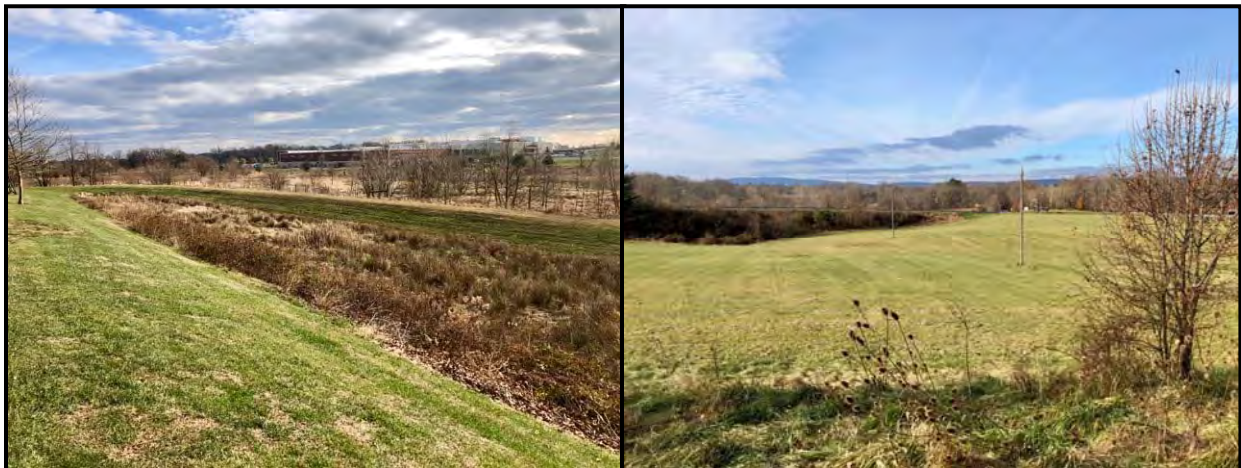
Figure 4-43: Photos of Woodgrove High School (3) potential site for tree planting

The third Woodgrove High School site is located off Alder School Road (Figure 4-43). It is owned and maintained by Loudoun County Public Schools and the site is easily accessible by foot, vehicle, or heavy equipment. The third site is at the far south end of the parcel, fully covered by maintained turf (100 percent), and it receives full sun exposure. Planting of the site, however, will require verification that it would not interfere with the current planned uses of the site and that tree planting could be a potential community project.

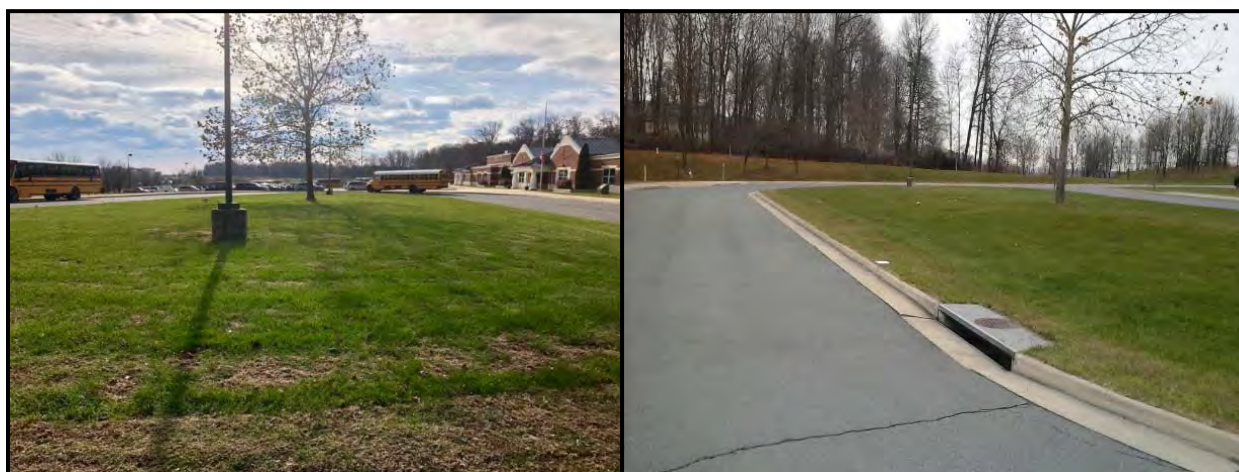
Figure 4-44: Photos of Mountain View Elementary School potential site for tree planting

The Mountain View Elementary School site is located off Alder School Road on the same parcel as Woodgrove High School (Figure 4-44). It is owned and maintained by Loudoun County Public Schools, and the site is easily accessible by foot, vehicle, or heavy equipment. It is a grassed bus circle; it is mostly covered by maintained turf (95 percent) and receives full sun exposure. The bus circle identified for tree planting is sloping to the west, with two street lamps present and two catch basins. Planting of this site, however, requires verification that it would not interfere with the current school uses of the site, future planning, needs, and that tree planting could be a potential community project. This site has also been marked as a potential site for a new stormwater treatment BMP.

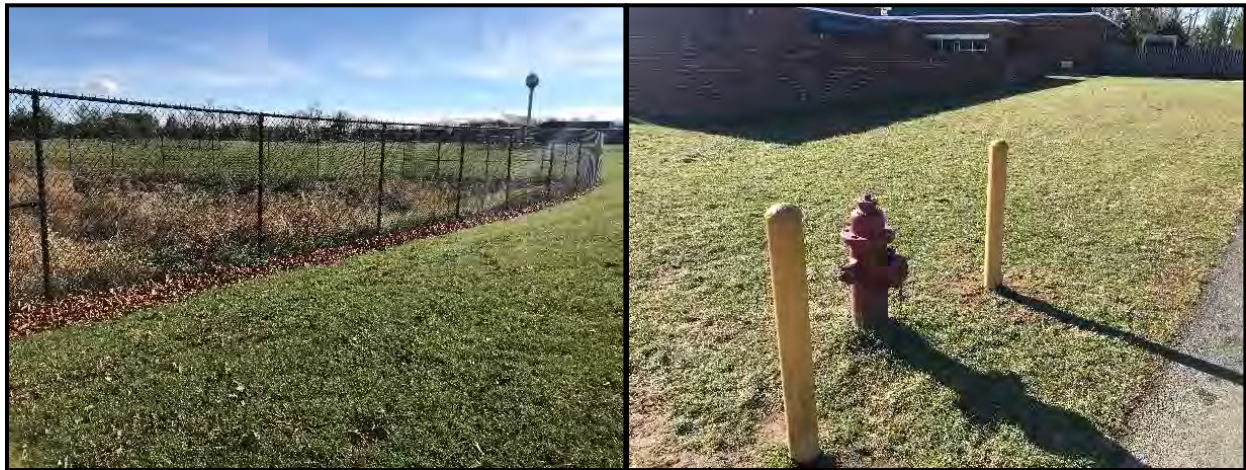
Figure 4-45: Photos of Culbert Elementary School potential site for tree planting

The Culbert Elementary School site is located north of West Colonial Highway (Figure 4-45). It is owned and maintained by Loudoun County Public Schools and the site is easily accessible by foot, vehicle, or heavy equipment. The site selected for tree planting is currently covered by maintained turf (100 percent) and it receives full sun exposure. Opportunities for tree planting at this site are located between the baseball field and a County owned dry pond. This will help slow overland flow to the dry pond and improve water quality. Tree planting could be a potential community project.

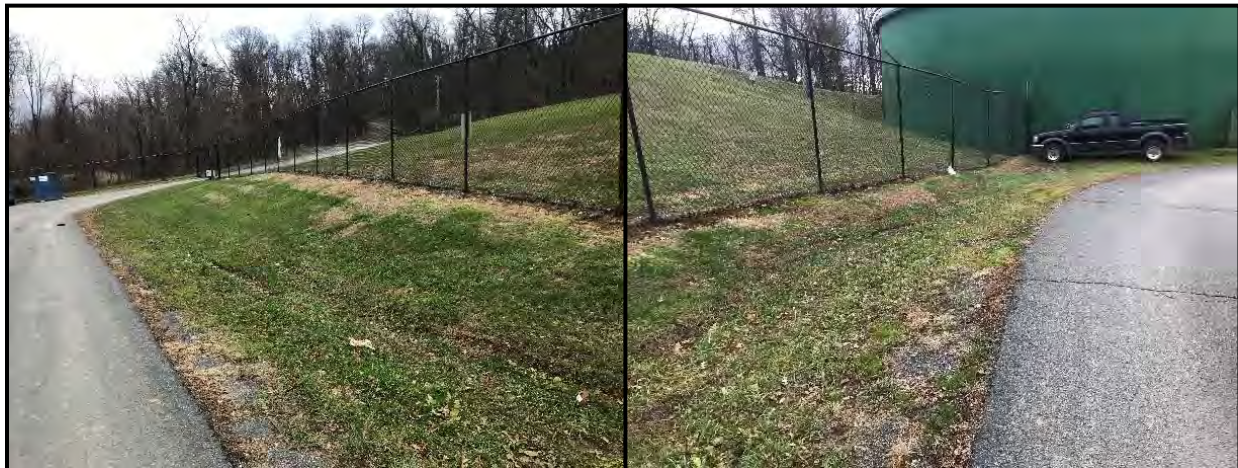
Figure 4-46: Photos of Purcellville Water Treatment Plant – Northeast potential site for tree planting

The Purcellville Water Treatment Plant – Northeast site is located immediately southwest of Short Hill Road (Figure 4-46). It is owned and maintained by the Town of Purcellville and is easily accessible by foot, vehicle, or heavy equipment. The site selected for potential tree planting is fully covered by maintained turf (100 percent) and it receives full sun exposure. Opportunities for tree planting at this site are located directly east of the fence around the water treatment plant, along the hill.

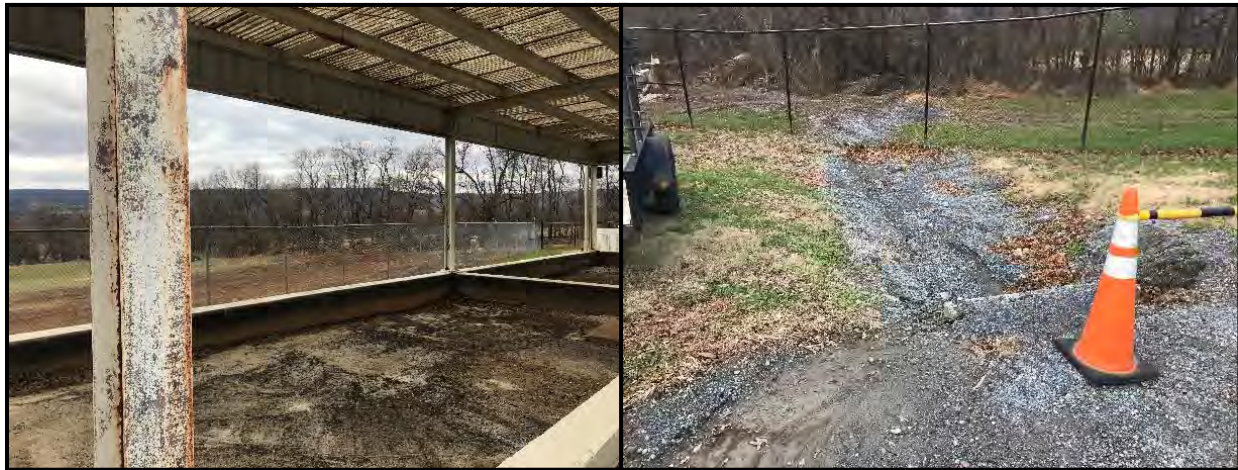
Figure 4-47: Photos of Purcellville Water Treatment Plant – Northwest potential site for tree planting beyond settling ponds and fence

The Purcellville Water Treatment Plant – Northwest site is located immediately southwest of Short Hill Road (Figure 4-47). It is owned and maintained by the Town of Purcellville and is easily

accessible by foot, vehicle, or heavy equipment. It is currently uncovered dirt (0 percent turf cover) because of maintenance occurring on site and it receives full sun exposure. An area of opportunity for tree planting at this site is located directly west of the fence around the water treatment plant. The area has been recently disturbed and would be easy to reintroduce trees to the site. Although the entire area is marked as a site for future expansion of the plant, an established forested buffer could be incorporated within the planning of the expansion.

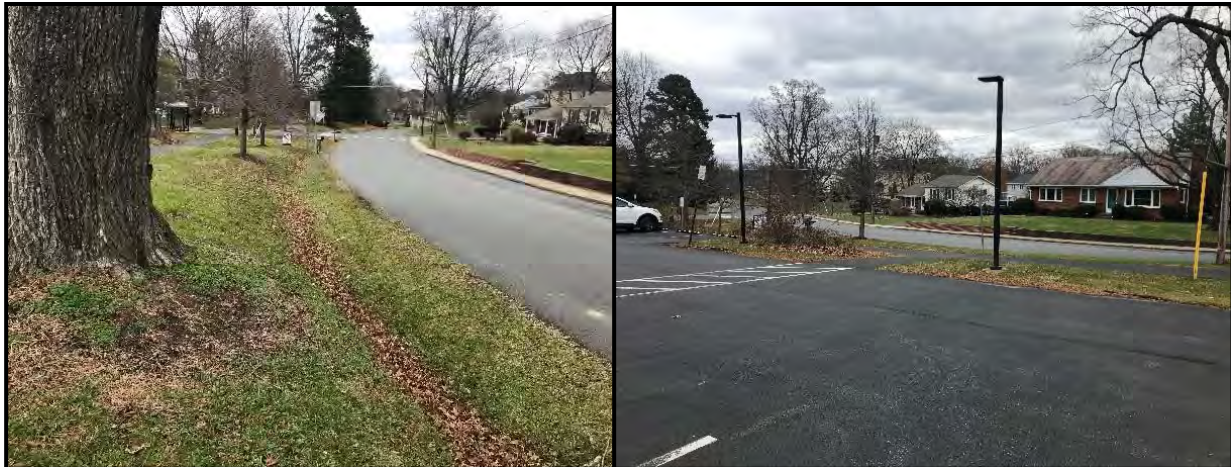
Figure 4-48: Photos of Loudoun Valley Community Center potential site for tree planting

The Loudoun Valley Community Center site is located off West School Street, at the intersection of South Nursery Street (Figure 4-48). It is owned and maintained by Loudoun County and all parts of the site are easily accessible by foot, vehicle, or heavy equipment. About ninety-five percent (95 percent) of the area to be reforested is covered by maintained turf and it receives full sun exposure. There is a path along South Nursery Street that would benefit from plantings along the whole path. The tree planting could be a potential community project.

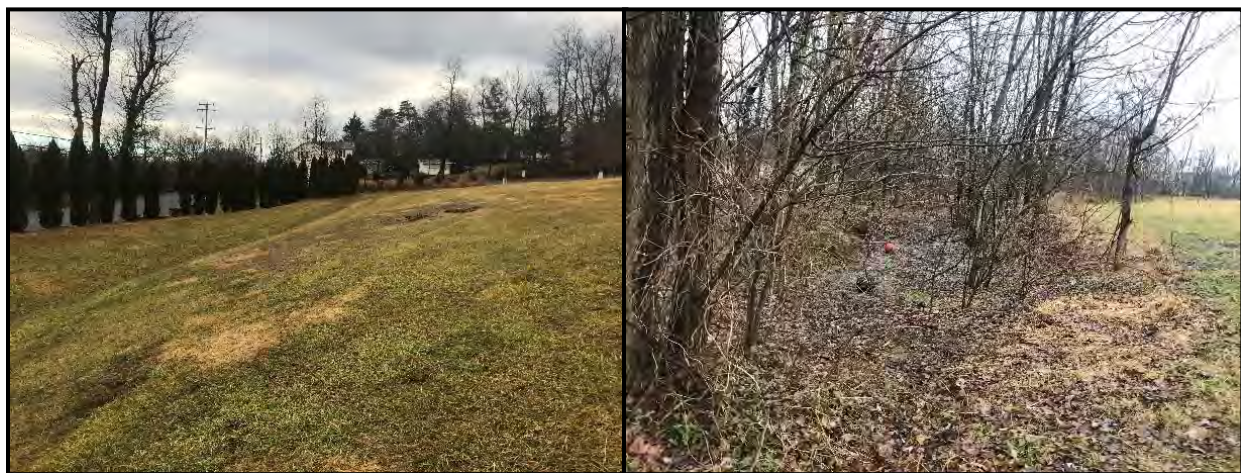
Figure 4-49: Photos of Blue Ridge Bible Church potential site for tree planting

The Blue Ridge Bible Church site is located off South 20th Street, north of East A Street (Figure 4-49). It is privately owned and maintained, and all parts of the site are easily accessible by foot, vehicle, or heavy equipment. The location for tree planting is fully covered by maintained turf (100 percent) and it receives full sun exposure. It is recommended that trees be added to the buffer already in place on the eastern stormwater conveyance leading to the dry pond and along the western conveyance also. Planting these areas would help to slow overland stormwater flows to the dry pond on site. Planting of this site, however, requires verification that it would not interfere with the current church uses of the site and future planning needs.

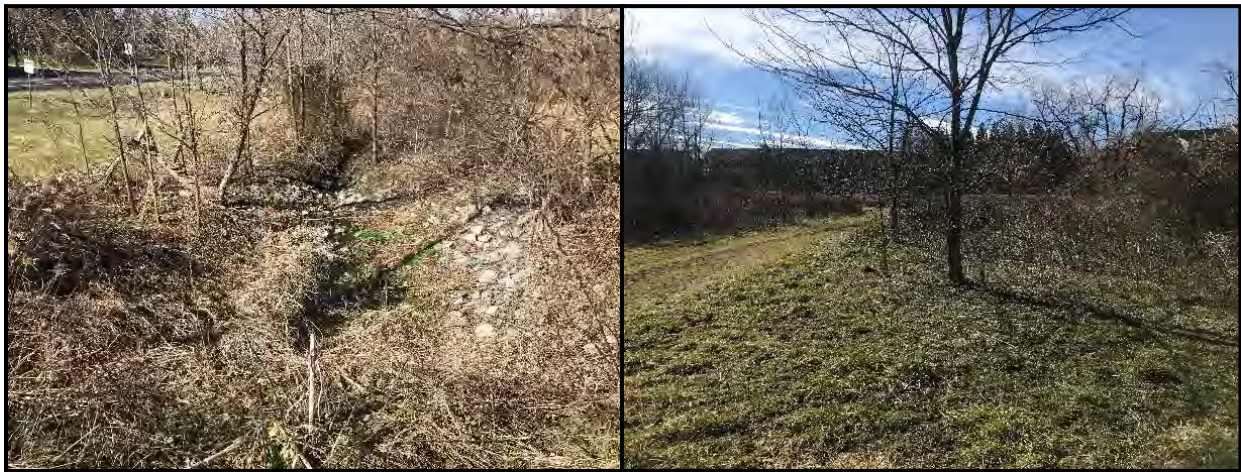
Figure 4-50: Photos of South Fork Catoctin Creek Conservation Easement potential site for tree planting

The South Fork Catoctin Creek Conservation Easement site is located off North 21st Street, at the entrance to the martial arts building (Figure 4-50). It is owned and maintained by the Town of Purcellville and all parts of the site are easily accessible by foot, vehicle, or heavy equipment. About forty percent (40 percent) of the site is covered by trees or shrubs and sixty percent (60 percent) other herbaceous plants and it receives full sun exposure. The location would add a stream buffer to a recommended regenerative stormwater conveyance. Upland locations are potentially available for planting as well. Planting trees in these areas after completing the retrofit would help to slow overland stormwater flows to the local tributaries. Planting of this site, however, requires verification that it would not interfere with the neighboring utility easement.

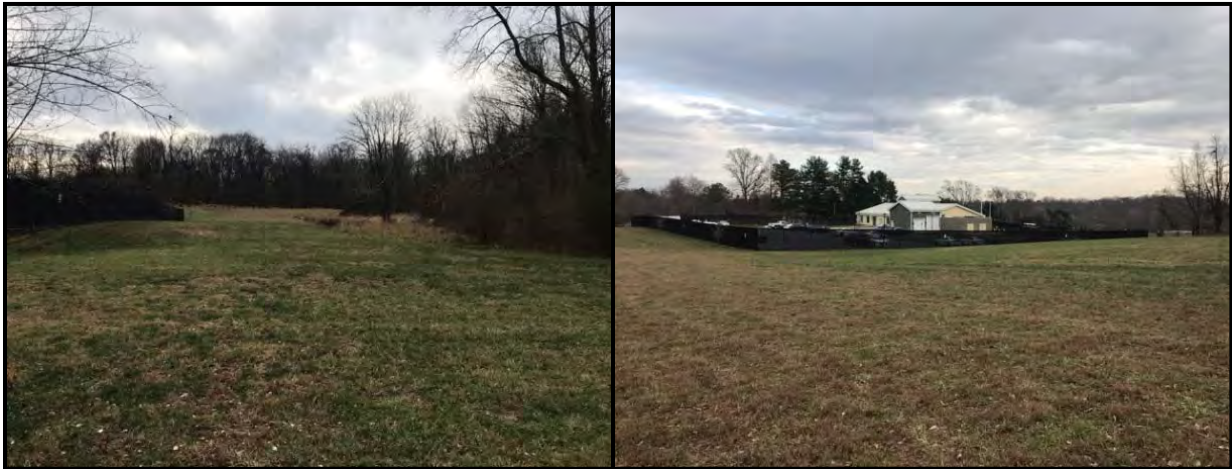
Figure 4-51: Photos of Loudoun County Sheriff's Office potential site for tree planting

The Loudoun County Sheriff's Office site is located off Michelle Way, north of West Loudoun Street (Figure 4-51). It is owned and maintained by Loudoun County and all parts of the site are easily accessible by foot, vehicle, or heavy equipment. About eighty percent (80 percent) of the site is covered by maintained turf and it receives full sun exposure. The large open upland fields behind the building appear to be ideal for tree planting. Tree planting could be a potential community project.

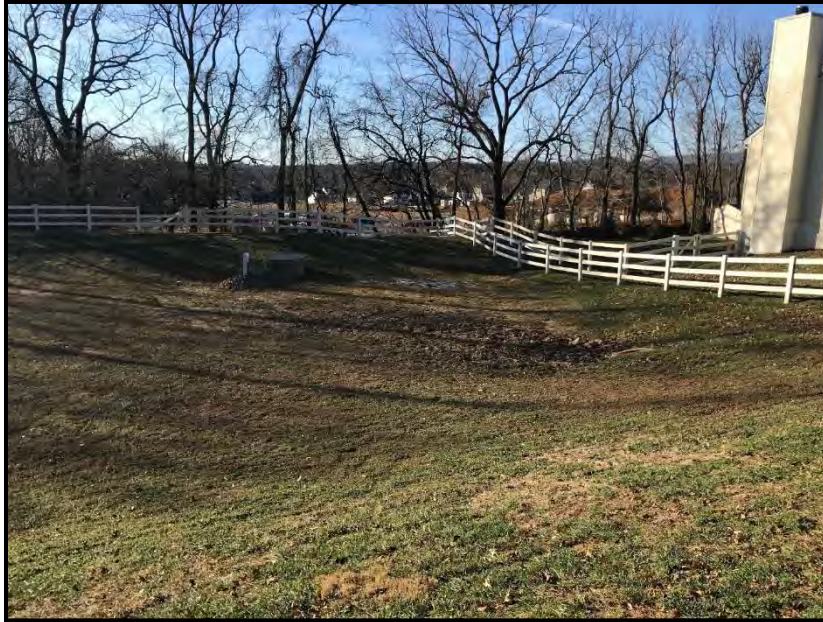
Figure 4-53: Dry Pond JC7170

Dry pond JC7170 (Figure 4-53) drains a residential section of the Oak Hill neighborhood. It is an offline pond that has been modified with extended detention elements. The low flow has been designed as a perforated drain pipe and gravel filter connecting to the existing low flow orifice. The existing outflow structure with grate provides conveyance and flow control (Figure 4-54). It is unknown if the additional extended detention elements added to the pond are appropriately credited. The western side of the dam wall is considerably lower and could cause overflow into neighbors' yard during intense rains (Figure 4-55). It is recommended that in addition to the extended detention elements already in place, more be added to help with the erosion seen along the outfall (Figure 4-56). A sediment forebay is recommended at the inlet, and flow diversions as needed to direct flow to the eastern side of the pond to use all available space and reduce deposition of finer settleable and suspended fractions on the gravel filter. In addition to these upgrades, the pond needs regular maintenance to prevent pond floor sedimentation and clogging of the gravel filter. Alternate designs for low flow and/or incorporating real-time control can provide improved sediment recovery.

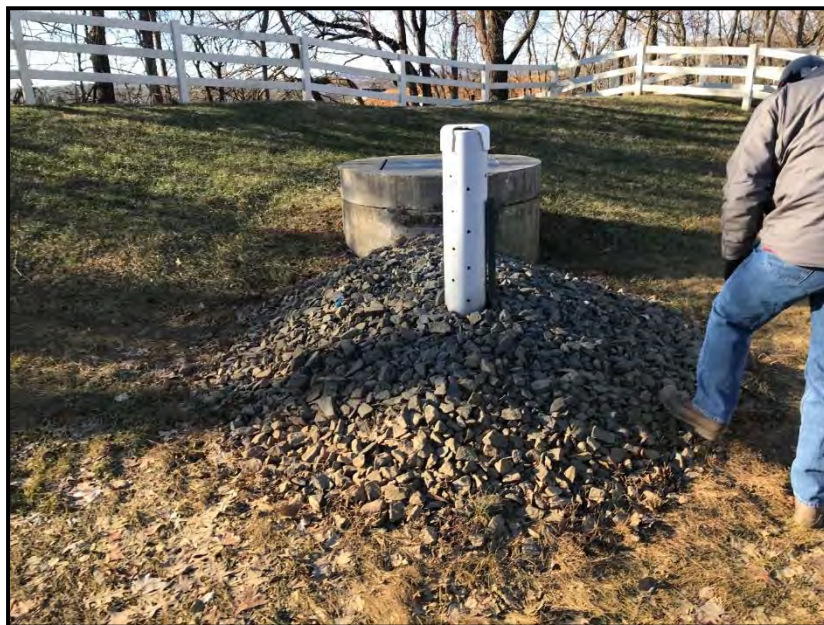
**Figure 4-54: Perforated stack pipe, gravel filter, and grated outflow with low flow orifice
in Dry Pond JC7170**

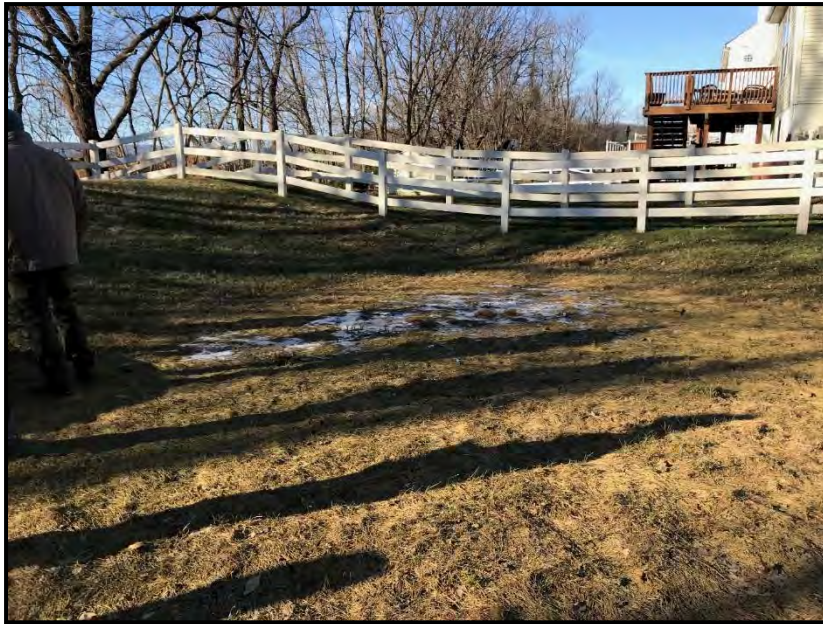
Figure 4-55: Low point along Western side of Dry Pond JC7170

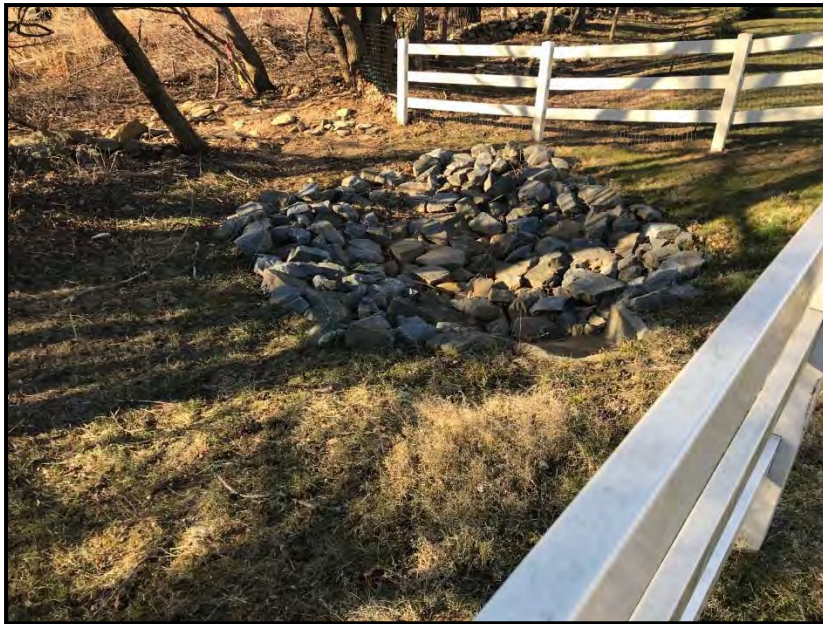
Figure 4-56: Erosion along outfall swale
