WESTERN HILLS WATERSHED MANAGEMENT PLAN

**Loudoun County
Department of
Building and Development
1 Harrison St.
Leesburg, VA 20175**

**Tetra Tech, Inc.
10711 Red Run Blvd., Suite 105
Owings Mills, MD 21117**

May 12, 2020

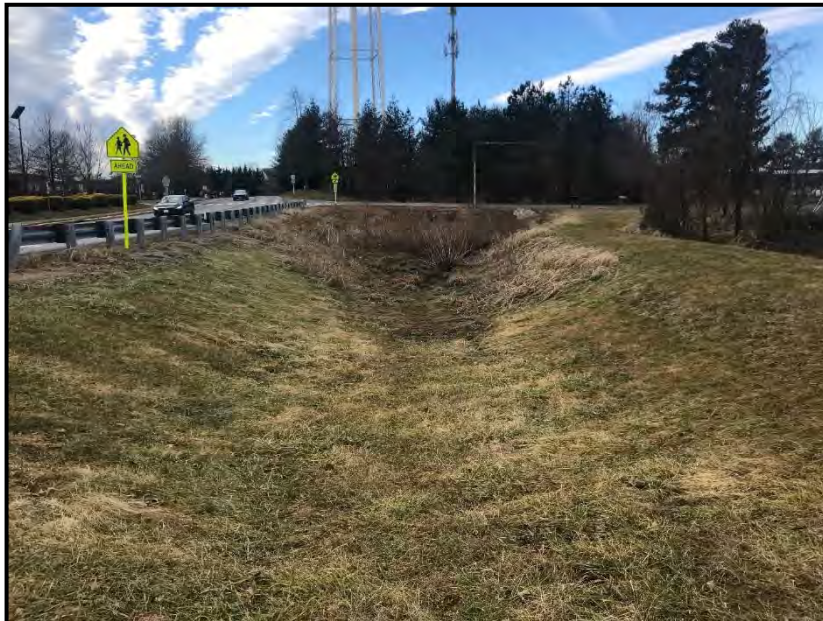
Figure 4-57: Dry Pond SWM24

Dry pond SWM24 (Figure 4-57) drains Loudoun Valley High School and portions of North Maple Drive. The pond was designed as an educational opportunity for the high school with a pollinator garden (Figure 4-58) but the pollinator species appear to have died out because of the pond holding water beyond the designed detention time which has caused continuous inundation (Figure 4-59). It is recommended that extended detention elements be added to the pond to improve the capacity. The flow path can be extended to fully use the space available in the pond by adding a berm. Currently, it appears the low flow orifice is experiencing sedimentation. Sediment forebays could be utilized at both inlets to prevent this sedimentation (Figure 4-60). The regular maintenance of the pond will ensure that wetland species do not crowd out the local and pollinator species and will ensure that this continues to be an educational opportunity for the high school.

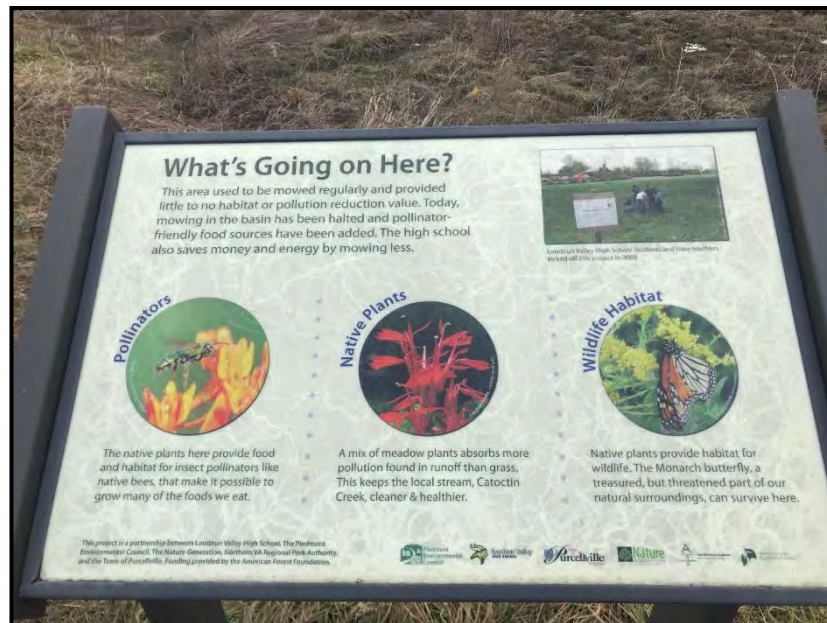
Figure 4-58: Sign at Dry Pond SWM24 indicating pollinator garden and educational opportunity

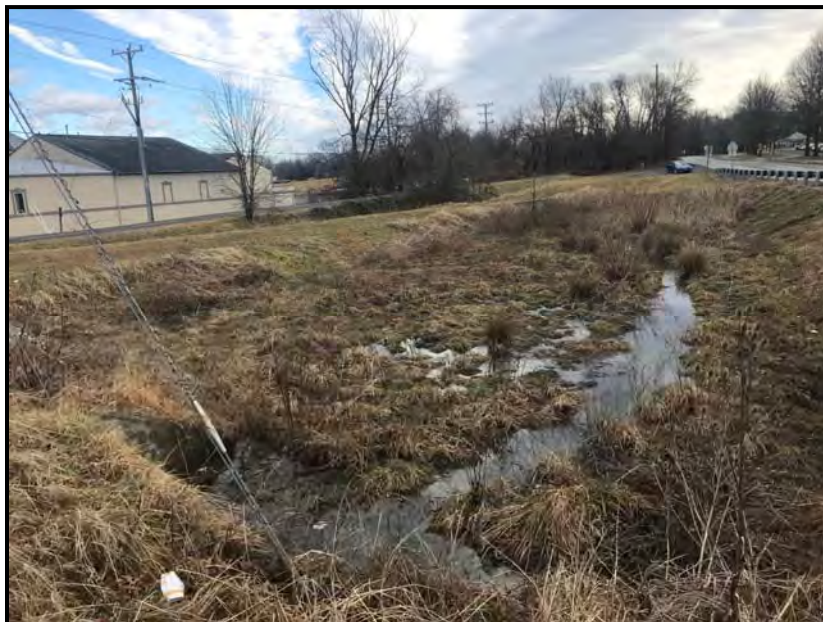
Figure 4-59: Continuous ponding at Dry Pond SWM24

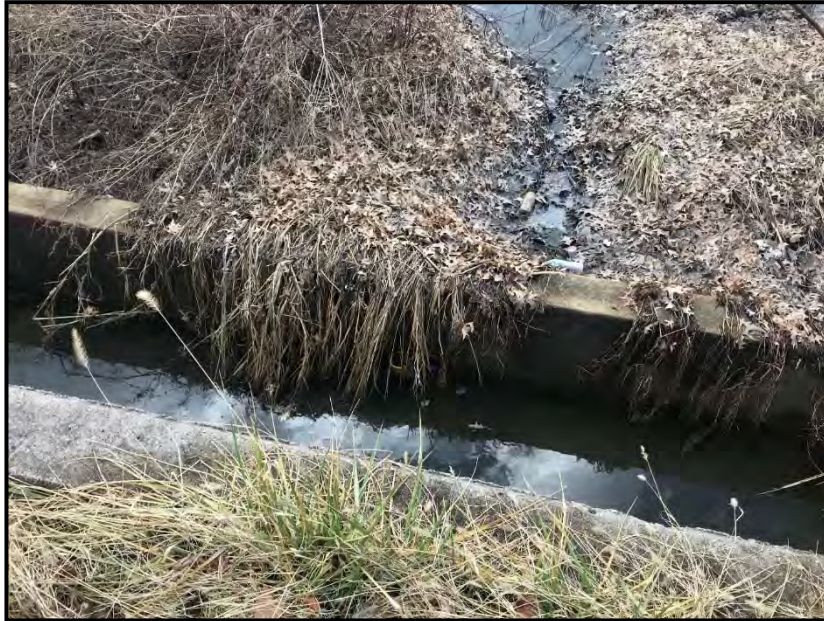
Figure 4-60: Outflow with standing water, assumed sedimentation within the low flow orifice

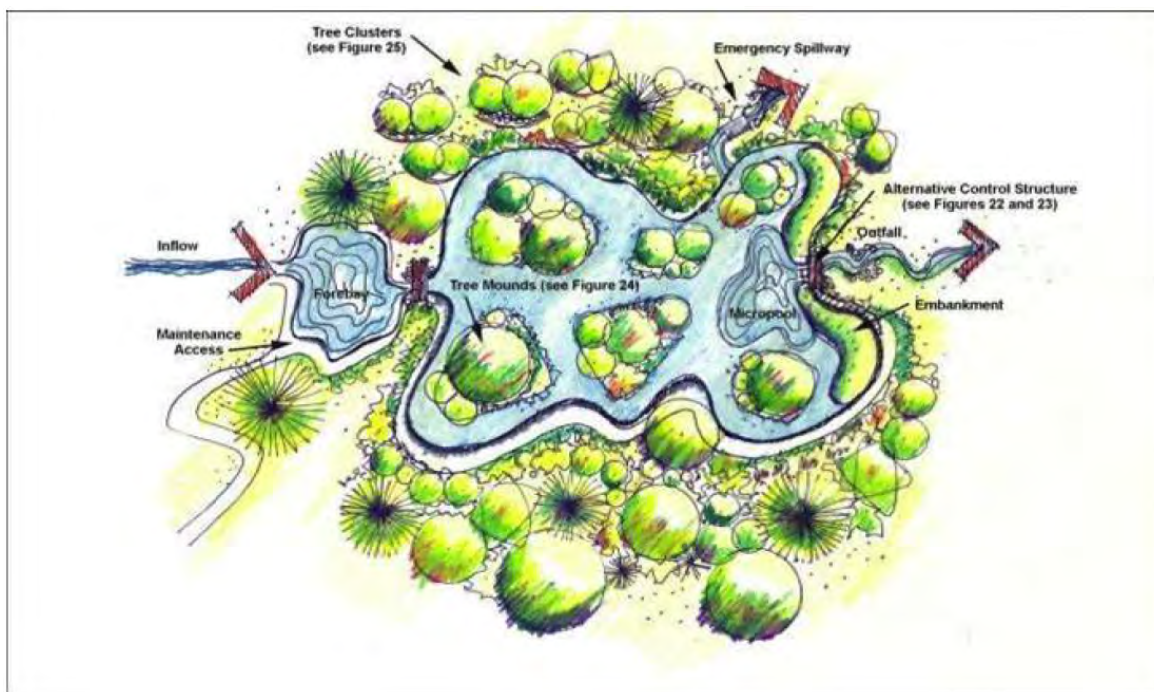
Figure 6-1: Constructed Wetland Standard Concept Design (Virginia DEQ 2011a)

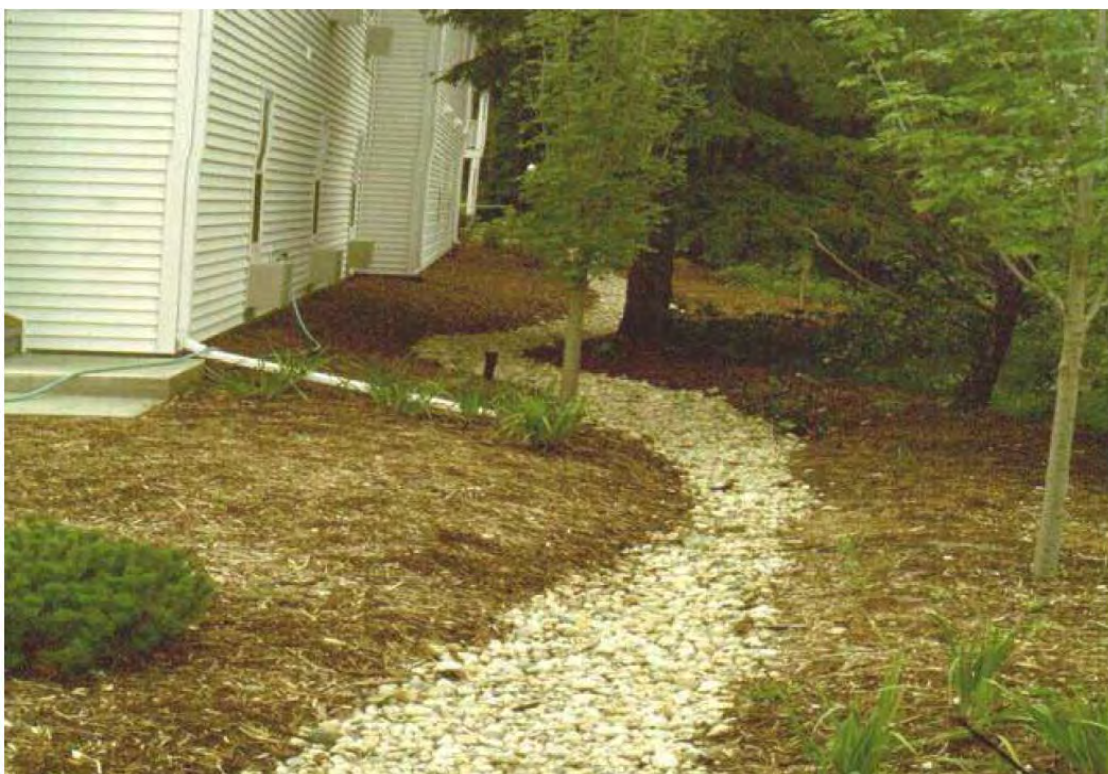
Figure 6-2: Residential Infiltration Trench (Virginia DEQ 2011b)

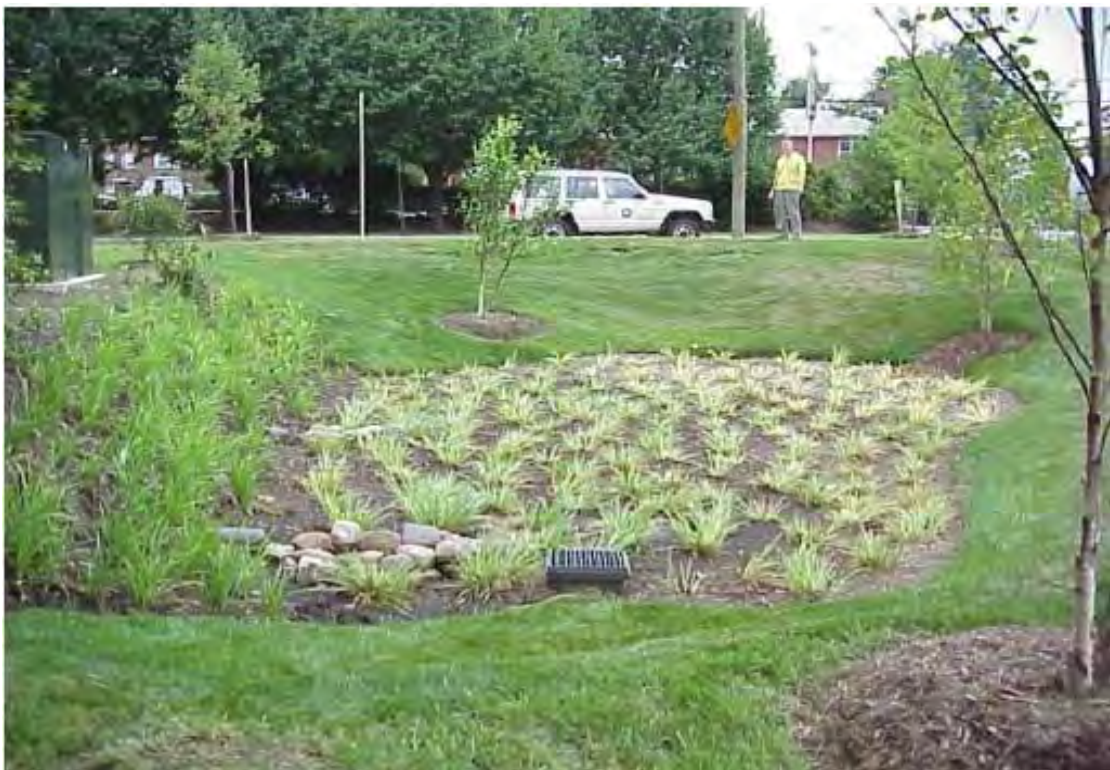
Figure 6-4: Photo of Bioretention Draining a Rooftop at a Commercial Facility (Virginia DEQ 2011c)

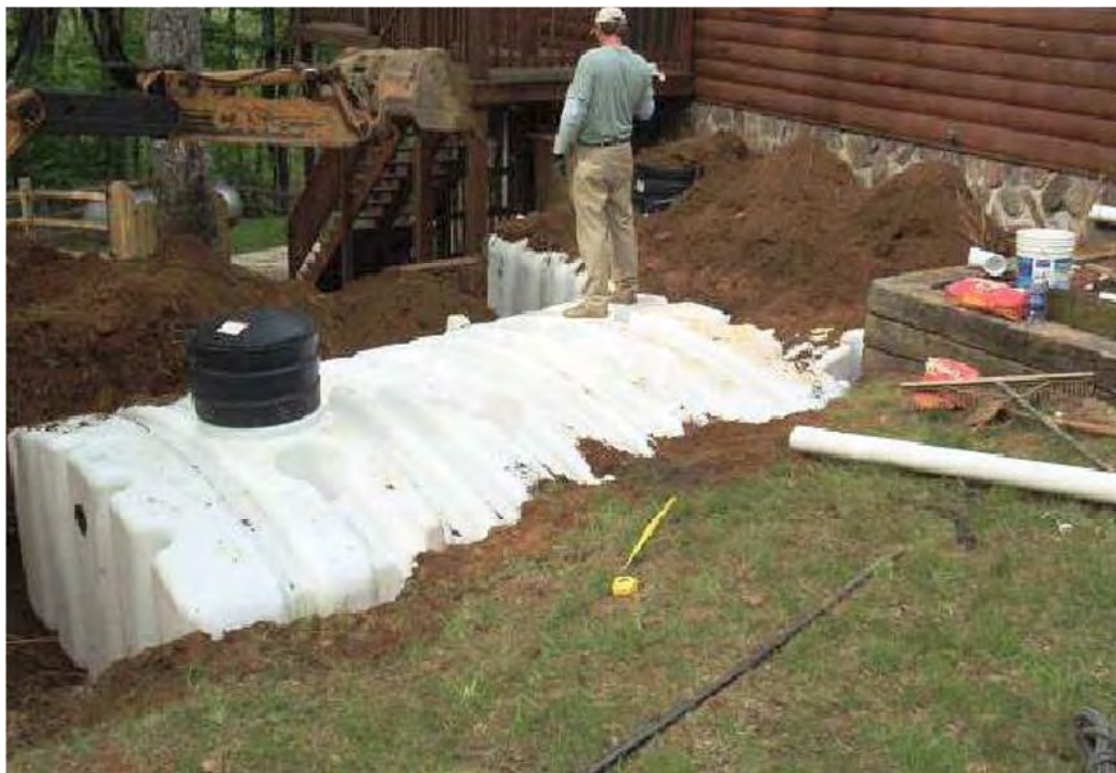
Figure 6-9: Subterranean Cistern (Virginia DEQ 2011f)

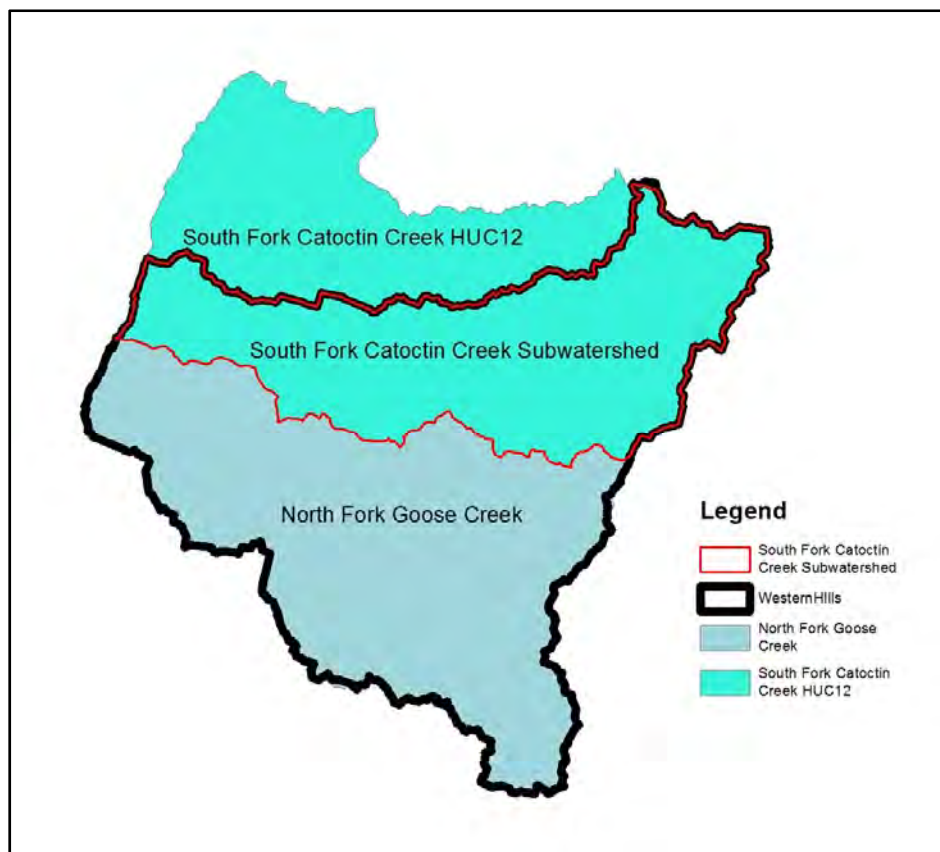
Figure 7-2: Western Hills Watershed – North Fork Goose Creek and South Fork Catoclin Creek subwatershed, which is a portion of the South Fork Catoclin Creek HUC12

Figure 7-1. The entire North Fork Goose Creek is within the Western Hills Watershed and is defined by the USGS 12-digit hydrologic unit code (HUC) 020700080602; however, the South Fork Catoclin Creek subwatershed, while entirely within the Western Hills Watershed, is only a

portion of the USGS 12-digit HUC 020700080301, known as South Fork Catoclin Creek; see Figure 7-2.

Because the entire North Fork Goose Creek watershed is within the Western Hills Watershed, the CAST land use and loading information can be used directly, without further processing. However, the South Fork Catoctin Creek HUC12 is composed of areas both within and outside of the Western Hills Watershed (Figure 7-2). Only the South Fork Catoctin Creek subwatershed is included in the Western Hills. To identify the land use for just the South Fork Catoctin Creek subwatershed, additional information is needed.

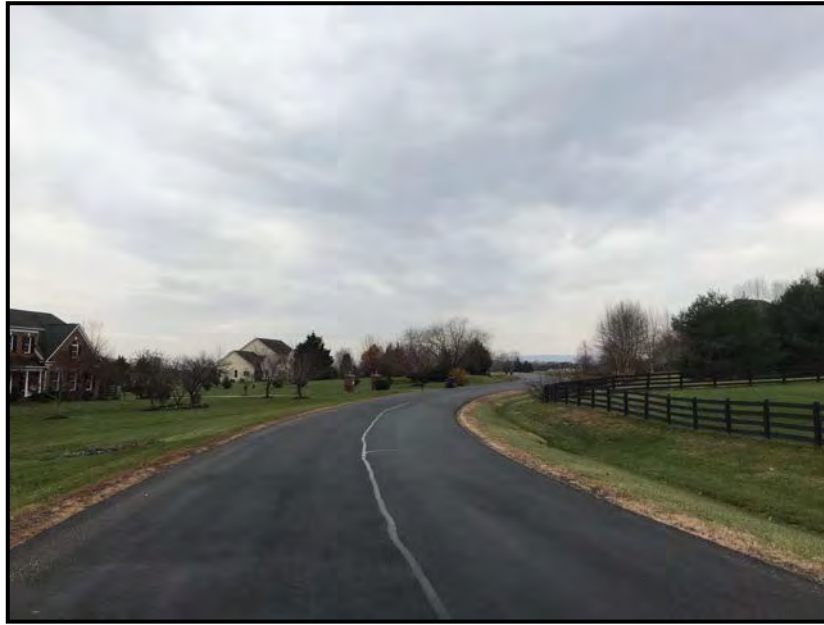
Figure 8-3: Large yards present an opportunity to plant rain gardens in NSA106

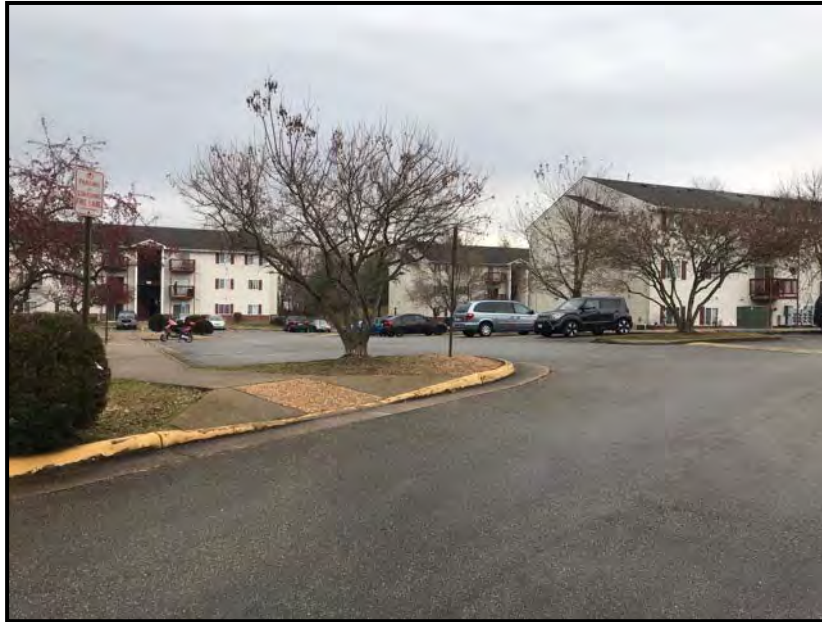
Figure 8-4: Add rain barrels to apartment buildings to collect rooftop runoff from heavy rains

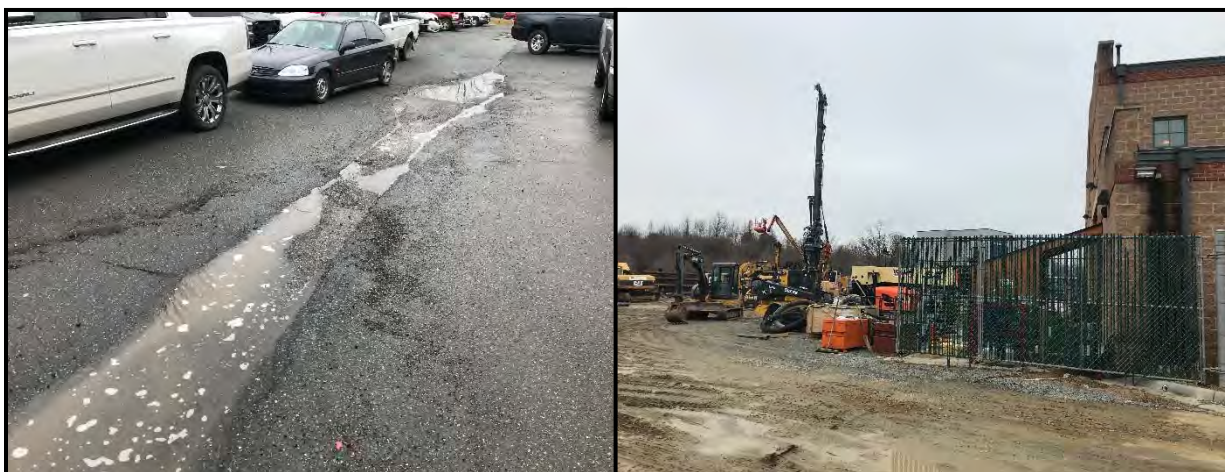
Figure 8-5: Washing and Parking Lot Break Up (left) at HSI08 and Large Equipment Storage (right) at HSI11

At the body shop, outdoor vehicle washing was observed, with washwater flowing to a storm drain. The asphalt within the vehicle storage parking lot was breaking up. Both issues are shown in Figure 8-5 (left). The equipment storage yard (Figure 8-5, right) was entirely bare soil and was used for storage of large equipment. The storage area discharged as direct runoff to a stream as well as to a storm drain system. There were signs of loading and unloading operations at the sales store.

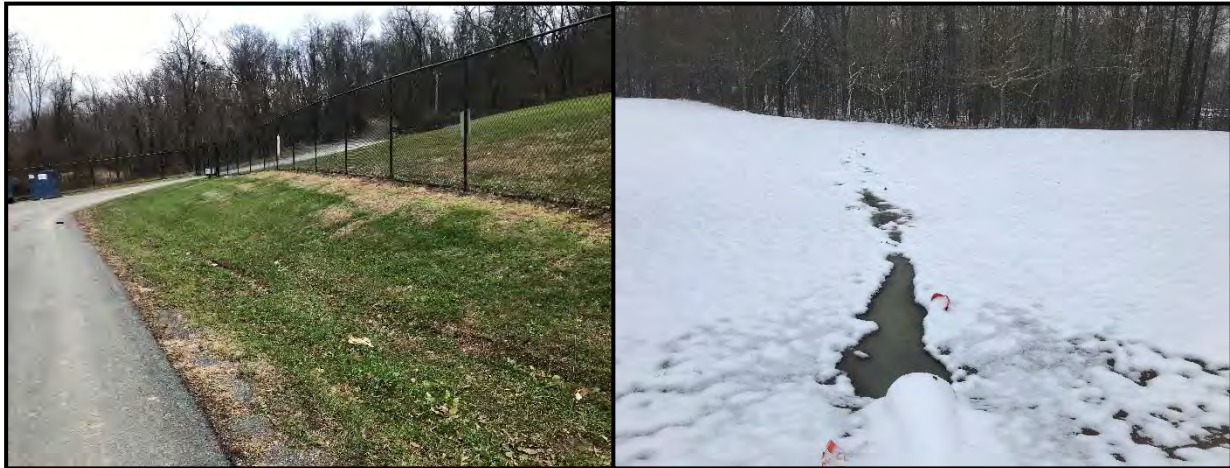
Figure 8-6: Tree Planting Opportunity along Slope (left) at ISI07 and Bioswale Opportunity (right) at ISI17

At ISI07, the pavement was found in poor condition and contained a lot of broken pavement areas. Downspouts were discharging directly to the impervious pavement. Due to the steep grade, shallow concentrated runoff channels were seen causing erosion. School buses are stored outside at ISI17. ISI07, ISI16, and ISI17 have opportunities for tree plantings as well as new SCMs to treat runoff generated onsite (Figure 8-6). Tree planting opportunities, as identified in the Urban Reforestation Site Assessments, are described below under Open Space Tree Planting Opportunities. Recommendations for new SCMs are described in Chapter 9.

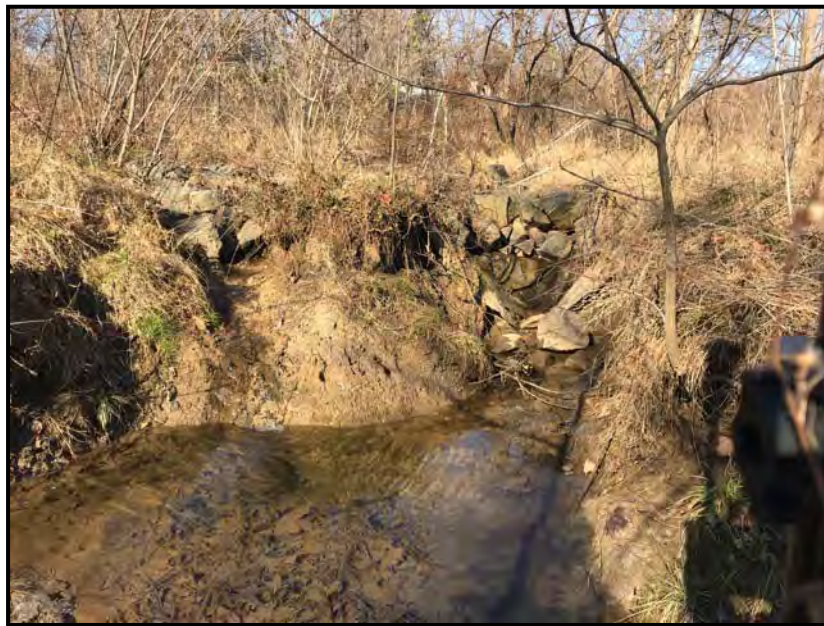
Figure 8-7: Erosion associated with culvert outfall.

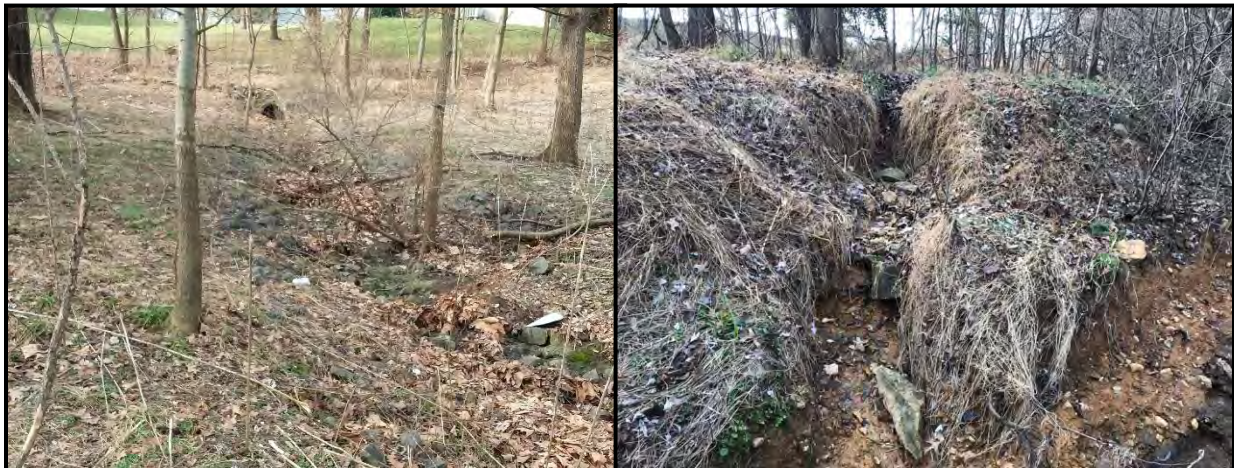
Figure 8-8: Runoff from neighborhood draining into stream (left) and gully created by football field drainage (right)

Field crews walked 2.61 miles of stream (12.7 percent of total stream miles) within the Upper South Fork Catoctin Creek subwatershed to identify potential water quality problems and restoration opportunities. Maps showing key findings of the stream corridor assessments are found in Section 4.1. A total of 26 problems were identified at stream reaches assessed in the Upper South Fork Catoctin Creek subwatershed. The predominant issues were erosion, which was generally rated moderate and with good opportunities of being corrected by stream restoration projects. Near the mainstem South Fork Catoctin Creek (Site 2) the presence of erosion is evident from drainage discharged from a culvert that outfalls 10 feet from the stream bank causing extreme erosion of the stream bank and floodplain area (Figure 8-7). At Site 1, near the football field at Woodgrove High School, a gully is being created as drainage runs off the football field. A pipe outfall observed during the stream assessment was related to runoff drainage from a neighborhood situated next to

South Fork Catoctin Creek at Site 2 (Figure 8-8). Several channel alterations have been previously implemented along South Fork Catoctin Creek in the form of riprap placed under road crossings and along the stream bank for the purpose of stabilization. Several fish barriers in the form of debris jams and beaver dams were also observed (see example in Figure 8-9).

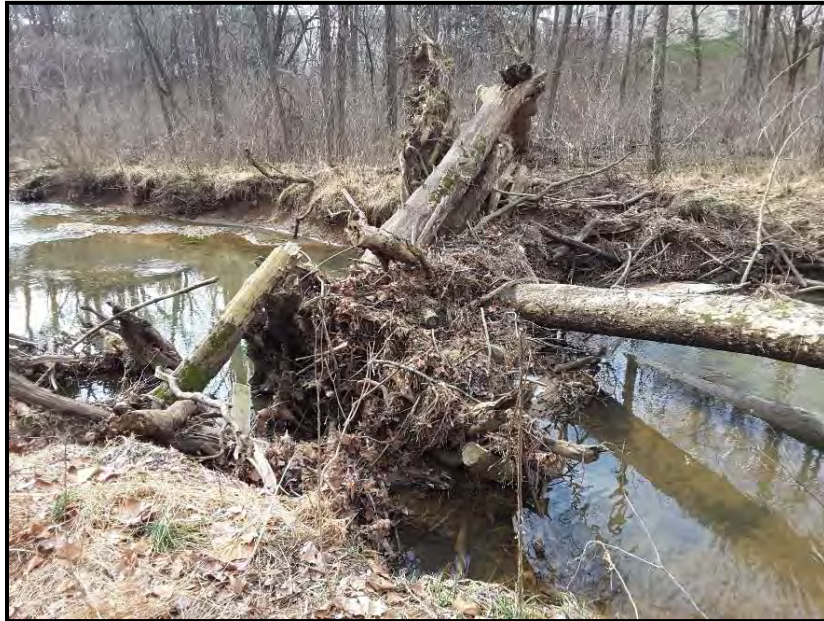
Figure 8-9: Debris jam creating fish passage barrier at Site 2

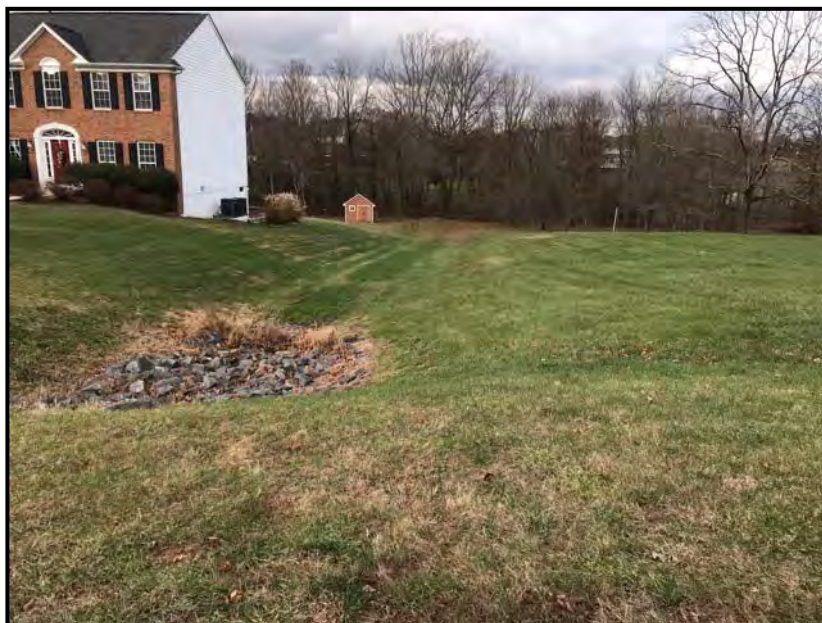
Figure 8-12: Opportunity for rain garden in drainage ditch to stream

The neighborhoods assessed within the Lower South Fork Catoctin Creek subwatershed had several opportunities for improvement. Large portions of the neighborhoods covered by mowed lawns provides a great opportunity for rain garden installation (Figure 8-12) and sustainable landscaping. In addition, actions as simple as reduced fertilizer application, adjusting mowing practices, and tree plantings are recommended to slow down high flows that cause bank erosion and to intercept nutrients and other pollutants before they enter the aquatic ecosystem.

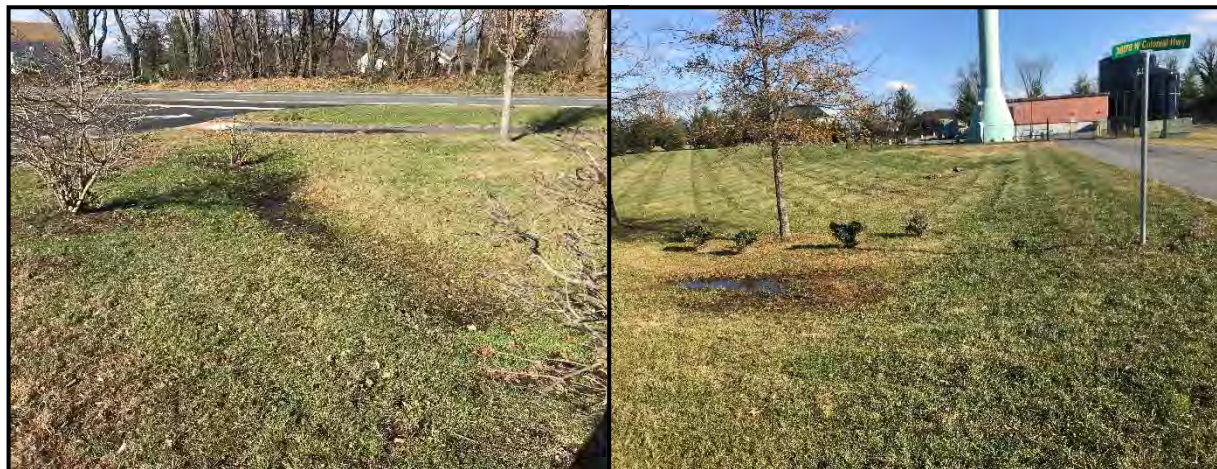
ISI01 is a well-maintained park with a gravel parking lot. There is good tree coverage along the perimeter. ISI02 has two existing SCM treatment systems to treat runoff from the site. Grass swales are used to convey the runoff from upstream areas to the SCM practices. There is good perimeter planting and already existing new planting at the site. At ISI03 there is potential for a new SCM opportunity (Figure 8-13). The parking lot on some areas of the site is breaking up. Some downspouts on the site discharge directly to impervious surface. There is potential for tree planting and new SCM opportunities at ISI04 (Figure 8-13).

Figure 8-13: Bioswale Opportunity (left) at ISI03 and Bioretention/Infiltration System Opportunity (right) at ISI04

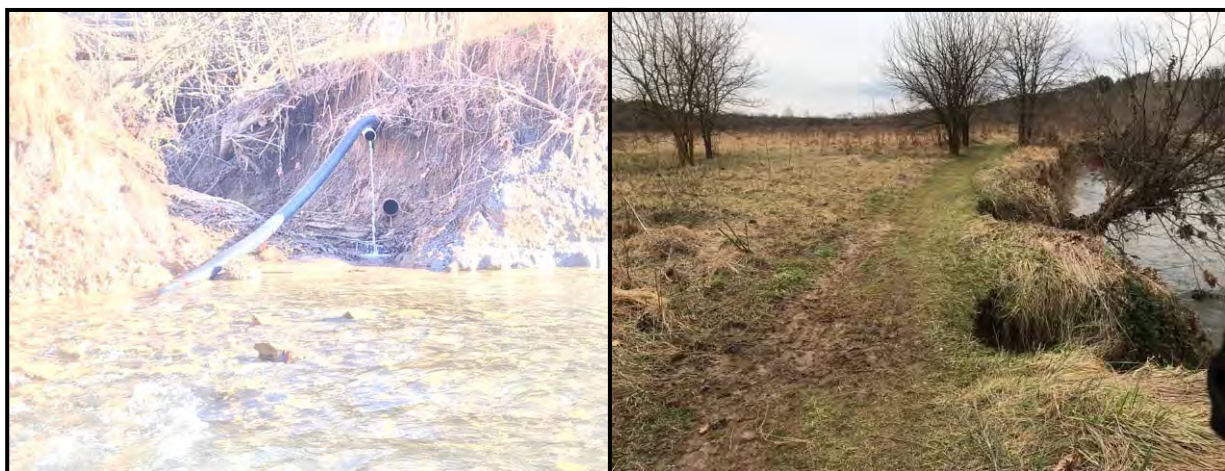
The South Fork Catoclin Creek near Waterford had 4 pipe outfalls and 2 instances of exposed pipes. Three of the five pipes were made of terra cotta/clay material, found at various locations along the length of the stream reach surveyed. Most of these occurred where the river bends near the houses on Main Street in Waterford so it is likely that serve as yard drainage (Figure 8-14). Also occurring in this location is overland stormwater flow from the adjacent meadow, which is downhill of Main Street, directly into the creek during high flows causing severe erosion to the stream bank. Observations from the stream reach assessed near Hamilton report moderate/severe erosion downstream of channelization near the town's municipal wastewater treatment facility. Inadequate buffer was also noted as a result of the close proximity of the facility to the stream (Figure 8-15).

Figure 8-14: Mainstem Catoclin Creek behind Main Street in Waterford: pipe outfalls behind homes (left) and overland flow from meadow into creek causing erosion of stream bank (right)

See Chapter 9 for information on potential stream restoration projects in the Lower South Fork Catoclin Creek subwatershed.

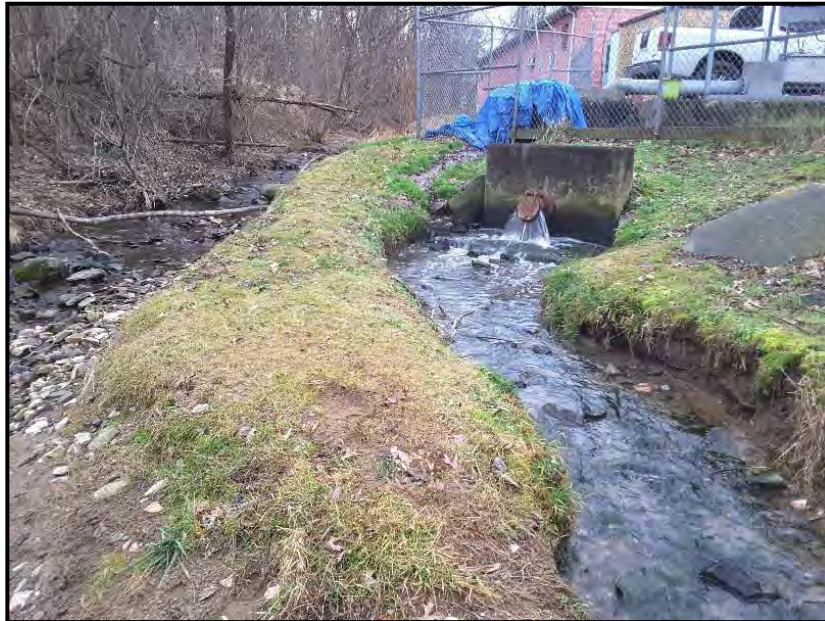
Figure 8-15: Town of Hamilton wastewater treatment outfall

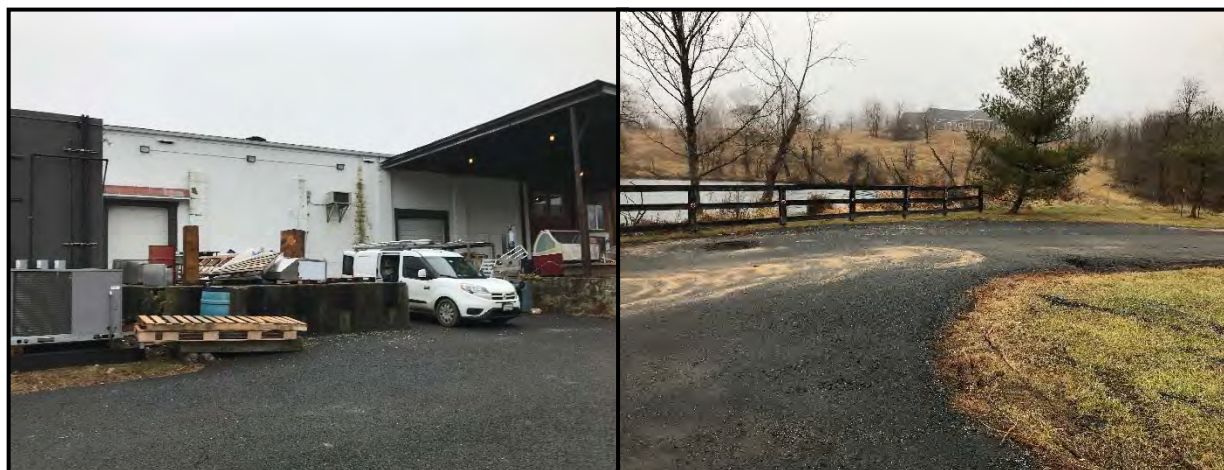
There were no vehicle operations at the business park. One of the businesses appeared to be undergoing renovations and was storing a lot of equipment outdoors. Loading and unloading operations were also present and uncovered with runoff flowing to the BMP on site (Figure 8-18). Building condition was dirty and the parking lot was breaking up at multiple places (Figure 8-18).

Figure 8-18: Uncovered Loading Operations (left) and Parking Lot Break Up (right) at HSI07

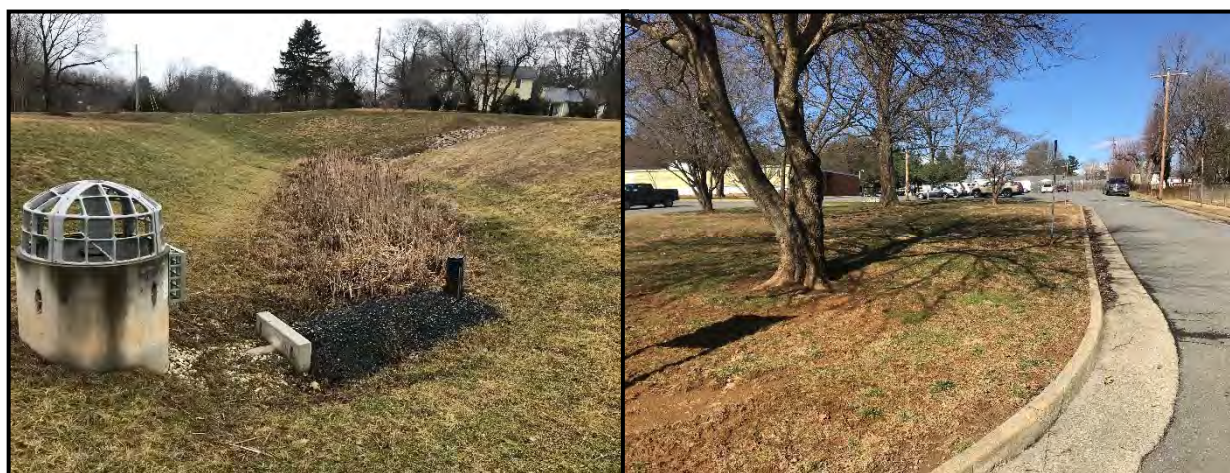
ISI12 has an existing SCM practice that has been identified as an SCM upgrade opportunity (Figure 8-19, left). Fleet vehicles are stored and potentially washed on the site. There are tree planting opportunities at the site. There are new SCM opportunities at ISI14 in addition to potential for impervious cover removal and wetland planting to improve the stream buffer (Figure 8-19, right). ISI19 has a cistern for stormwater reuse to water an existing garden. There is potential to add other smaller rain barrels for landscape watering needs. A trailer is stored on site.

Figure 8-19: SCM Upgrade Opportunity (left) at ISI12 and Micro-bioretention Opportunity (right) at ISI14

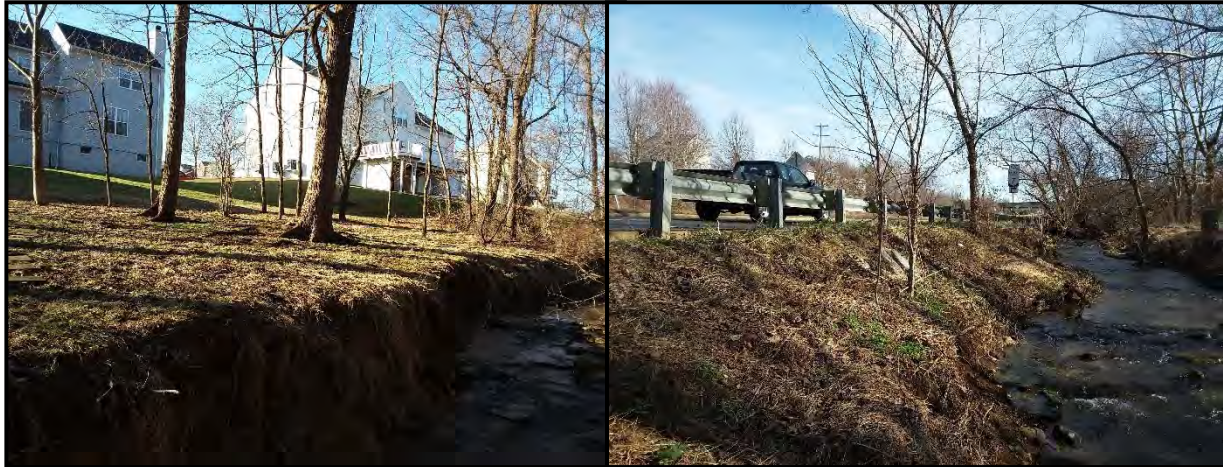
located between Greenwood Drive and Woodgrove Road. In the middle and downstream portions of this reach six stormwater outfalls, inadequate buffers related to mowing (Figure 8-20), and two head cuts (see example, Figure 8-22) were observed, which collectively led to stream restoration recommendations for this reach.

Figure 8-20: Two examples of inadequate buffers in Upper North Fork Goose Creek subwatershed. Mowing too closely to stream banks (left) and roadways that run closely parallel to streams (right) reduce the opportunity for runoff to be filtered before reaching streams.

See Chapter 9 for information on potential stream restoration projects in the Upper North Fork Goose Creek subwatershed.

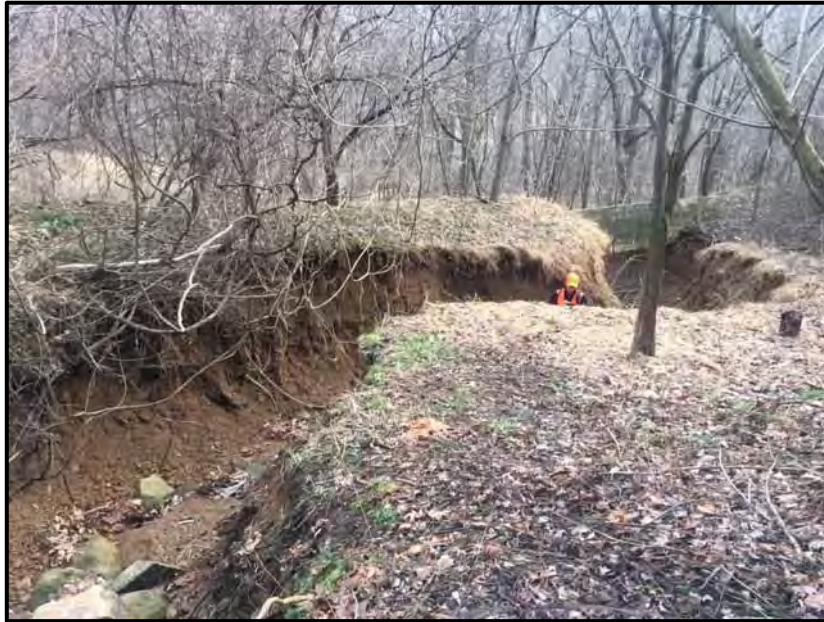
Figure 8-21: Outfall channel erosion presenting an opportunity for RSC design

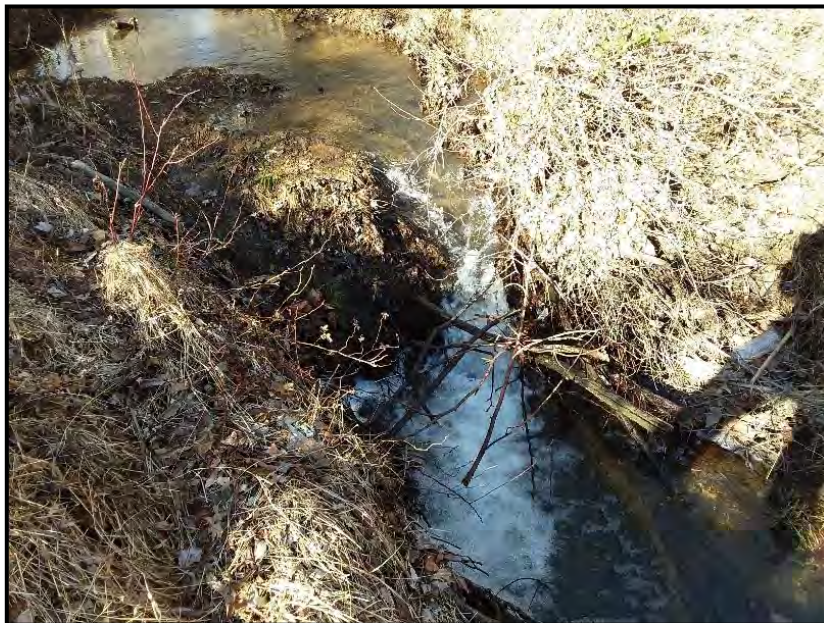
Figure 8-22: Head cut stream in Upper North Fork Goose Creek subwatershed

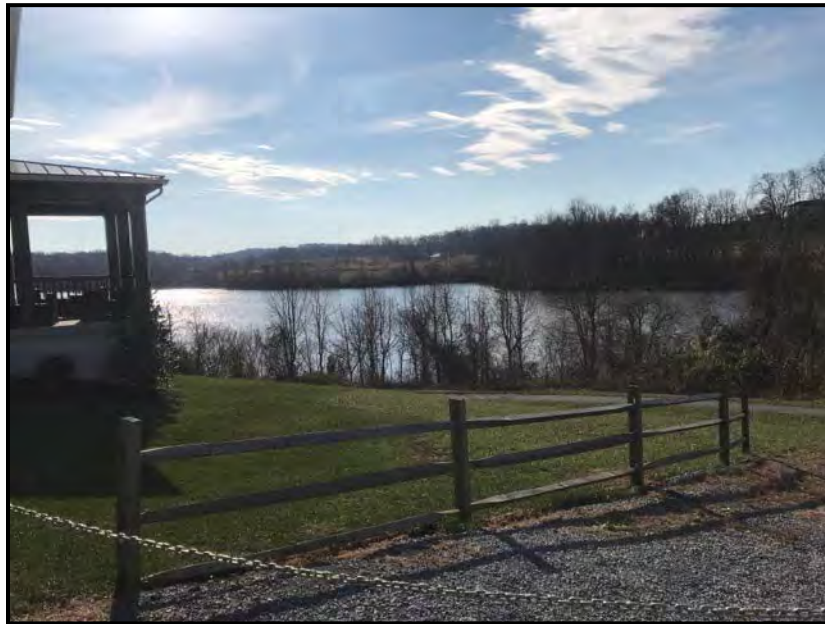
Neighborhoods assessed within the Lower North Fork Goose Creek subwatershed had opportunities for improvement. Storm drain marking, rain gardens, sustainable landscaping, fertilizer reduction, pet waste management, and tree plantings were recommended. The neighborhood next to Sleeter Lake, NSA102, could be encouraged to engage residents in an awareness campaign focusing on the water quality in Sleeter Lake (Figure 8-25). The park at the end of Shrewsberry Court overlooking Sleeter Lake would be a great location to begin the awareness campaign with signs explaining how stormwater runoff affects the lake (Fig. 8-26). Lower North Fork Goose Creek subwatershed had good opportunities for open space tree plantings, which were recommended in NSA102, NSA109, and NSA111 (Figure 8-26). A lack of community space kept tree planting from being recommended in NSA103, but considering the large lot sizes, planting on private property would be a possibility (Figure 8-27). Small lot sizes in NSA102 and 60 percent opportunity for downspout disconnection make this neighborhood a good candidate for the installation of rain barrels and, in the case of larger lots, rain gardens or sustainable landscaping. Rain gardens and sustainable landscaping were not recorded as recommended actions during the NSA102 assessment because the majority of yards in this neighborhood were not large enough, but in other neighborhoods of similar design there may be

Figure 8-25: NSA102 Sleeter Lake

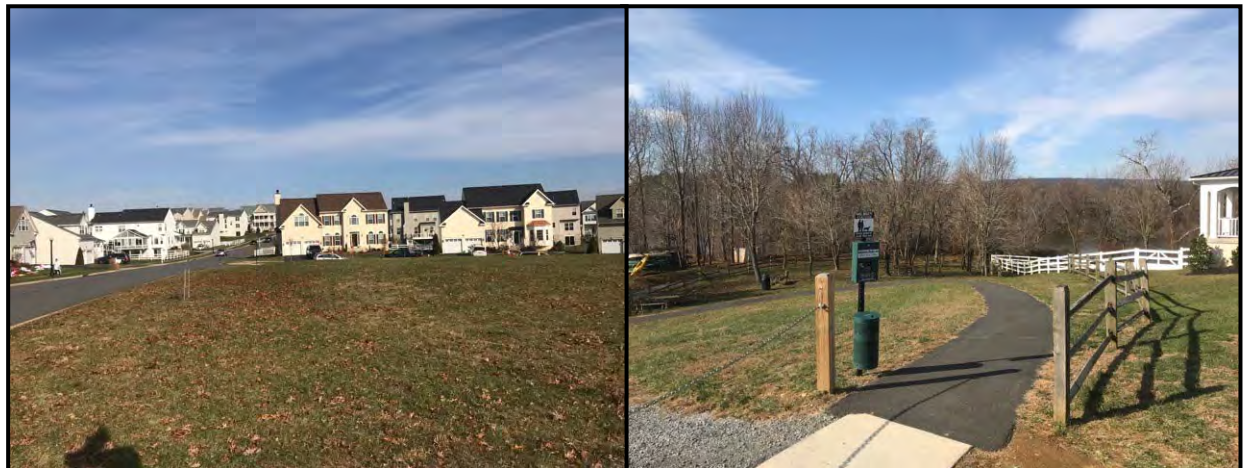
Figure 8-26: NSA102 Open space tree planting opportunity (left) and Shrewsberry Park (right)

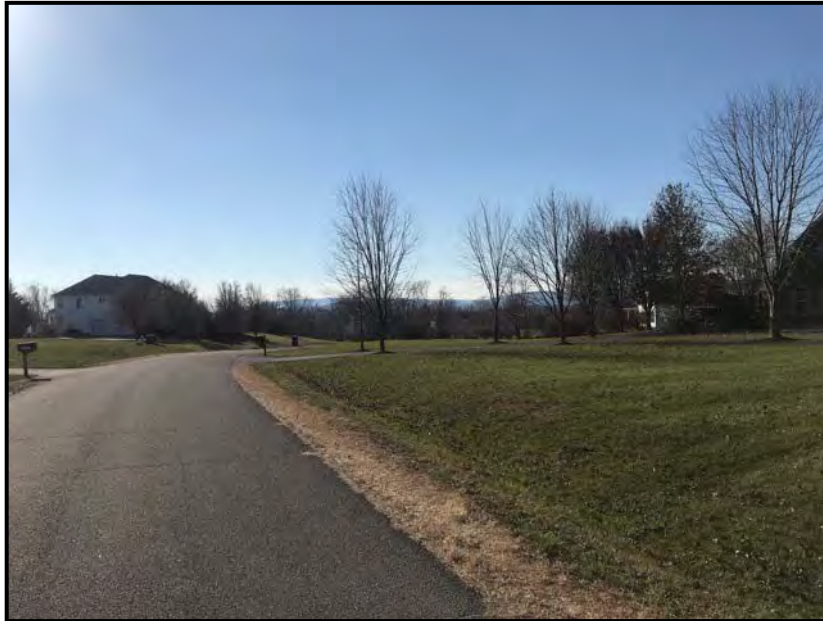
Figure 8-27: Large yard lots in NSA103 present an opportunity to promote tree plantings

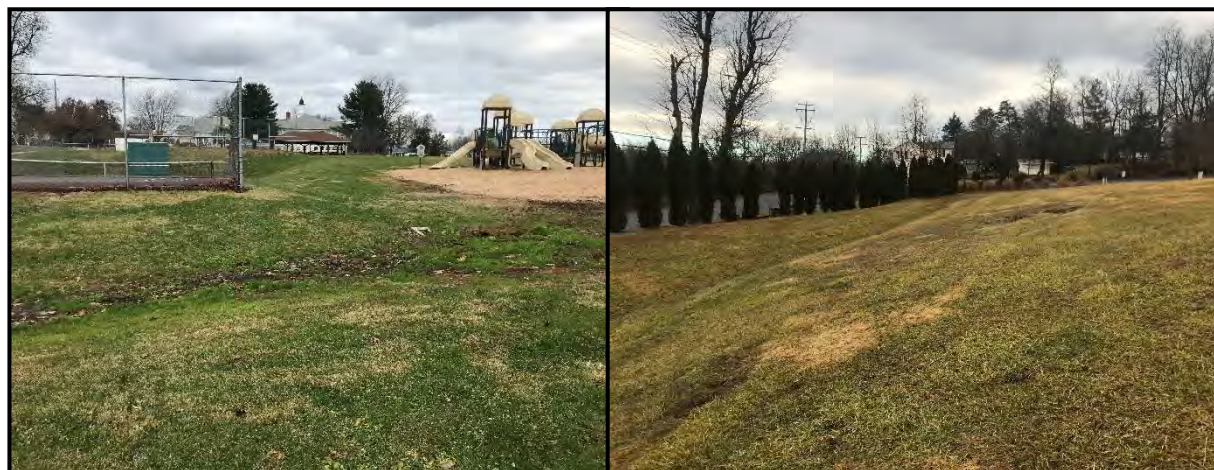
Fleet vehicles were stored at ISI08. There is potential for tree planting and new SCM opportunities on the site (Figure 8-28). ISI09 is well-planted with trees. The parking lot is broken and there were signs of leakage from the dumpster with stains on the ground in the vicinity. There is an existing SCM that needs maintenance. There is an existing SCM practice at ISI18. There are tree planting and new SCM opportunities at ISI18 (Figure 8-28).

Figure 8-28: New Bioretention or Rain Garden Opportunity (left) at ISI08 and Bioswale Enhancement Opportunity (right) at ISI18

ISI18	✓	See URSA		✓	✓					Tree planting, stormwater retrofit (existing and new), Future education effort
ISI20	✓									<i>No additional comments</i>

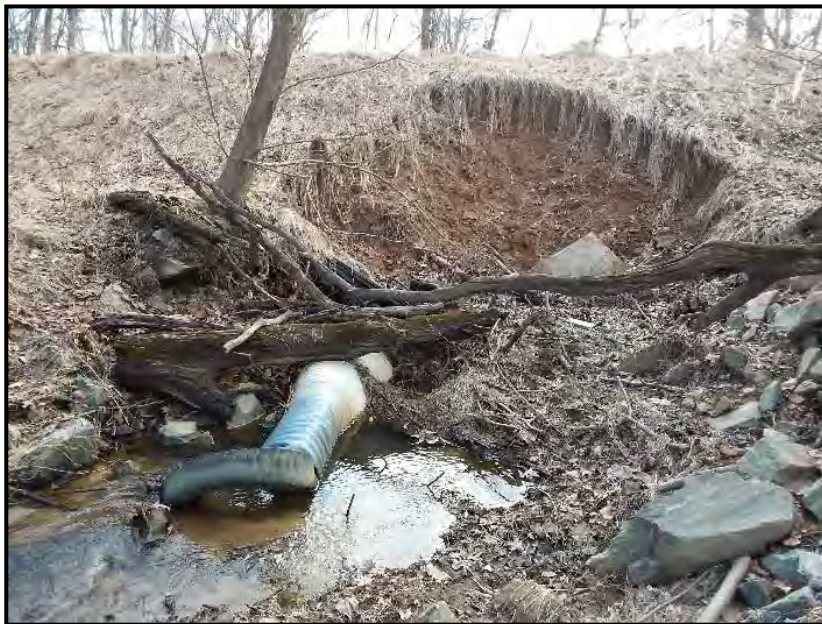
The predominant issues were erosion, mostly moderate in severity, which made up nearly 73 percent of the total problems recorded. Within a portion of stream assessed near a neighborhood adjacent to Sleeter Lake, field staff observed a collapsed culvert and eroding bank that poses a risk of further erosion of the nearby embankment (Figure 8-29). This same tributary was also noted as having an inadequate riparian buffer, at residences with yards near the stream channel, potentially at risk of future bank erosion. On the grounds of the Town of Purcellville wastewater and maintenance facilities, moderate/severe erosion sites (Figure 8-30), channelization, and barriers to fish passage were all reported.

Figure 8-29: Collapsed culvert and eroded bank near Sleeter Lake

See Chapter 9 for information on potential stream restoration projects in the Lower North Fork Goose Creek subwatershed.

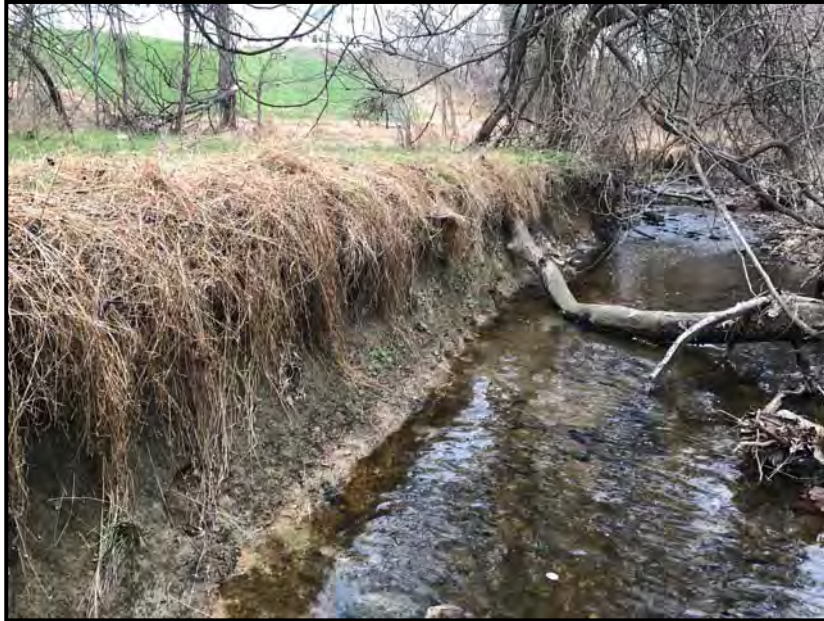
Figure 8-30: Erosion in stream reach next to Town of Purcellville wastewater and maintenance facilities

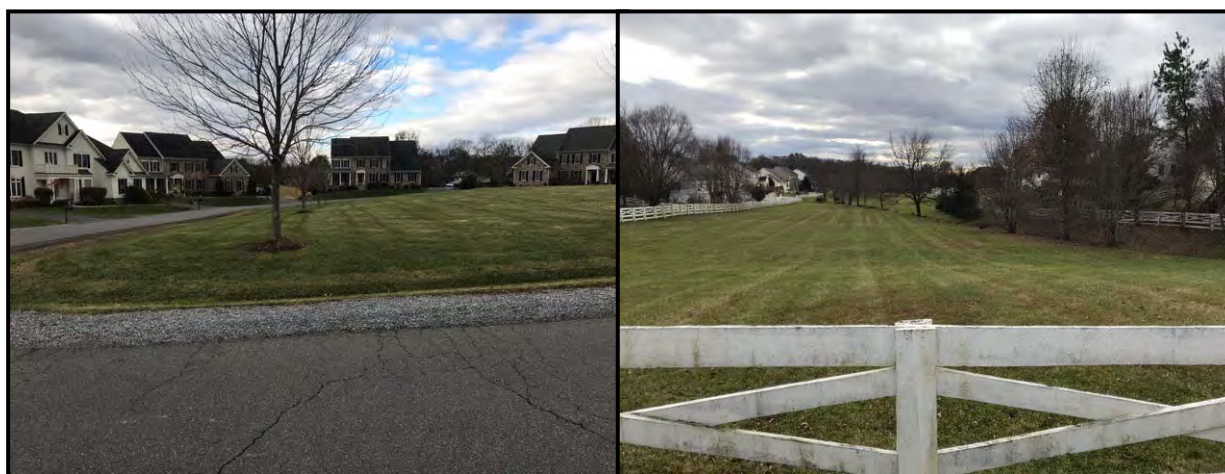
All of the neighborhoods assessed within the Crooked Run subwatershed had several opportunities for improvement. Circular roadways in NSA112 created grassy common areas where trees or rain gardens could be planted, and pet waste stations installed (Figure 8-33). The stream flowing through the common area in NSA113 could benefit from native plantings along the stream banks to assist in stabilization as well as signage educating homeowners about the purpose of the planting and what effects neighborhood runoff has on stream habitat and water quality (Figure 8-33). In NSAs 104 and 105 the large percentage of lots covered by mowed lawns provides a great opportunity to educate regarding fertilization reduction and reduce stormwater runoff on individual lots through rain barrel installation and sustainable landscaping. Additionally, the hillside next to the playground in NSA105 could provide an opportunity for bioretention.

Figure 8-33: Opportunities for tree plantings in common area of NSA112 (left) and stream in need of bank stabilization plantings (right) at NSA113
