WESTERN HILLS WATERSHED MANAGEMENT PLAN

**Loudoun County
Department of
Building and Development
1 Harrison St.
Leesburg, VA 20175**

**Tetra Tech, Inc.
10711 Red Run Blvd., Suite 105
Owings Mills, MD 21117**

May 12, 2020

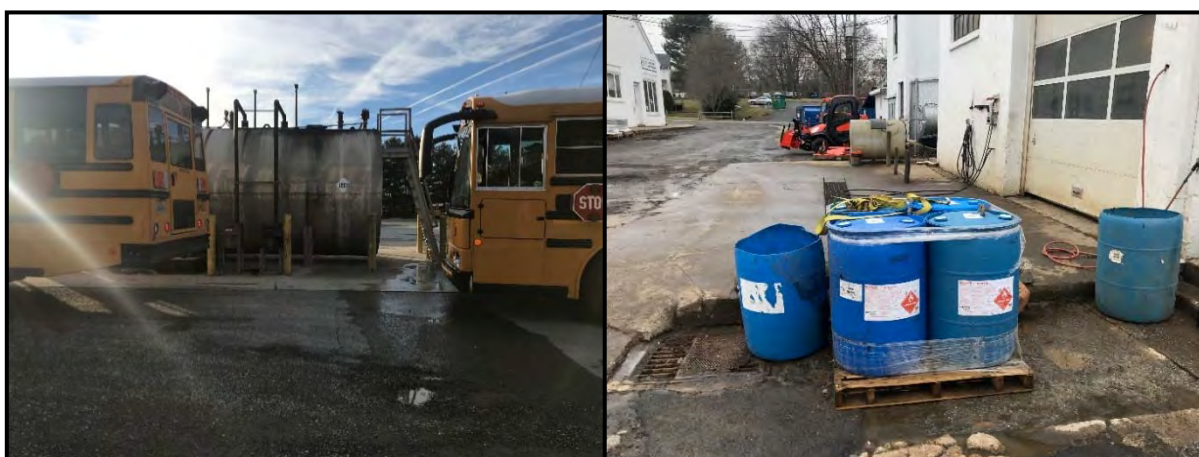
The municipal building lot and the yard equipment business had a large number of vehicles/equipment storage. Uncovered fueling operations were observed at both sites. In addition, the outdoor vehicle washing area discharged directly to storm drain and adjacent stream and it was noted that materials were stored outdoors without secondary containment. In both instances, the parking lot asphalt was broken. Multiple observations at both sites are shown in Figure 8-34.

Figure 8-34: Uncovered Fueling Operations (left) at HSI01 and Outdoor Materials Storage, Fueling, and Vehicle Washing Operations (right) at HSI10

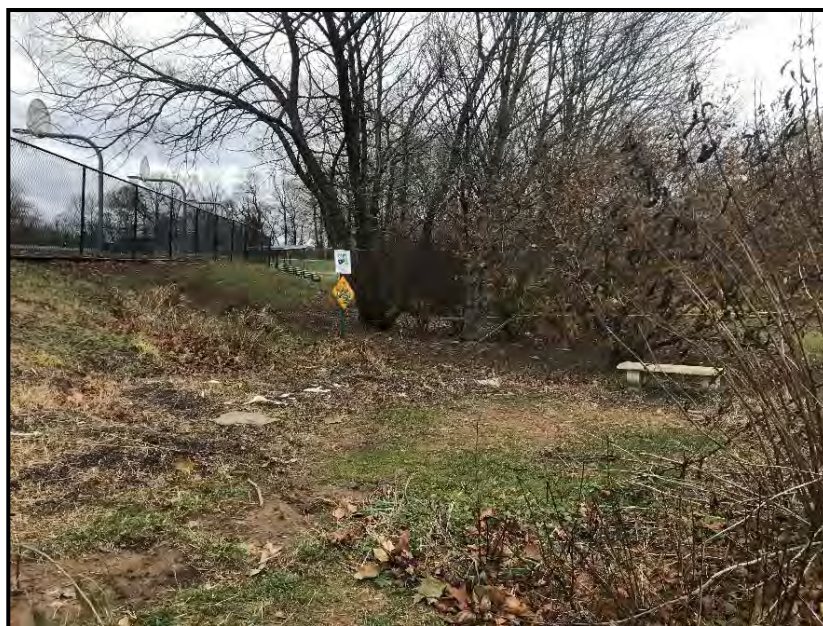
Figure 8-35: Bioretention or Infiltration Swale Upgrade Opportunity at ISI10

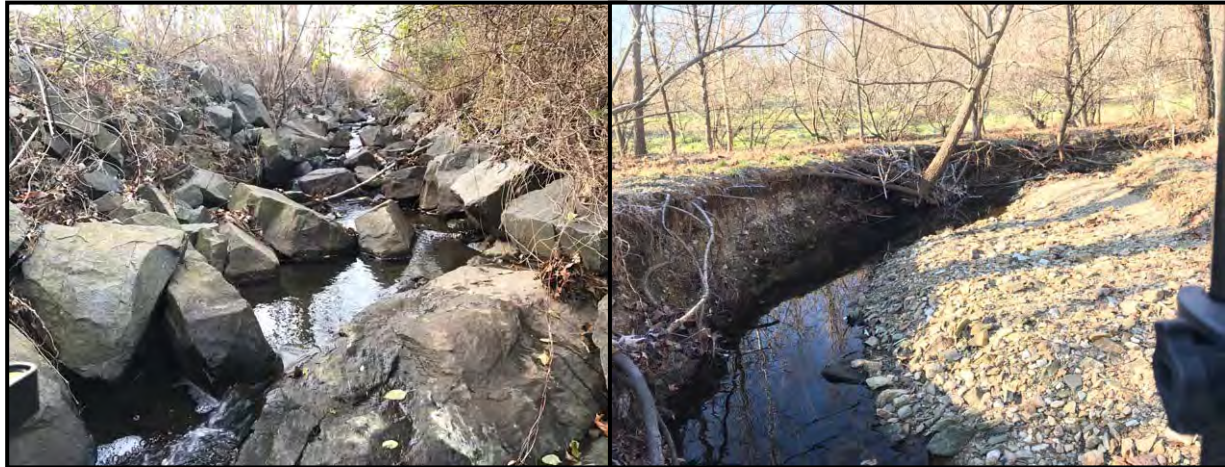
Two stream reaches were assessed in the Crooked Run subwatershed. The reach located in the northern portion of the Crooked Run subwatershed area is near Route 7 which is a busy thoroughfare in the Town of Purcellville. Upstream development, impervious surfaces, upstream installation of riprap (Figure 8-36), and orchard activity surrounding the middle portion of the reach has caused widespread erosion (Figure 8-36) through this assessed area. The second reach is centrally located in the Crooked Run Watershed with more rural surroundings. Though there is less development, the surrounding area is primarily pasture and some areas of inadequate buffer zone along the reach were found (Figure 8-37). Areas of moderate erosion have also formed at many bends or constricted areas within the assessed segment.

Figure 8-36: Channelization (left) and erosion (right) in stream reach in Crooked Run subwatershed.

See Chapter 9 for information on potential stream restoration projects in the Crooked Run subwatershed.

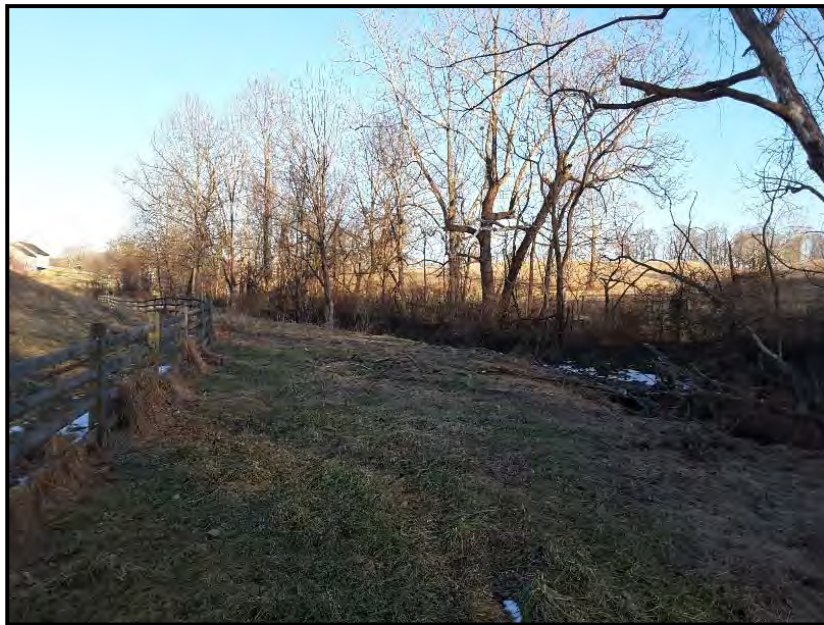
Figure 8-37: Inadequate buffer surrounding stream reach in Crooked Run subwatershed
