Tall Cedars Parkway and Elk Lick Road Intersection Improvement Project

Dulles District Town Hall

February 26, 2019

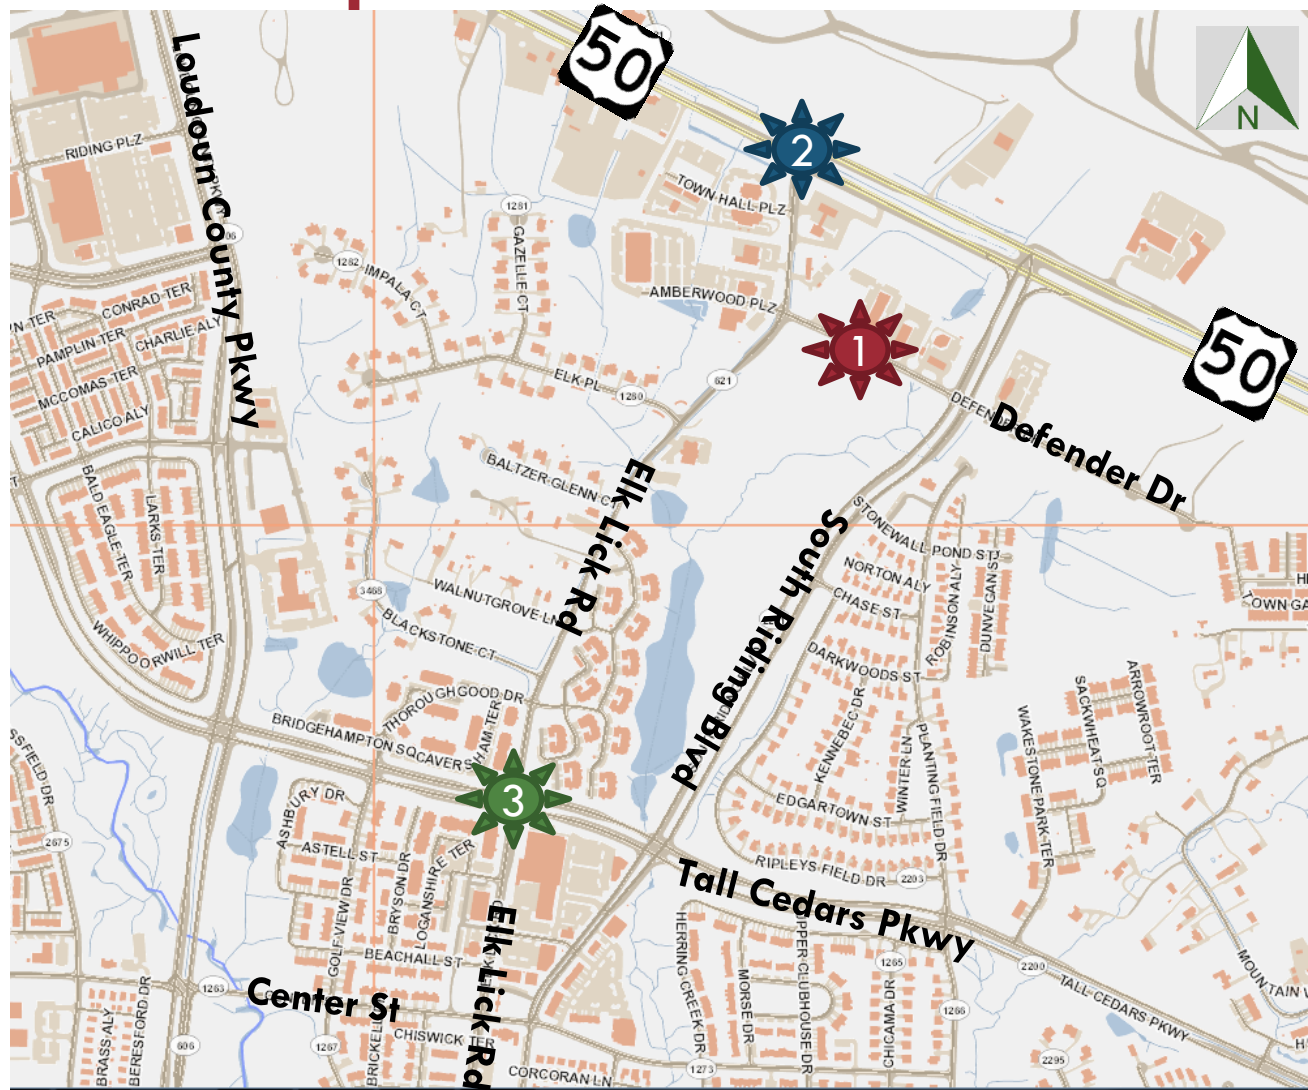
Safety Improvement Projects:

1. Defender Dr restriping
2. Route 50 median closure at Elk Lick Rd
3. Elk Lick Rd and Tall Cedars Pkwy Intersection Improvements

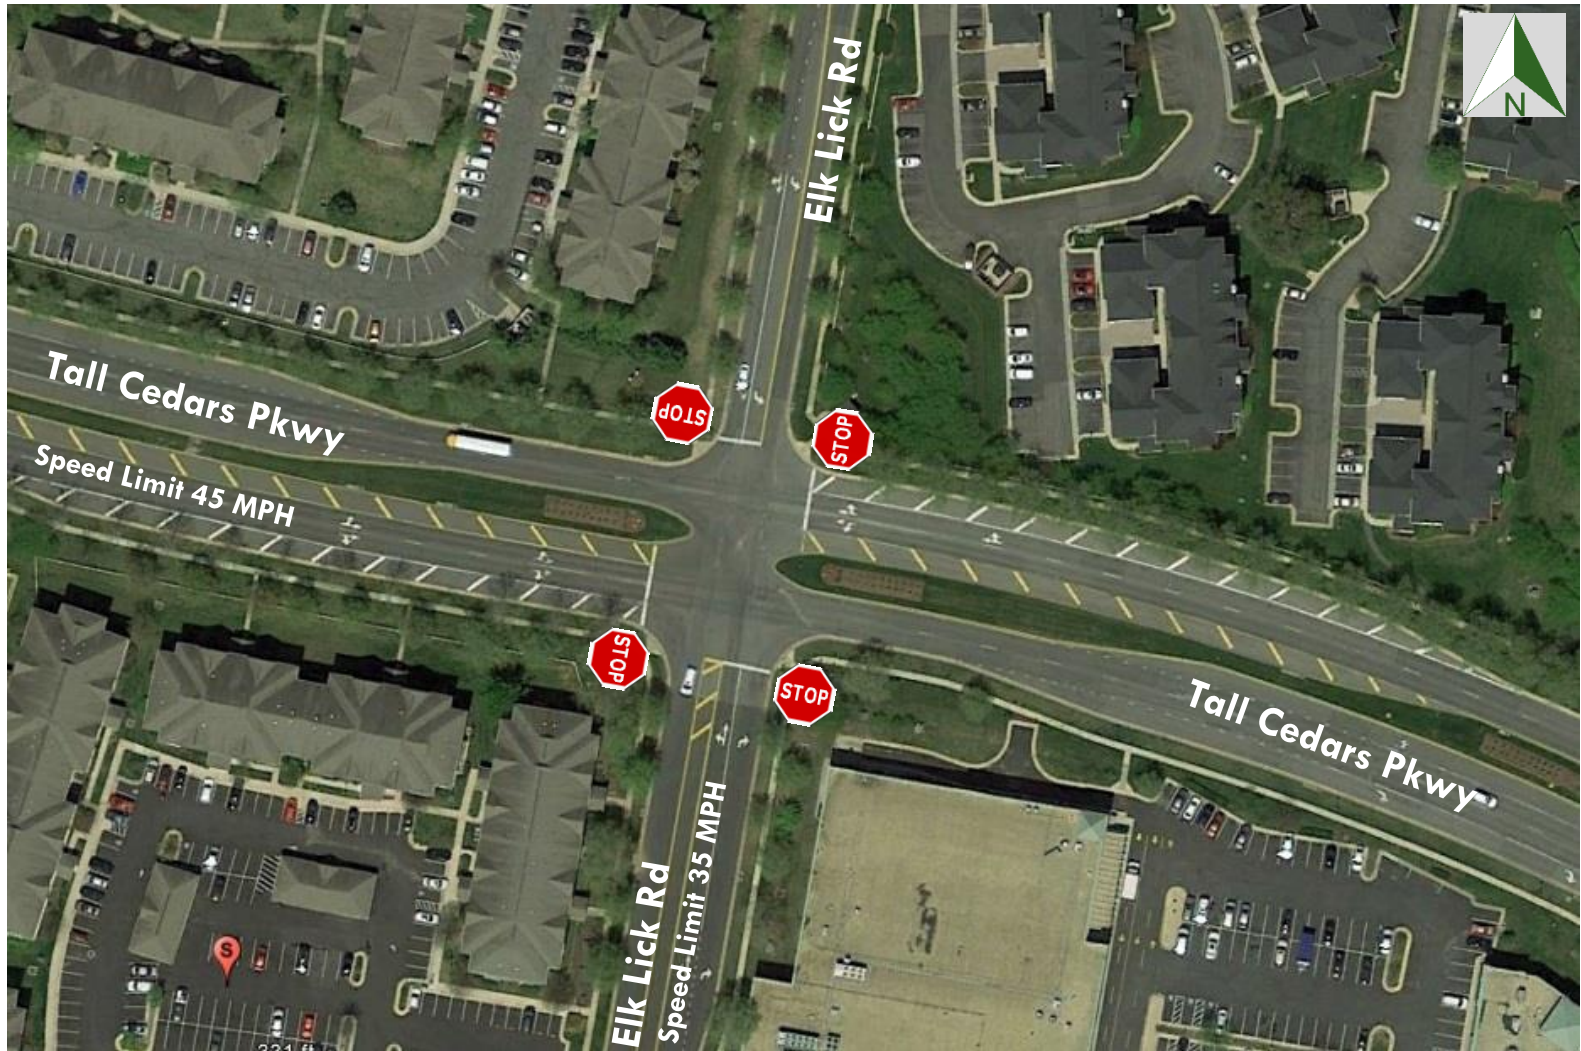
Project Intersection:

Existing
Conditions

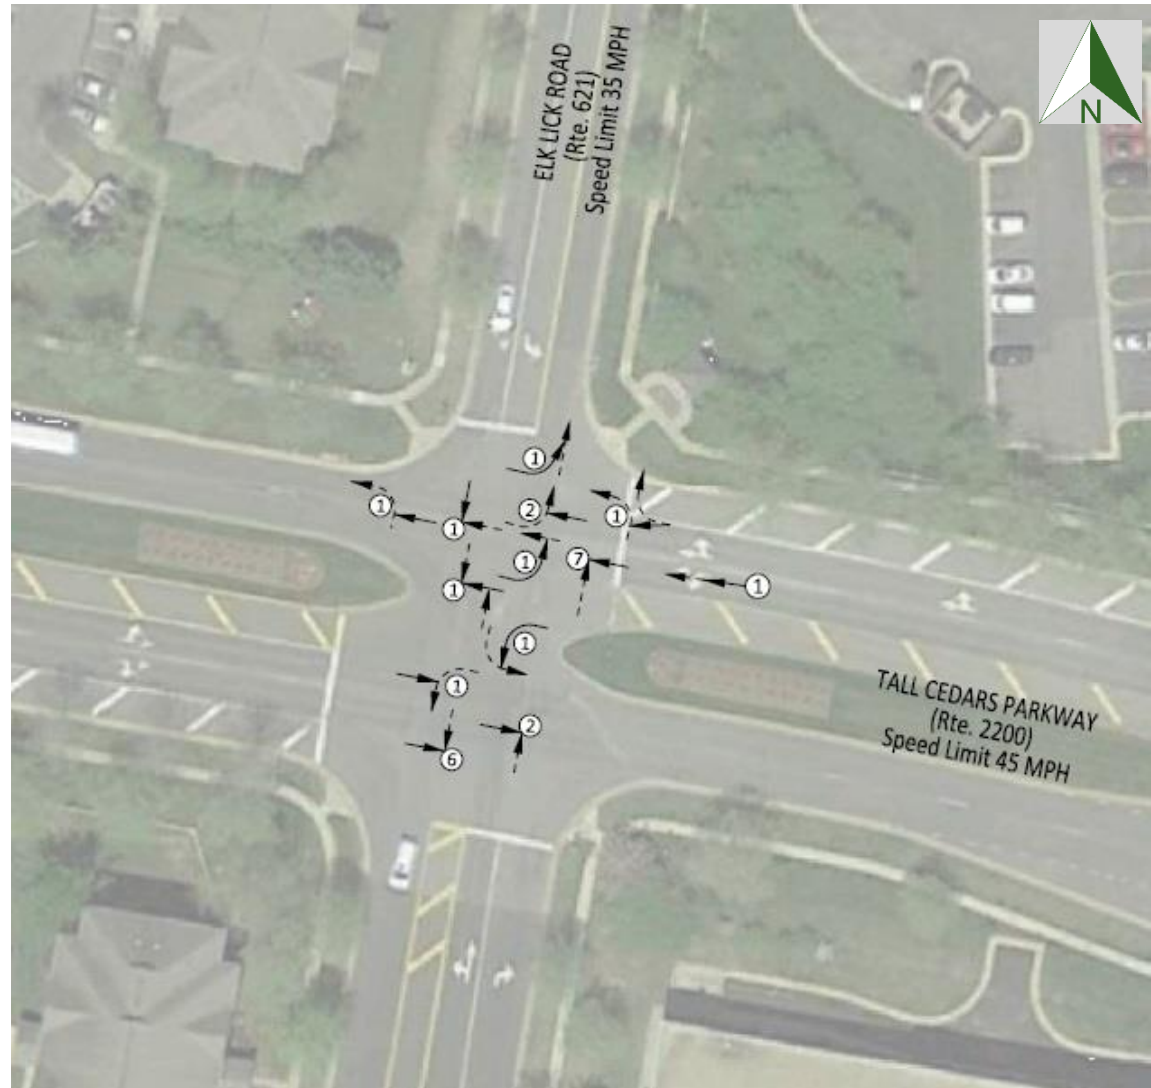
Intersection Crash Summary

- Last 3 Years (Jan 2016 – Nov 2018) ~ **25** angle crashes
- **11** angle crashes after Route 50 Median closure
- Sept 2018 - Oct 2018 – **5** injuries
- Average 1 crash every 35 days

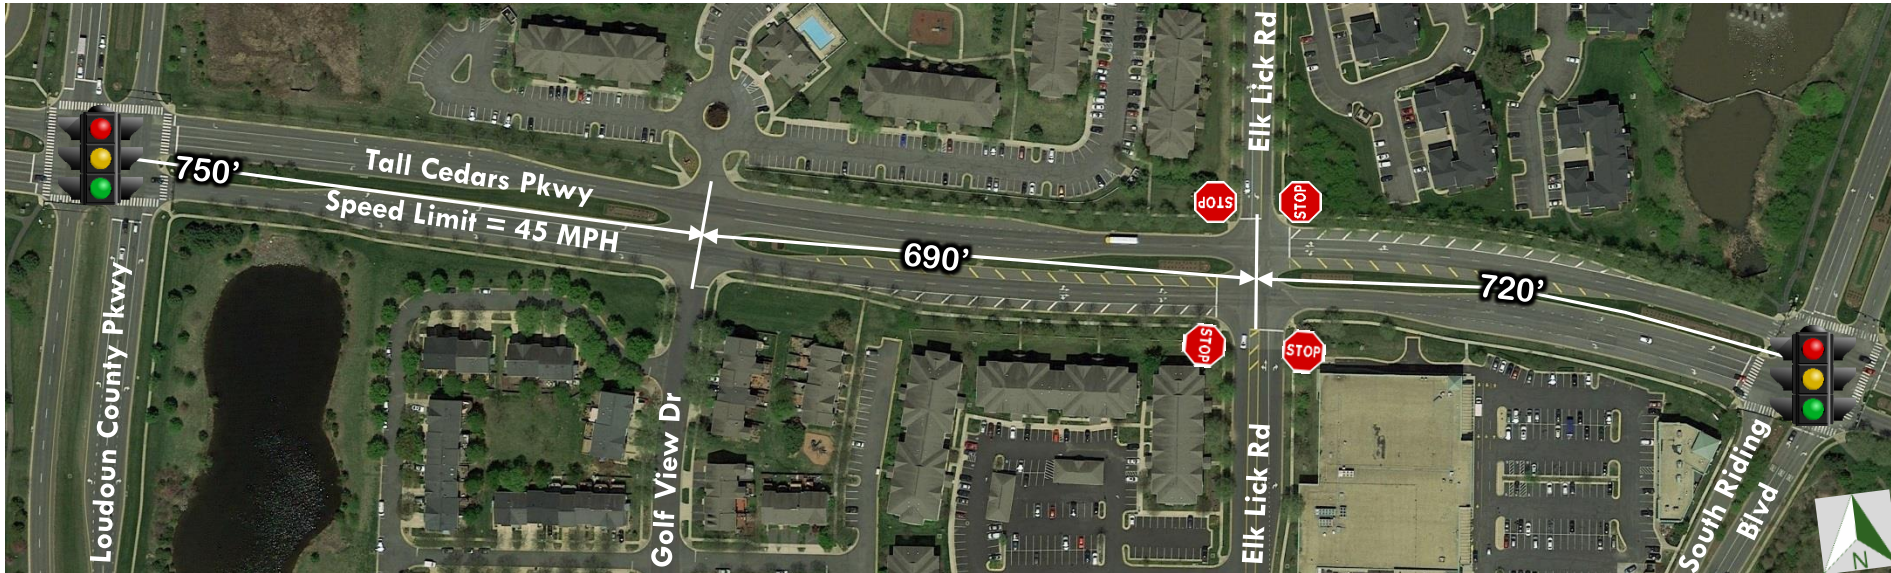
Why is a Traffic Signal NOT a solution?

- Distance to adjacent signal = 720'
- Required distance between signals = 1,050'
(Per VDOT Road Design Manual on Minor Arterial)
- Conflict Points still an issue

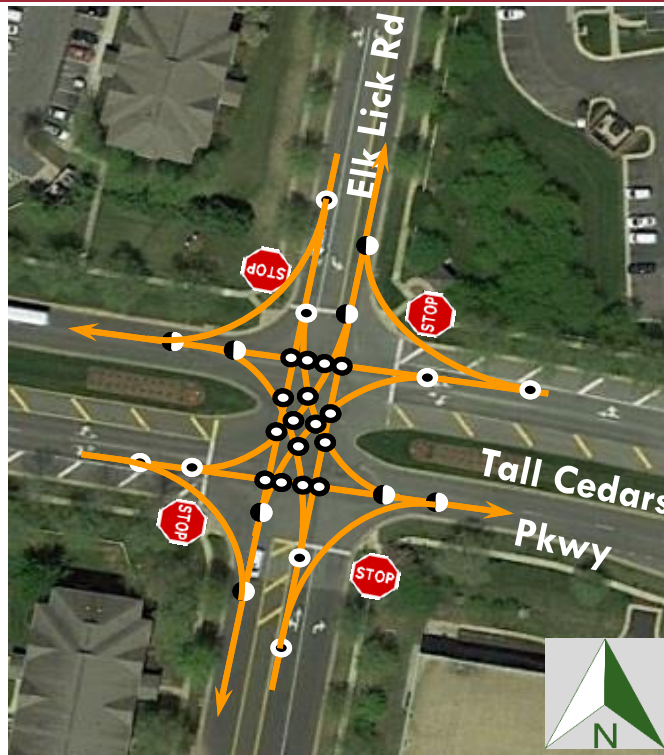
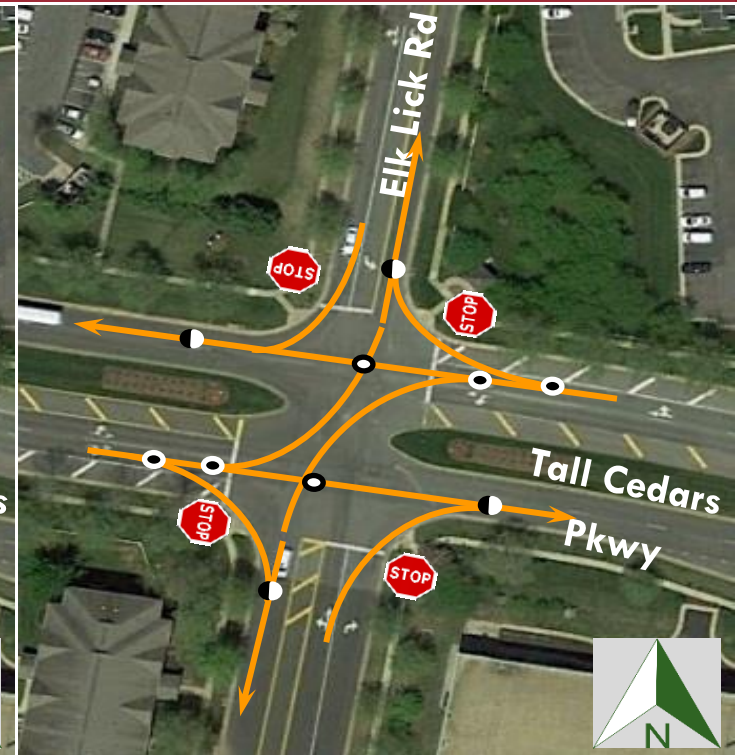
Conflict Point

Right-in, Right-out, Left-in

Type	Existing	Implementation of Solution
Merging	8	4
Diverging	8	4
Crossing	16	2
Total	32	10

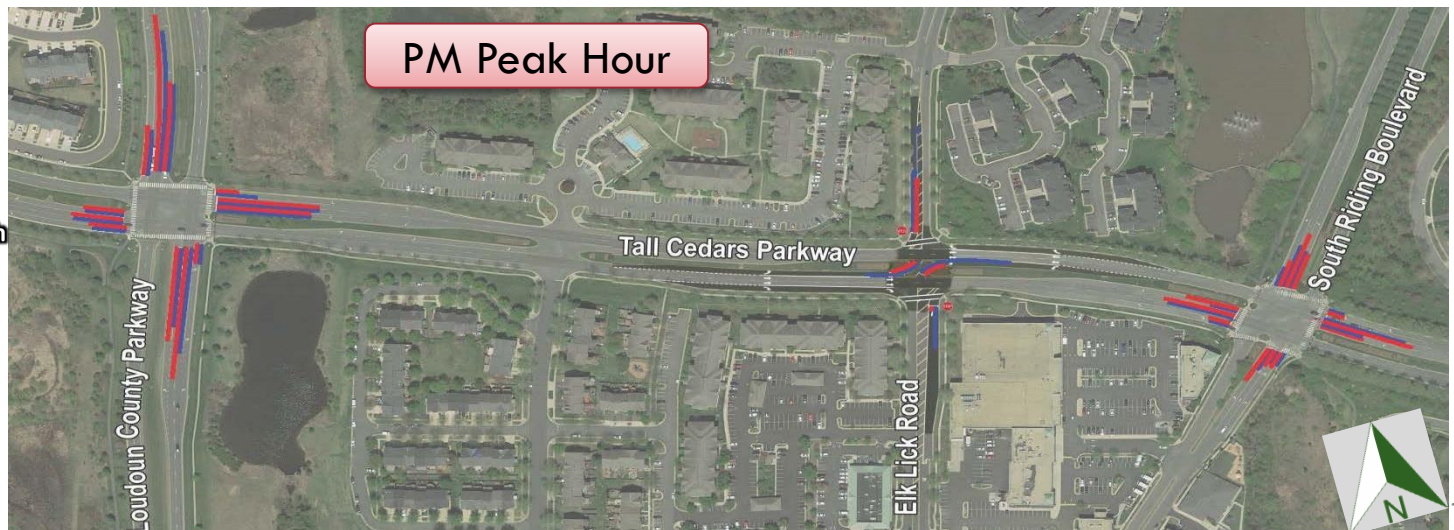
Right-in, Right-out, Left-in: Peak Hour Queues

Difference in queue lengths = Approx. 2 vehicle lengths
