UPPER BROAD RUN WATERSHED MANAGEMENT PLAN

Prepared for
Loudoun County
Department of
Building and Development
1 Harrison St.
Leesburg, VA 20175

Nancy Roth, Mark Voli, Steve Schreiner,
Alexi Boado, Allison Brindley, Tom Jones,
Steve Harriott, Jodi Dew-Baxter, and
Mark Southerland
Versar, Inc.
9200 Rumsey Road
Columbia, MD 21045

September 30, 2014

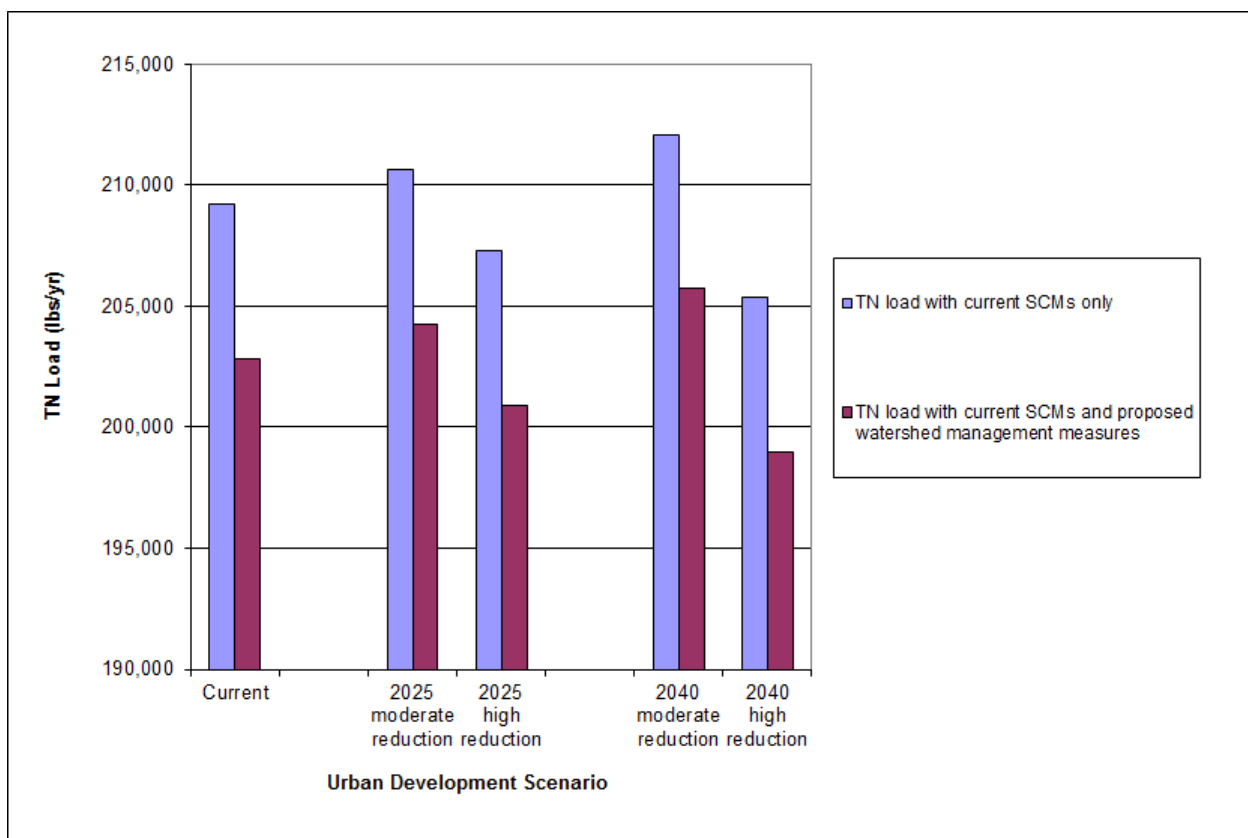
Upper Broad Run total nitrogen (TN) loads estimated for current, 2025, and 2040 land use, without and with implementation of watershed management measures proposed in this plan. Two stormwater management scenarios are presented for each of the future land use scenarios: “moderate reduction” assumes stormwater from new urban areas is treated at rates comparable to current levels, “high reduction” assumes enhanced water quality and quantity treatment, consistent with newer Virginia Stormwater Regulations.

Modeling results indicate that both the implementation of watershed plan recommendations and the type of stormwater treatment employed with future development will likely have a great effect on pollutant loads. For example, if new urban development proceeds with no changes to the suite of SCM practice types commonly used today (“moderate reduction” scenario), annual TN loads would actually increase in 2025 and 2040. However, with improved practices on new urban lands (“high reduction” scenario), TN loads would be expected to decrease. Implementation of the watershed management measures proposed in this plan will further decrease TN loads. According to the model, annual loads of TP would actually be expected to decrease (as a result of converting agricultural lands to urban). Implementing watershed recommendations will further decrease TP loads.

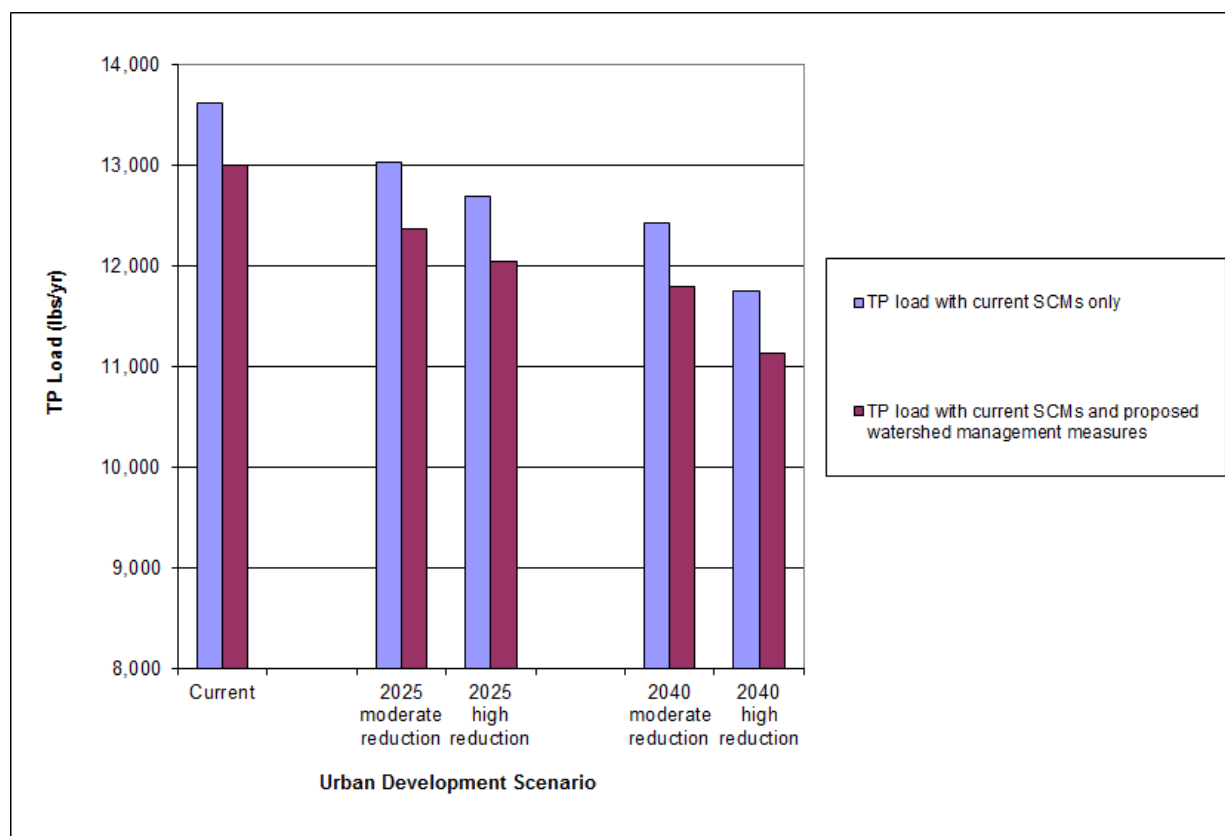
Upper Broad Run total phosphorus (TP) loads estimated for current, 2025, and 2040 land use, without and with implementation of watershed management measures proposed in this plan. Two stormwater management scenarios are presented for each of the future land use scenarios: “moderate reduction” assumes stormwater from new urban areas is treated at rates comparable to current levels, “high reduction” assumes enhanced water quality and quantity treatment, consistent with newer Virginia Stormwater Regulations.

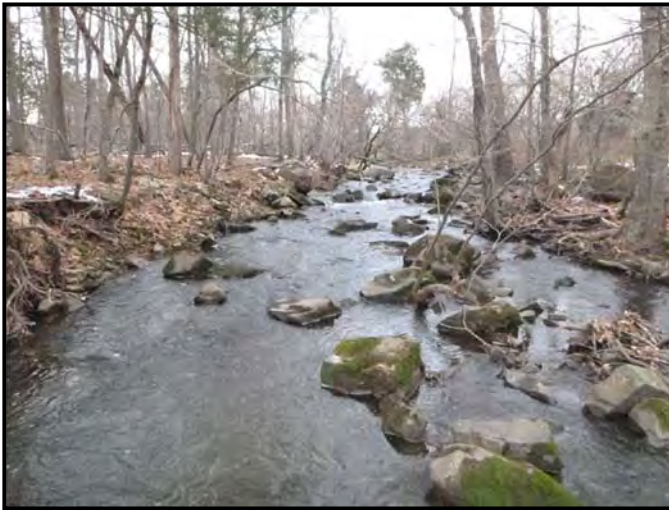
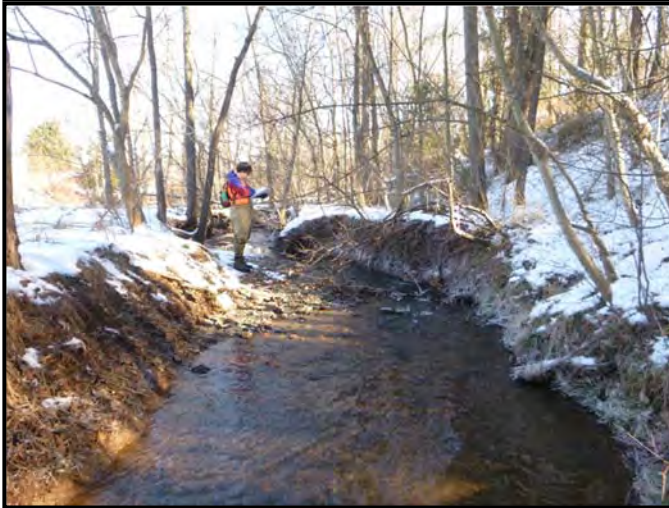
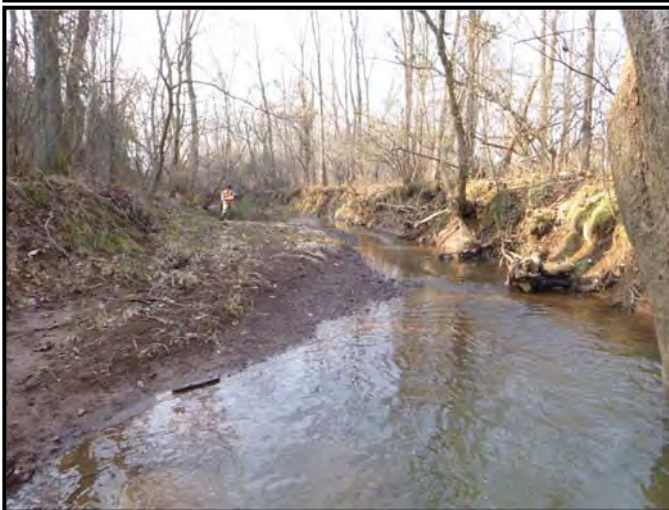
Stream reach with an optimal habitat rating

Stream reach with a suboptimal habitat rating

Stream reach with a marginal habitat rating

Figure 4-3: Three Different Upper Broad Run Habitat Sites with Three Different Habitat Ratings

Locations and overall habitat score ratings for the 2013 SCA representative habitat assessment sites, along with habitat assessment sites from the 2009 Loudoun County Stream Assessment, are shown in Figure 4-2. Figure 4-3 depicts three different example habitat sites with three different ratings for overall habitat score.

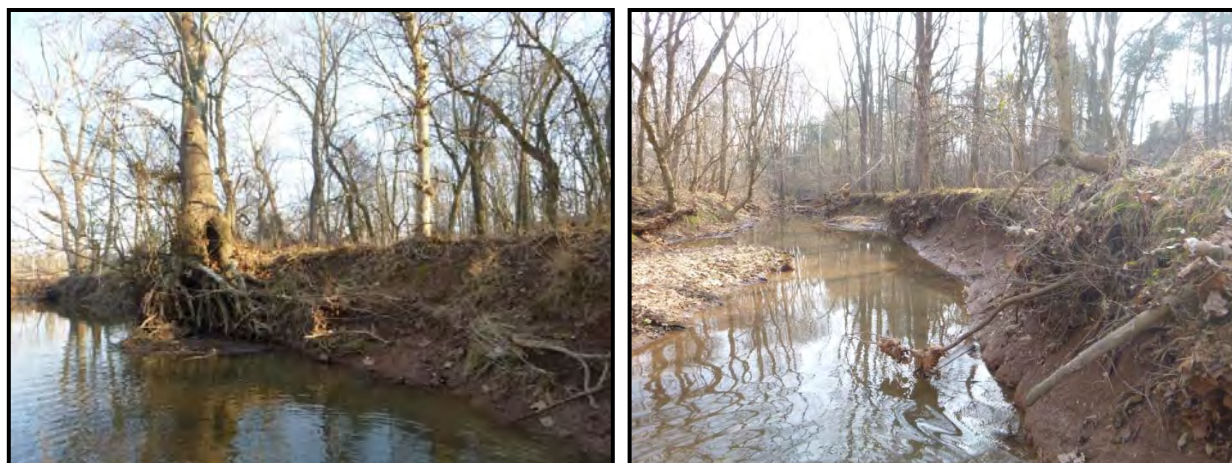
Figure 4-5: Examples of Upper Broad Run Sites with Severe Erosion

Approximately 85 percent of the documented erosion sites were rated as either moderate or low severity. Typically erosion sites assigned a severity of “very severe” are greater than 1,000 feet in length and have channels that are incised several feet. None of the streams assessed within the Upper Broad Run watershed fit this description, likely due to the large presence of cohesive soils (i.e., clays) within the watershed. Figure 4-5 depicts erosion sites documented within the watershed that were assigned a rating of severe.

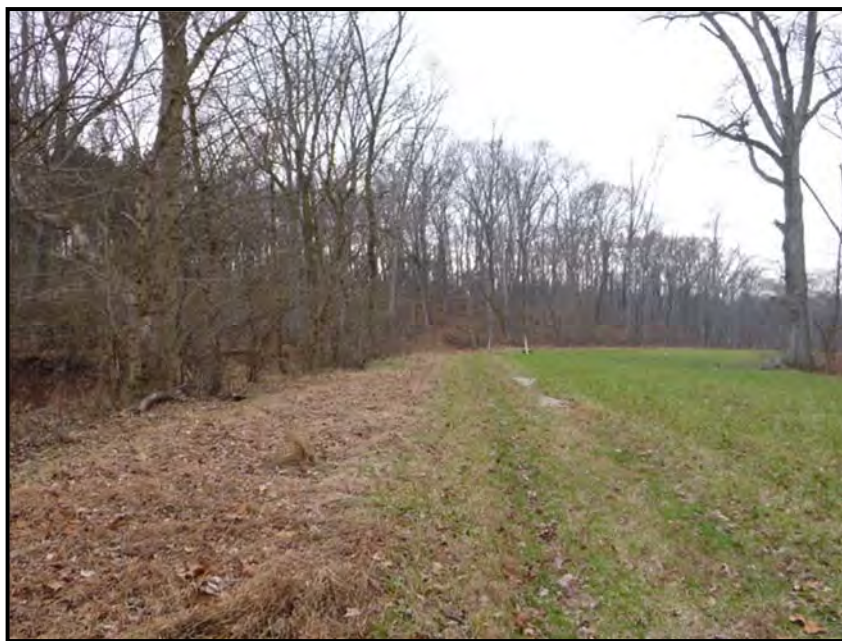
Figure 4-6: Example of an Upper Broad Run Inadequate Buffer Site Rated as Severe. Note the presence of the Loudoun Water sewer line right-of-way.

The severity of inadequate stream buffers was rated according to length and width. The most severe sites received a severity rating of 1 if they had a significant length of stream (> 1,000 feet) that was completely open with no trees on either side. Figure 4-6 depicts one typical site that was rated as possessing a severe inadequate buffer. A few sites represented potential opportunities for stream buffer reforestation, but these were often limited because of the presence of the County sewer line ROW within the stream corridor.

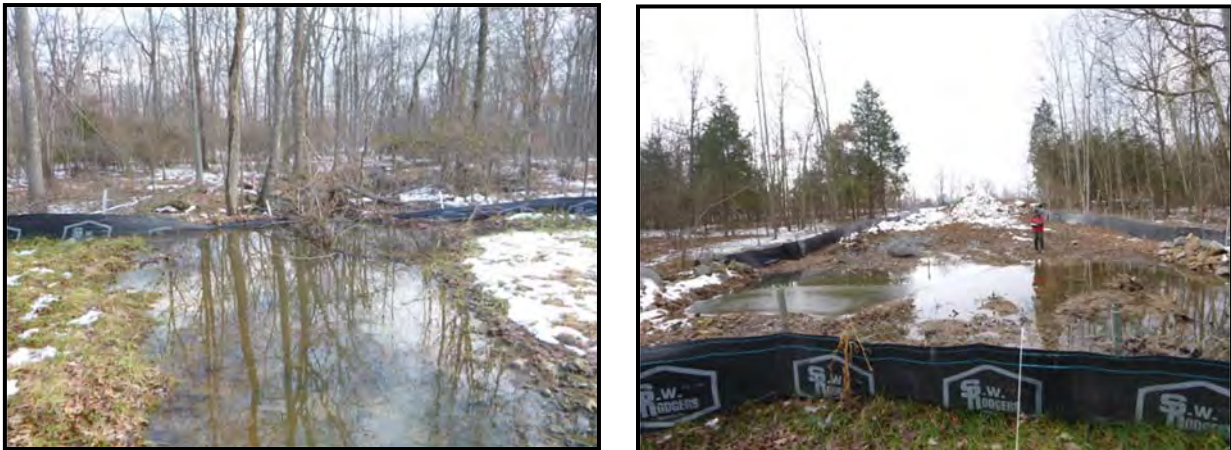
Figure 4-9: Near Stream Construction with Super Silt Fence Placed within the Stream in an Area with a Recently Installed Sewer Line, Rated in the Survey as Severe (Left Photo) and Absence of Super Silt Fencing Along Right Bank is Exposing Stream to Runoff from Active Construction Site Rated in the Survey as Severe (Right Photo).

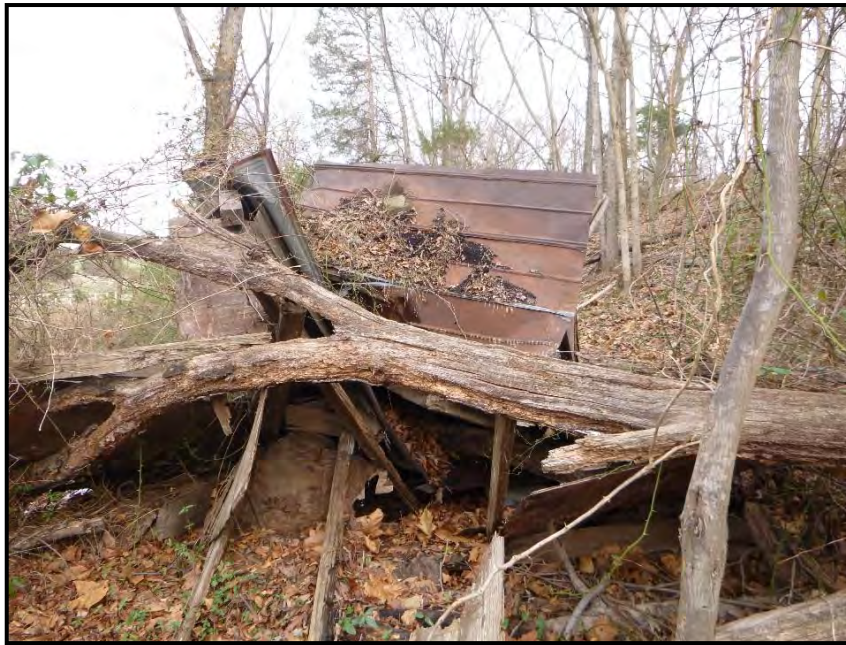
Figure 4-12: Photo of a Low Severity Trash Dumping Site

A total of only two trash dumping sites were documented as part of the Upper Broad Run SCA survey (Figure 4-11). The severity of both these trash dumping sites was rated low, according to the amount and type of trash present, their location, and whether cleaning up the trash would present problems (access and safety). Type of trash was classified as one of the following: residential, industrial, yard waste, floatables, tires, construction, or other. Low severity and minor trash dumping sites are those with easy access and typically where there is potential for a volunteer cleanup. The amount of trash was estimated in terms of number of pick-up truck loads for completely clearing the site. One site was estimated to take one pick-up truck load, and the other would take two pick-up truck loads. One trash pile consisted of concrete rubble, and the other site consisted of tires and construction debris. Figure 4-12 shows an example of a low severity trash dumping site where approximately two truckloads of residential trash (tires and construction debris) was observed. Both of these sites were considered as possible volunteer projects.

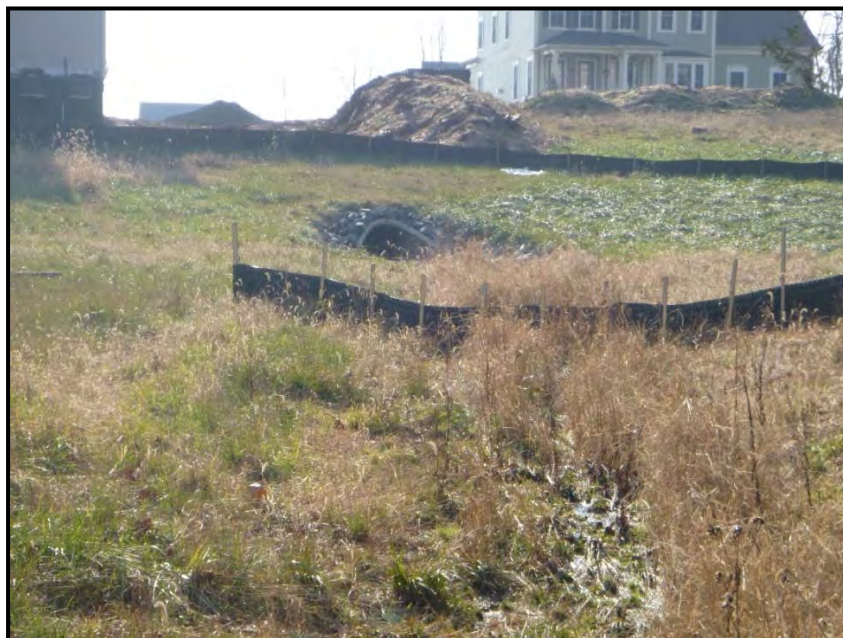
Figure 4-13: Photo of a Moderate Severity Pipe Outfall Site

A total of three pipe outfalls were identified during the Upper Broad Run SCA survey. Of these, one was rated as moderate severity, and two were rated as minor severity. The moderate rated pipe outfall was located within the Lower North Fork Broad Run subwatershed and was part of a rock-lined swale that was a conveyance to the stream. It consisted of a 24-inch CMP in an 8-inch-wide swale. The minor severity pipe outfalls were located within the Lenah Run subwatershed and consisted of 4-inch and 6-inch corrugated plastic pipes, respectively, and both exhibited evidence of small amounts of clear stormwater discharge. Access and correctability were rated as best for both of the minor outfalls, but correctability was rated one step lower (more difficult) at the moderate severity pipe outfall, owing to its larger size. Figure 4-11 shows the location of outfalls noted during SCA surveys. Figure 4-13 depicts a moderate severity Pipe Outfall site that drains to the Lower North Fork of Broad Run.

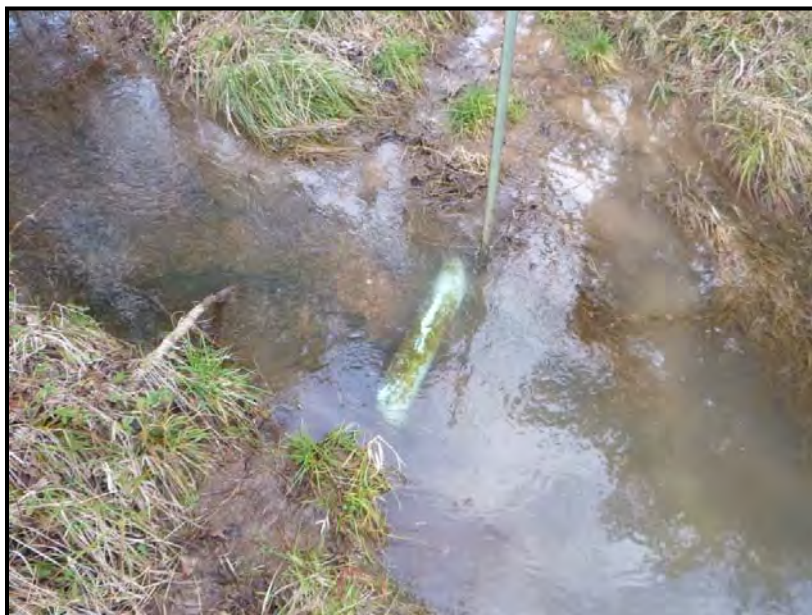
Figure 4-14: Exposed Pipe within the Streambed of Upper Broad Run

A total of only one exposed pipe site, rated as moderate severity, was identified during the Upper Broad Run SCA survey. It consisted of a 6-inch plastic sewer line (though it is listed as a 12-inch plastic pipe in Loudoun Water's Gravity Sewer Line GIS layer) that has become exposed in the stream bed. Correctability and access were both rated as one score less than best, because of the site's location within the streambed, and access to the site could involve impacts to nontidal wetlands. Figure 4-11 shows the location of the exposed pipe. Figure 4-14 depicts the exposed pipe within the streambed.

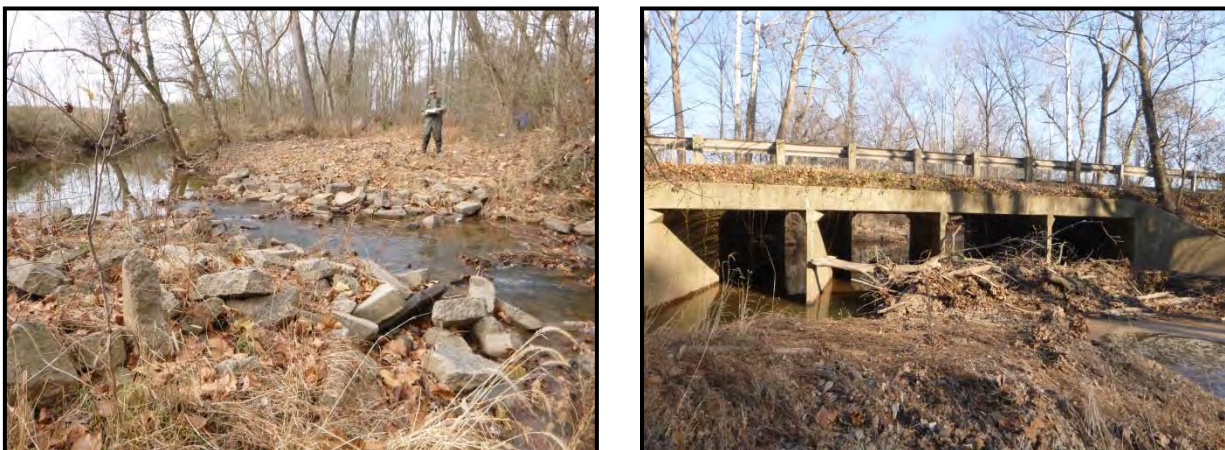
Figure 4-16: Examples of Unusual Conditions Encountered During SCA Surveys. The photo on the left is the remains of an old bridge and the photo on the right is a large debris jam upstream the Evergreen Mills Road crossing. Both are located within the Lower North Fork Broad Run subwatershed.

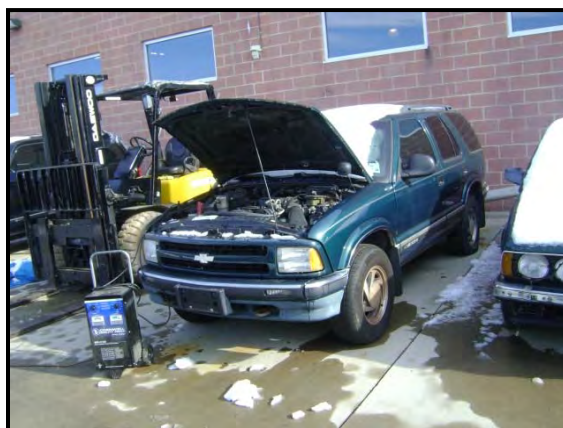
Figure 4-29: Outside Maintenance of a Vehicle at HSI-016

Outdoor vehicle maintenance, without benefit of canopy cover or garaging, was found at several of the sites investigated. Outdoor maintenance of vehicles was mostly found at businesses with fleets and businesses dedicated to automotive maintenance, for example an auto body shop (Figure 4-29). At HSI-002, several delivery vehicles and box trucks were found in the rear of the property, some undergoing maintenance.

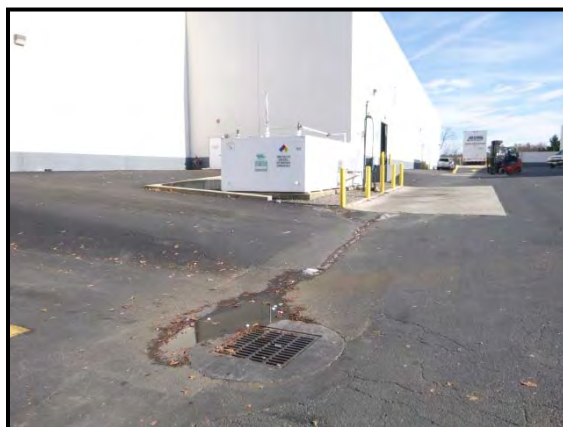
Figure 4-30: Uncovered Fueling Station at HSI-014. Note that the liquid near the storm drain inlet is melted snow.

Uncovered fueling stations were found at a variety of businesses with the common denominator being fleets and the necessity to fuel them. Onsite fueling stations are a convenience, however the proper sheltering of them under canopies was rare. Fueling stations included both diesel and gasoline. Examples of uncovered fueling stations included tanks with nozzles found at a construction company and more advanced designs noted at HSI-014 (Figure 4-30).

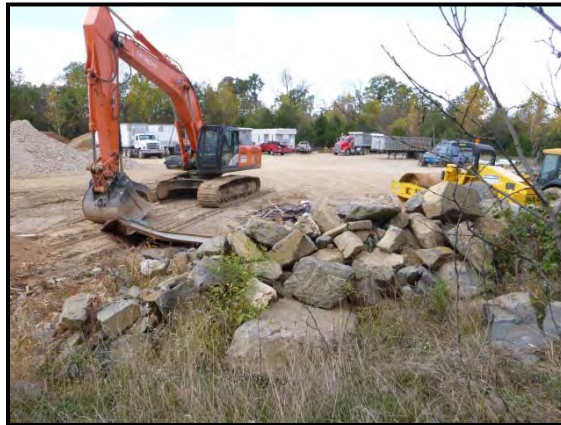
Figure 4-31: Outside Storage of Bulk Materials without the Benefit of Silt Fencing at HSI-008

Material was found stored outside and uncovered at several locations. If uncovered, such material can leach pollutants or suspended solids to the storm drain system and eventually make its way to surface waters. Material stored outside was occasionally found in pervious areas (i.e., gravel or open ground), such as a construction staging area found within an industrial district. At the construction staging area, boulders, gravel, dirt, and other items were noted being stored in the open (Figure 4-31). Other bulk material storage included mulch yards at garden centers, piping at plumbing contractors, junked equipment parts, and merchandise. In some instances, material was found in close proximity to storm drain inlets, providing a direct pathway for pollutants to be transferred to surface streams via stormwater runoff.

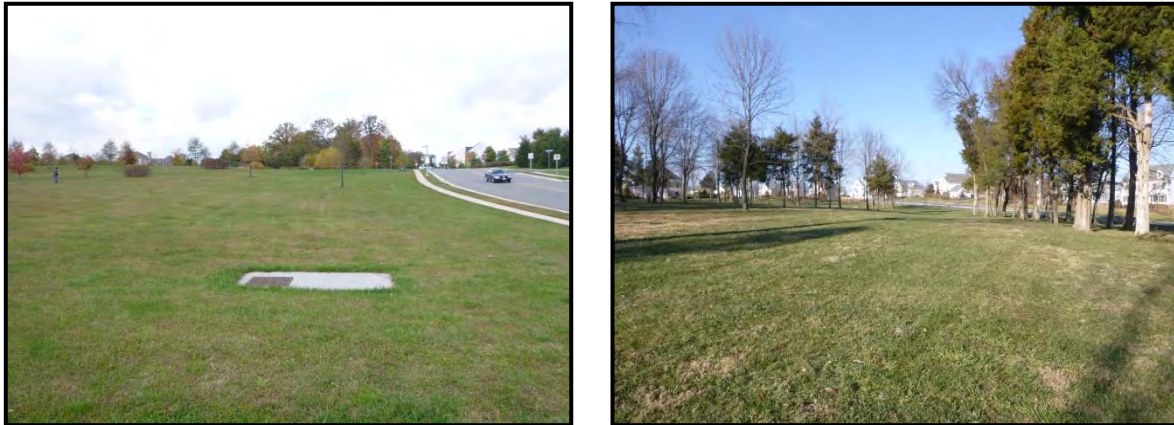
Figure 4-34: Potential Tree Planting Areas at ISI-004 (left) and at ISI-008 (right)

An estimated 5,118 trees can be planted at institutions within the Upper Broad Run watershed. Trees were recommended for all nine institutions assessed. During field assessments, tree planting areas were identified in the field and drawn on field maps. Small (i.e., less than 10) quantities of trees were recommended for smaller-acreage institutions such as the Arcola-Pleasant Valley fire station while greater numbers of trees were noted as appropriate for public schools, which tend to have greater quantities of available acreage in which to plant. Two examples of potential tree planting areas are shown in Figure 4-34. At Legacy Elementary School, a sloping area in front of the school near a County road has been planted with young trees; however, additional trees can be planted in the same area to create a more robust canopy. At Creighton's Corner Elementary School, to provide another example, an area adjacent to the main athletic fields contains cedars and other trees that were not removed to accommodate the school. The more sparsely planted areas of this outparcel can be planted with additional trees.

The number of trees was estimated based on 40-foot spacing between trees. Planning-level estimates presented in Table 4-19 can be refined during follow-up site evaluations.

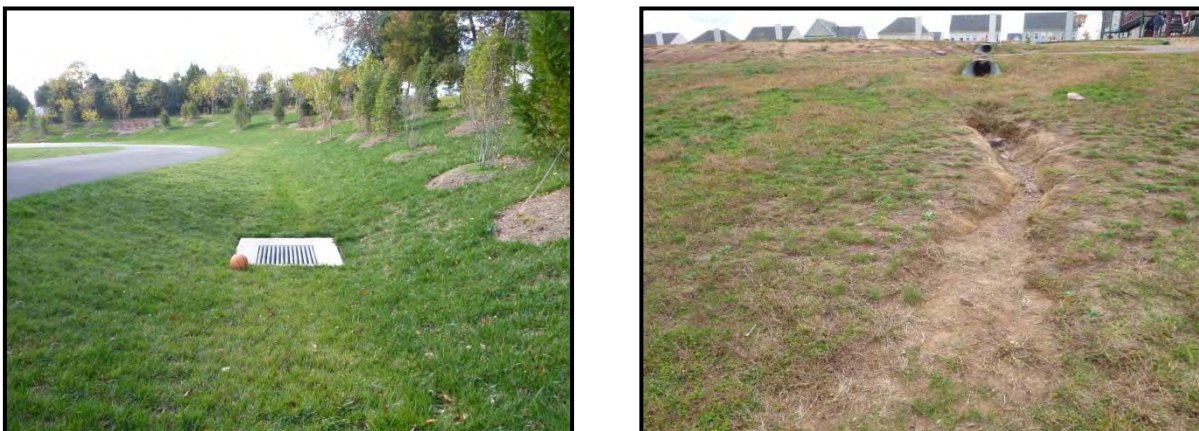
Figure 4-35: Opportunities for Bioretention at ISI-005 (left) and at ISI-004 (right)

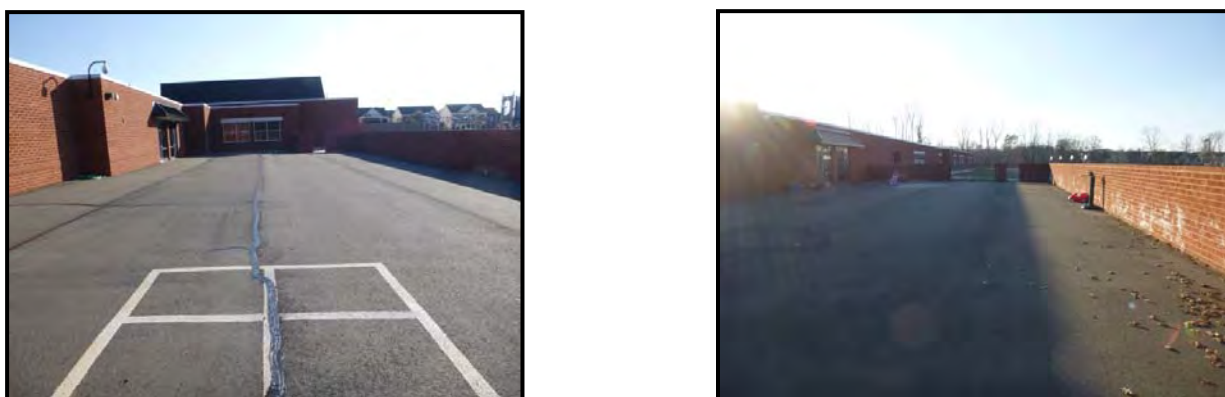
Figure 4-36: Play Area Impervious Cover at ISI-008 (left) and ISI-009 (right)

The potential for impervious cover removal was initially noted at three of the nine institutions investigated, all at elementary schools. Two examples include impervious enclosed play areas at Creighton's Corner Elementary School and Rosa Lee Carter Elementary School (Figure 4-36). However, the removal of these impervious areas is not recommended due to safety and maintenance issues. An alternative that should be considered at school facilities in the future is the installation of pervious pavement in schoolyard play areas.

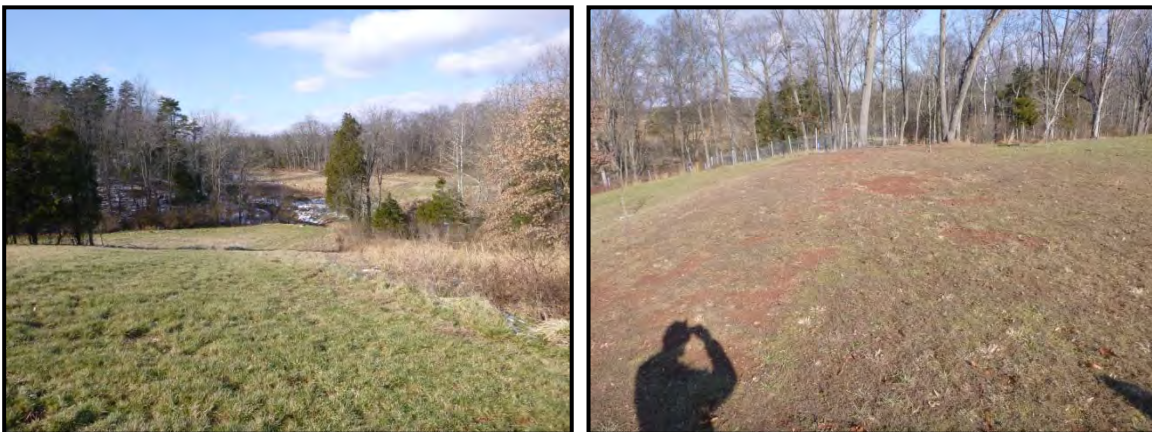
Figure 4-37: Potential Stream Buffer Restoration at ISI-006 (left) and ISI-007 (right)

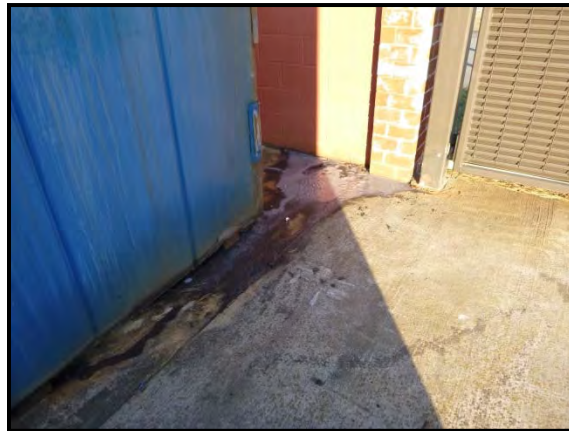
Figure 4-38: Trash Management Opportunity at ISI-009

All institutions generate waste, which if managed will remove a source of chemical pollution to waterways and minimize washing of litter into streams. Improvements to waste management were recommended for seven of the nine institutional sites. Waste management is improved through education and outreach efforts. Current waste management problems, such as leaking dumpsters, open or uncovered dumpsters where trash can leave the site or rainfall can infiltrate, and dumpster placement near storm drain inlets or streams, as well as signs of past problems such as stains or rust on impervious surfaces near dumpster areas were noted on field data sheets (Figure 4-38).

Nearly all dumpsters were found in good condition and with lids properly placed except for at one elementary school, and one municipal facility. At another municipal facility, a recycling dumpster was found to be overflowing. Dumpsters were found with evidence of past leakage at nearly all schools. Active leakage from dumpsters was found during field investigations at two elementary schools. Inappropriate storage of material outdoors in dumpster stalls (varnish, waste cooking oil, and unknown drums) was found at four elementary schools. At a municipal facility, a dumpster was found in poor condition and overflowing, and a lay-down area contained junked equipment and was uncovered. These trash management problems may be addressed through various measures such as waste management education.

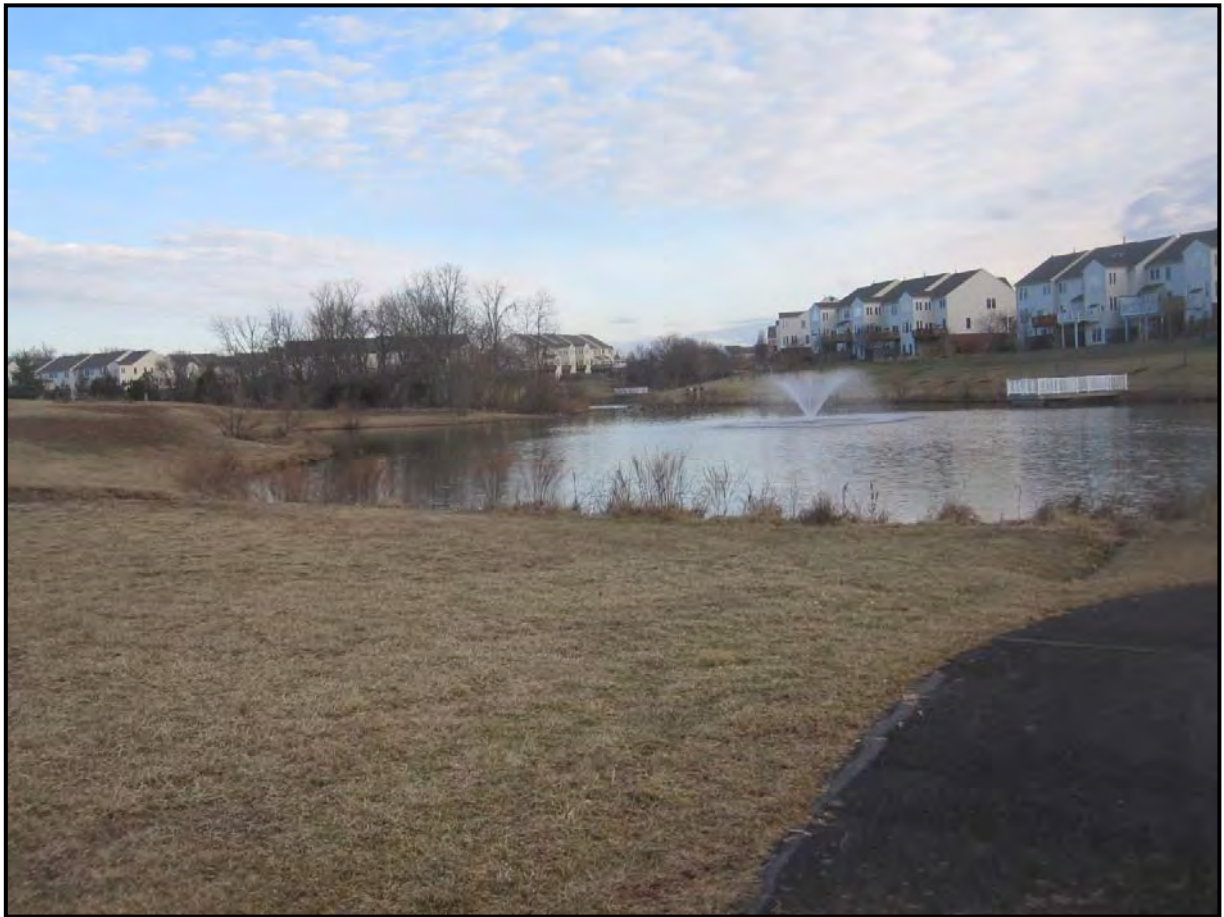
Figure 4-49: Inline Pond JC3947

Wet pond JC3947 (Figure 4-49) drains Loudoun Valley Estates and traverses some of Lyndora Park. It is an inline pond, intercepting a perennial stream. Additionally, the stream channel from

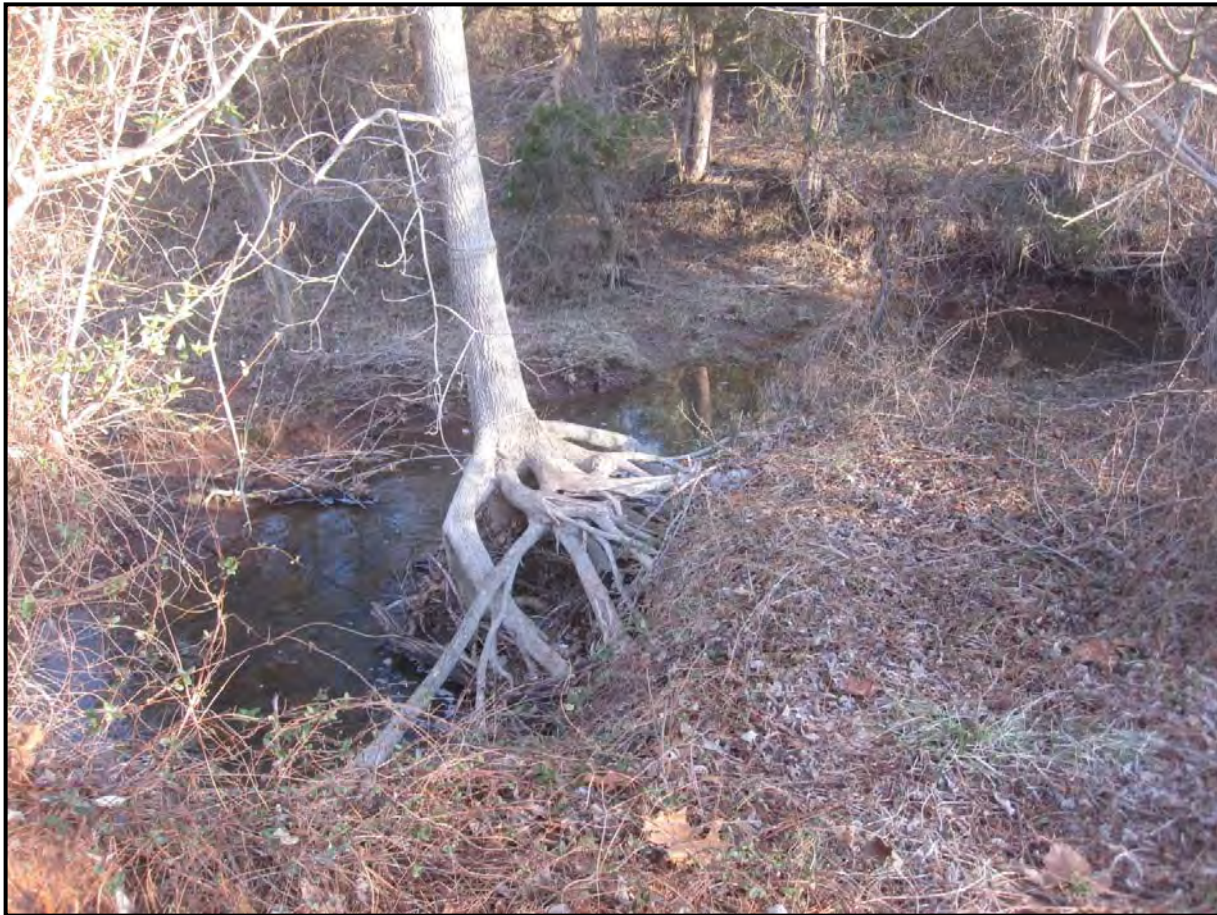
Figure 4-50: Bank Erosion Along Stream Channel above Pond JC3947 within Loudoun Valley Estates

Loudoun County Parkway to initiation of the stormwater management pond has eroding banks (Figure 4-50) and in one instance bank erosion is proximate to a structural wall (Figure 4-51). Enough open space exists in and around Lyndora Park to consider separating the perennial stream channel from the pond, restoring the natural hydrology of the perennial stream, while simultaneously removing the fish blockage caused by the wet pond. The stream channel could be restored through Loudoun Valley Estates and downstream (Figure 4-52) to prevent further erosion, and protect the development. An added benefit of taking the pond offline would be the ability to better control Canada Goose populations which are an obvious source of nutrients and bacteria to the pond and perennial stream which flows through it.

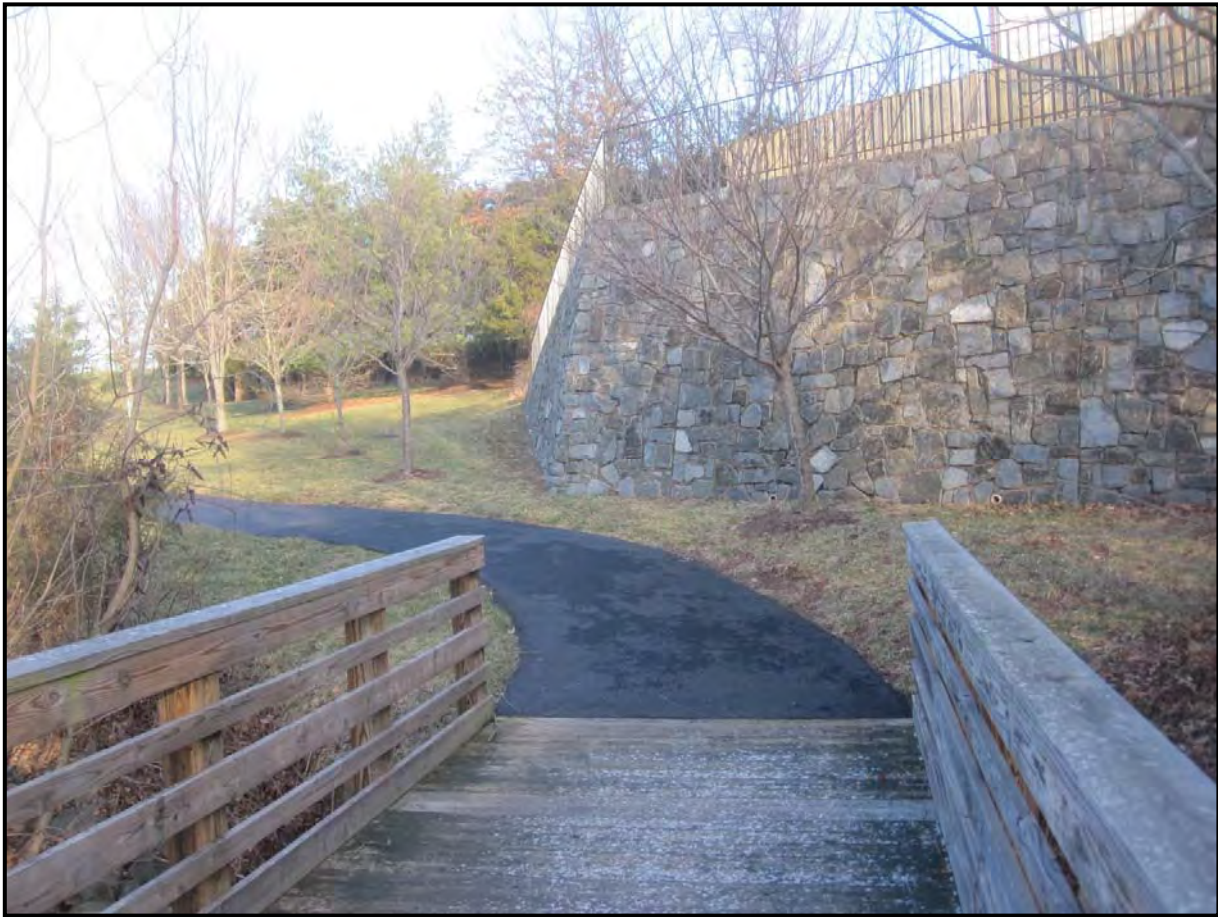
Figure 4-51: Structural Wall which may Eventually be Threatened by Bank Erosion, Loudoun Valley Estates

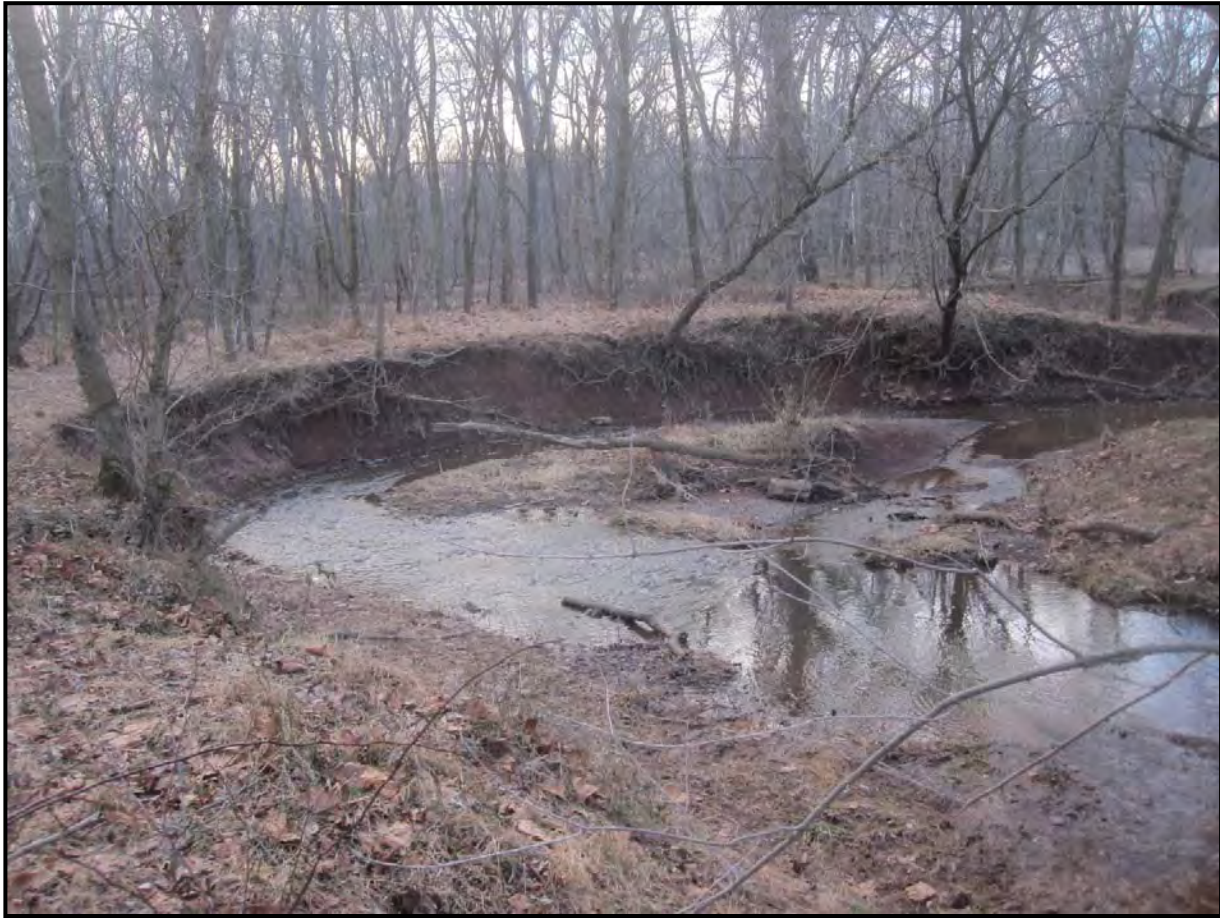
Figure 4-52: Streambank Erosion Observed just Downstream of Dewatering Structure of Pond JC3947 at Loudoun Valley Estates and Lyndora Park

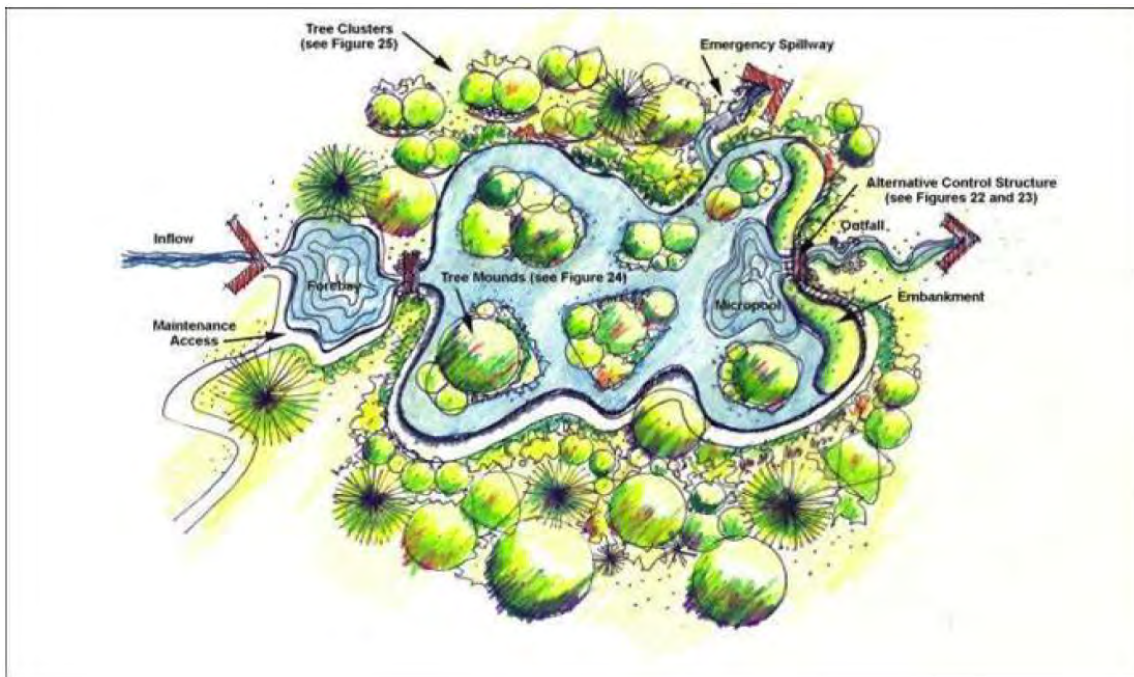
Figure 5-1: Constructed Wetland Standard Concept Design (Virginia DEQ 2011a)

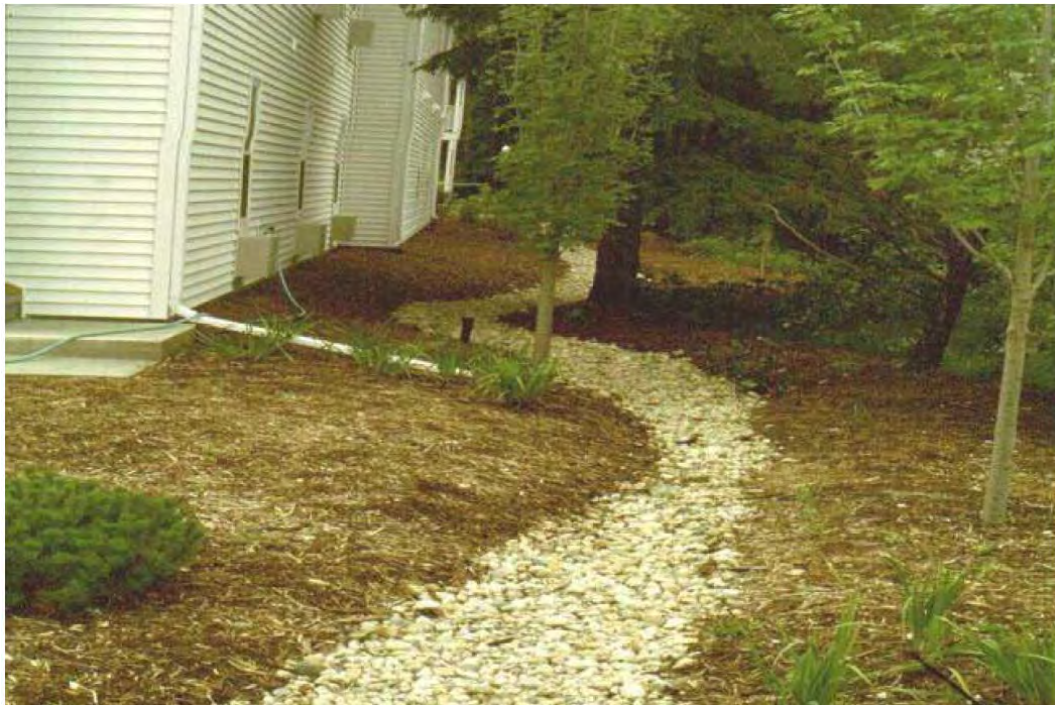
Figure 5-2: Residential Infiltration Trench (Virginia DEQ 2011b)

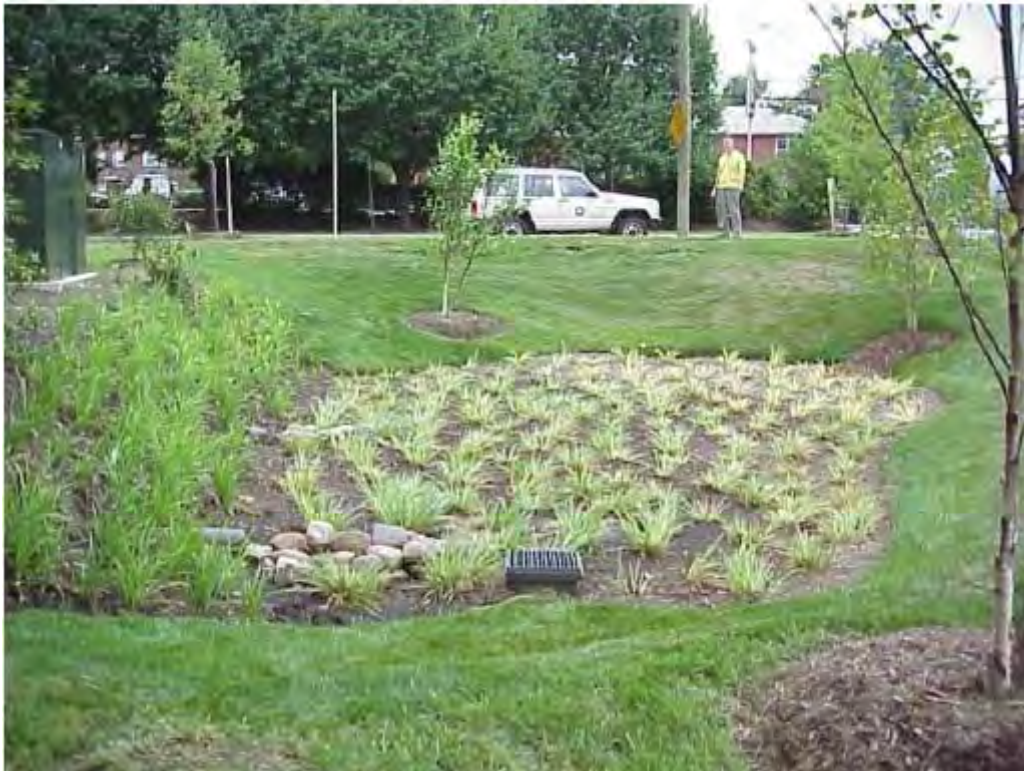
Figure 5-4: Photo of Bioretention Draining a Rooftop at a Commercial Facility (Virginia DEQ 2011c)

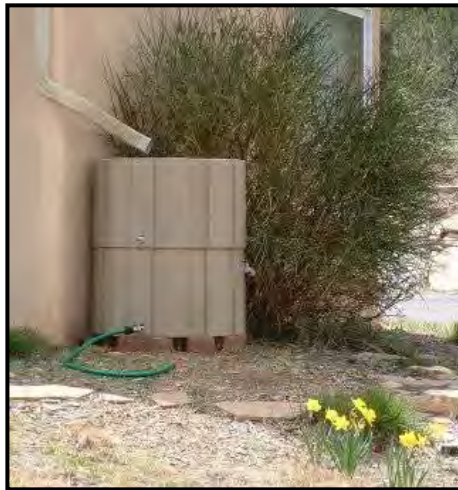
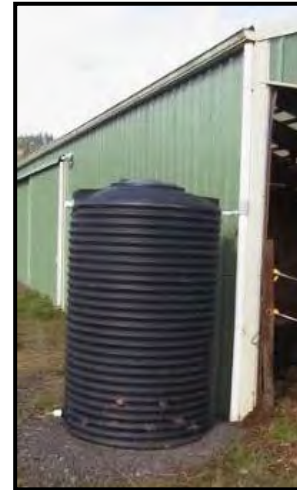
Figure 5-8: Rain Barrel Standard Section and Photos of Rain Barrel and Above-ground Cistern (Sources: Prince George's County 1999; www.aridsolutions.com; and www.plastmo.com)

- Rain barrels are low-cost, effective, and easily maintainable detention or retention devices that can be used in residential, commercial and industrial sites. They are connected to downspouts to retain or detain rooftop runoff (Figure 5-8). Rain barrels can be used to store runoff for later use in lawn and garden watering or can discharge into dry wells. The Loudoun County Soil and Water Conservation District actively educates local residents about the many benefits of rain barrels during several rain barrel workshops each year (Loudoun SWCD 2013).

- Rainwater Harvesting uses larger rainwater storage via Cisterns placed either above or below ground (Figures 5-8 and 5-9). The water they capture is suitable for non-potable uses including flushing of toilets and urinals inside buildings (with proper cross-connection prohibition), landscape irrigation, exterior washing (e.g., car washes, building facades, sidewalks, street sweepers, fire trucks, etc.), fire suppression (sprinkler) systems, supply for chilled water cooling towers, replenishing and operation of water features and water fountains, and laundry, if approved by the local authority. Rainwater harvesting via cisterns can be combined with a secondary (down-gradient) runoff reduction practice to enhance runoff volume reduction rates and/or provide treatment of overflow from the rainwater

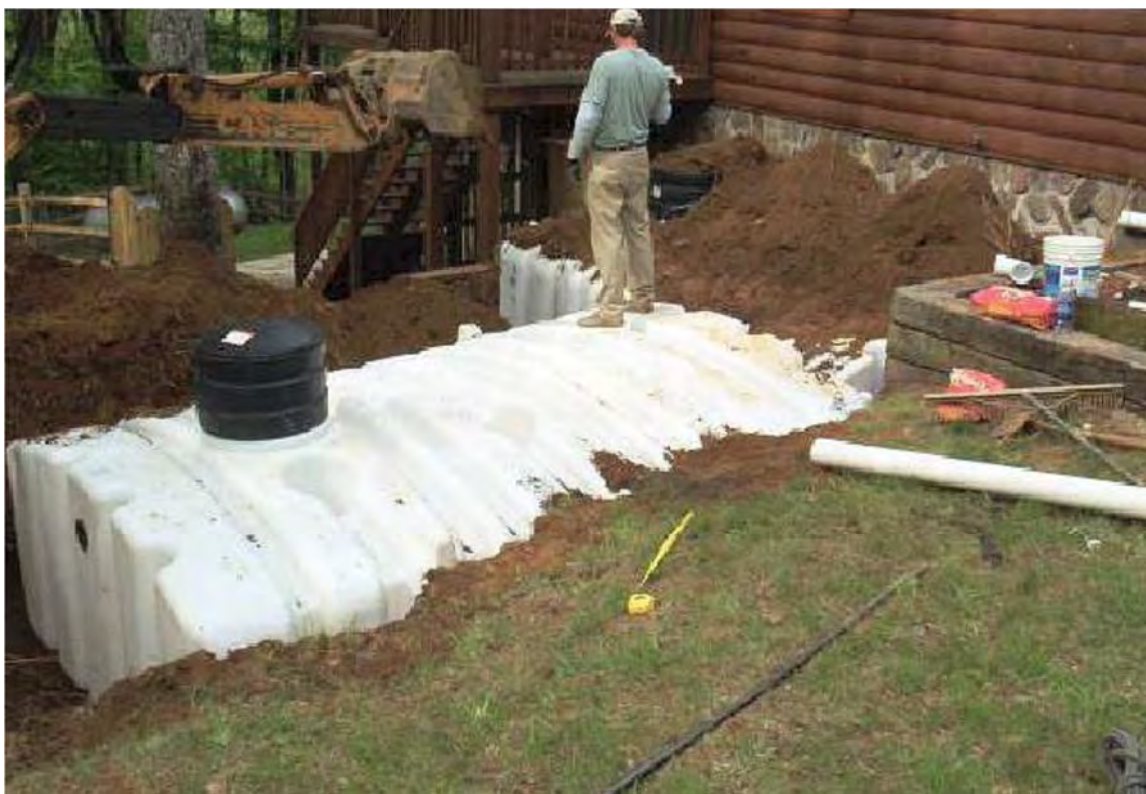
Figure 5-9: Subterranean Cistern (Virginia DEQ 2011f)
