UPPER BROAD RUN WATERSHED MANAGEMENT PLAN

Prepared for
Loudoun County
Department of
Building and Development
1 Harrison St.
Leesburg, VA 20175

Nancy Roth, Mark Voli, Steve Schreiner,
Alexi Boado, Allison Brindley, Tom Jones,
Steve Harriott, Jodi Dew-Baxter, and
Mark Southerland
Versar, Inc.
9200 Rumsey Road
Columbia, MD 21045

September 30, 2014

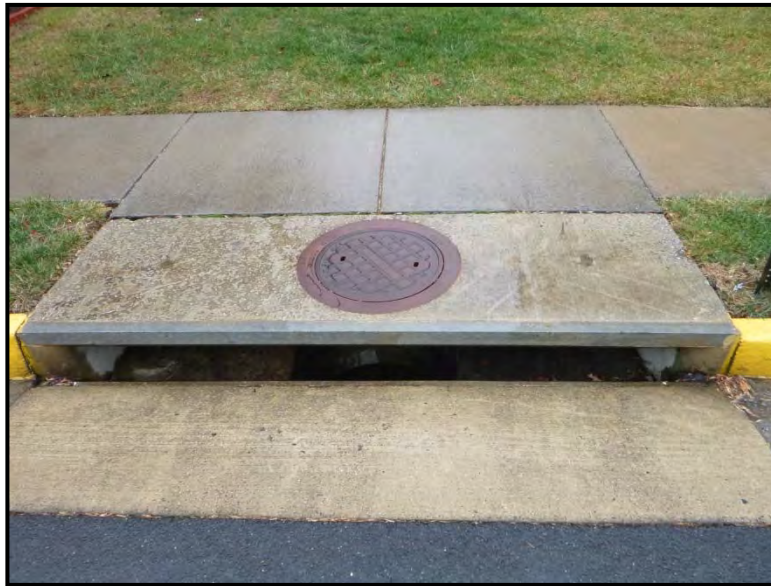
Figure 7-3: Unmarked Storm Drain in Brambleton Neighborhood

All of the neighborhoods assessed within the Brambleton subwatershed had opportunities for improvement. Storm drain marking (Figure 7-3), rain barrels, conservation planting, and new SCMs were widely recommended. Storm drain marking is popular because this relatively easy and inexpensive action can have a great effect by reminding residents not to dump potentially dangerous materials into the storm drain. It can also be easily paired with other education efforts, for example, with education regarding the effects of pet waste on water quality, in neighborhoods where both were recommended. Rain barrels serve as temporary storage of roof runoff, decreasing the volume of stormwater running off site, but also do a great job of promoting stormwater runoff awareness. NSA-21 has a large amount of open space in several portions of the neighborhood and is considered a great site for a tree planting project (Figure 7-4). NSA-1B, NSA-4A, NSA-13, and NSA-15 are good sites for bioretention area/rain garden installation projects. Projects on this scale may encourage widespread community engagement and are ideal opportunities for children and families to become involved with their watershed in a concrete way. In addition, actions as simple as adjusting mowing practices and planting trees along stream channels and drainage ditches may help to slow down high stream flows that cause bank erosion and to intercept nutrients and toxins before they enter the aquatic ecosystem.

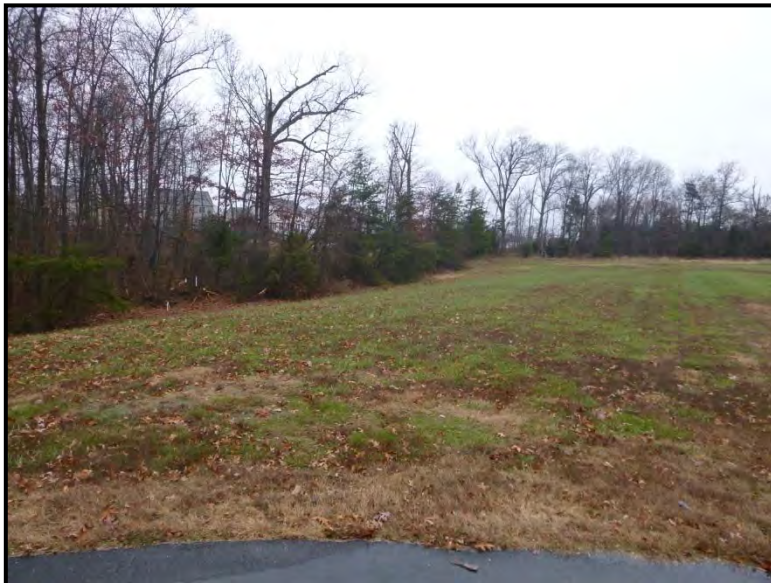
Figure 7-4: Tree Planting Opportunity at NSA-21

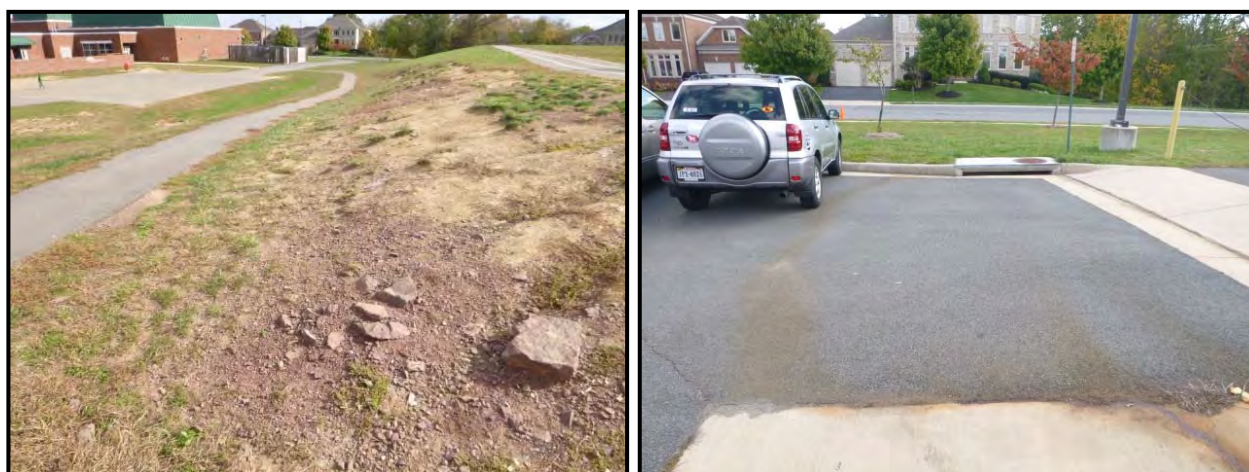
Figure 7-5: Terracing Opportunity to Address Erosion (left) and Stains Leading from Dumpster to Storm Drain Inlet (right) at ISI-004

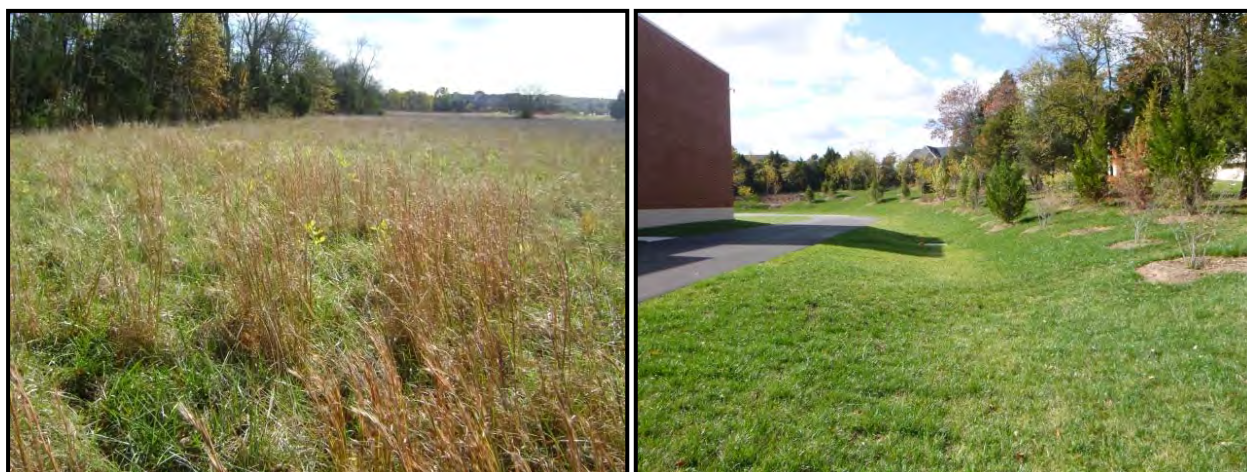
Figure 7-6: Opportunities for Stream Buffer Augmentation (left) and Bioretention (right) at ISI-005

ISI-005 is a recently constructed elementary school in the Brambleton subwatershed. New environmental education initiatives could include activities such as tree planting to improve forest cover and stream buffer sizes. Field staff noted buffer encroachment issues at both the front (east) and rear (west) property lines (Figure 7-6). The school is maintaining portions of these areas as meadows; however, the planting of trees would improve stormwater infiltration and stream buffer character even more. For stormwater management, the school features level spreading and infiltration. To augment treatment, bioretention can be installed in areas where grassy swales currently handle stormwater runoff from impervious areas, particularly playground areas to the rear and to the north of the school building. These demonstration projects would be just steps away from the school doors and provide a valuable connection between human activities and stormwater quality and what steps can be taken to improve instream conditions.

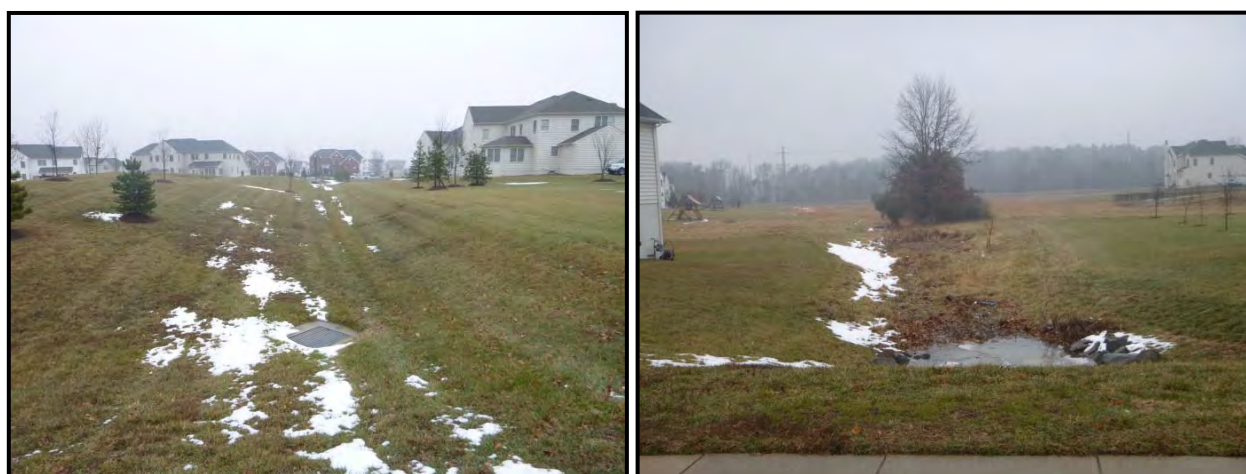
Figure 7-9: Bioretention Opportunity (left) and Tree Planting Opportunity (right) Within NSA-10

The neighborhood assessed within the Upper Broad Run Mainstem subwatershed had several opportunities for improvement. It was estimated that 50% of the downspouts within this neighborhood are directly or indirectly connected to the storm drain. The large portion of the neighborhood covered by mowed lawns provides a great opportunity for rain garden installation and conservation planting. Storm drain marking, which offers an opportunity to not only engage residents, but to serve as a visual reminder of the downstream effects of residents' actions, was also recommended for this neighborhood. A large amount of open space in common areas that is suitable for bioretention areas/rain gardens and tree planting was noted in several portions of the neighborhood (Figure 7-9). In addition, actions as simple as adjusting mowing practices and tree plantings along the ephemeral channel that carries stormwater offsite may help to slow down high flows that cause bank erosion and to intercept nutrients and toxins before they enter the aquatic ecosystem.

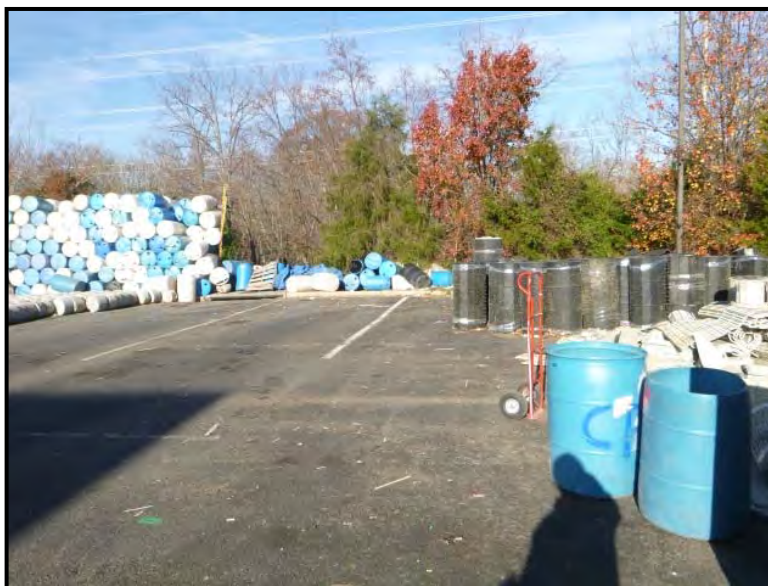
Figure 7-10: Inventory Stored Outside, on Impervious Surface, Near Storm Drain Inlet

At the two business parks, a preliminary field reconnaissance was performed to identify those buildings and businesses where issues were readily apparent. Special attention was paid to outdoor fueling, material storage, and housekeeping problems, especially if they were in the immediate vicinity of storm drain inlets. At HSI-002, a number of housekeeping problems were apparent. Substantial inventory, stored material, and discarded material was placed out in the open on the rear parking lot. Materials included: floating barrels, concrete blocks, bundles of material, fencing, pallets, barrels, and scrap metal. Other items were stored inside and under trailers. Some material was stacked and placed near a storm drain inlet (Figure 7-10). For these storage problems, a network of canopy covers or hardened shelters would be highly beneficial and would reduce the likelihood of washing of pollutants to storm drain inlets.

Evidence of vehicle maintenance activities was inferred from the presence of at least one truck with an open hood. Fleet fueling operations without the benefit of a canopy was therefore noted. Two dumpsters were found onsite with tops open and with noticeable trash accumulation along a tree line behind the rear parking and inventory storage area. Recommended improvements to the site include the addition of sheltering structures for the fueling area, waste management training for employees, and movement of truck maintenance activity indoors as not to be exposed to precipitation.

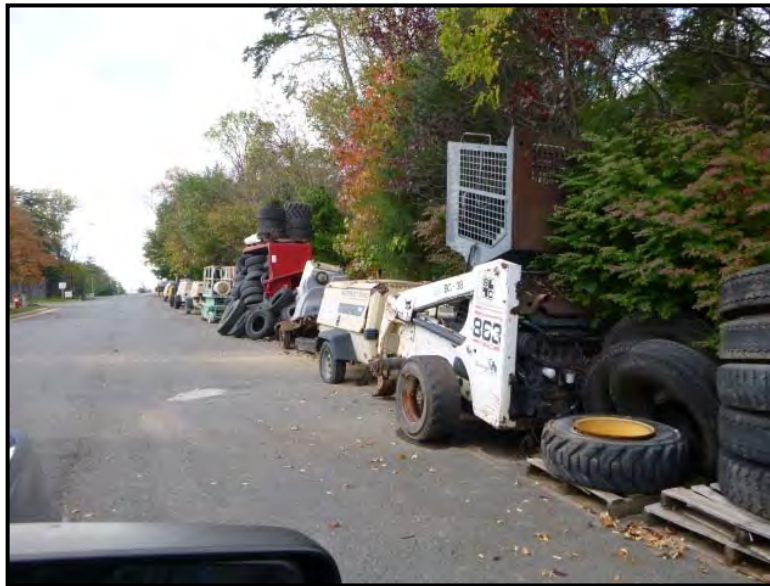
At HSI-009, field staff identified a number of housekeeping problems in the rear lot. Storm drain inlets were found blocked by absorbent logs. In another area, bundles of used and broken up tire treads were found stacked along a gutter pan that led to a storm drain inlet (Figure 7-12). One bundle was found resting on top of a storm drain inlet. Junked or inoperable equipment was also found parked along the same gutter pan; a Bobcat had obvious oil staining underneath. Staff also identified a scrap metal pile on an impervious surface, a rollaway dumpster full of waste construction material, scrap metal bins and lumber and chain link fencing inventory stored in the open on impervious surfaces.

Figure 7-12: Junked Equipment and Tires Awaiting Disposal on Impervious Surface

For inventory and equipment storage, especially on this impervious rear lot, canopies and shelters are recommended. Staff would also benefit from training on the proper storage of waste materials. Sediment and hydrocarbon runoff should be addressed with modifications to onsite procedures and not by relying on berms at storm drain inlet orifices. Increasing the frequency of inoperable equipment removal would also greatly benefit the site by removing pollution-causing materials from a direct route to storm drain inlets at this site.

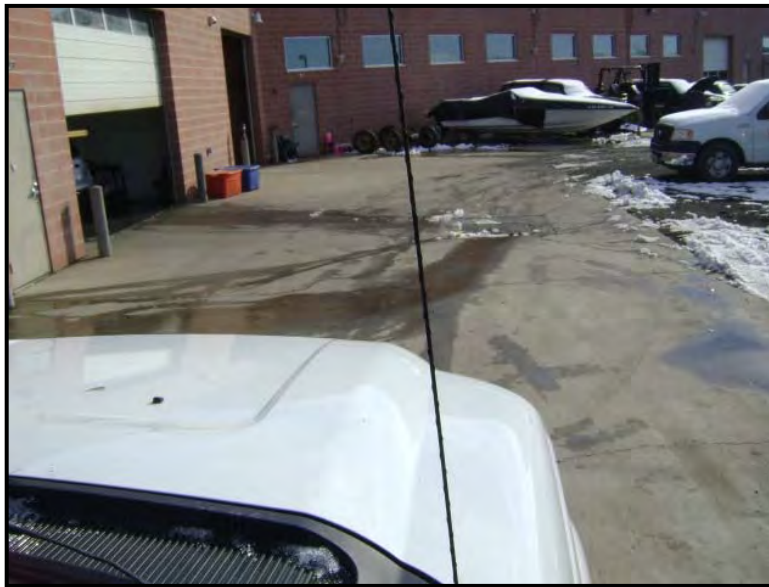
An auto body shop was one of many businesses visited within a business park to assess for hotspot status. Field staff noted substantial repair and storage of automobiles outside and without the benefit of cover. Vehicles were being washed indoors; however, excess water was flowing out of the indoor areas and toward a storm drain inlet (Figure 7-13). Other materials, such as car parts and drums, were being stored likewise in the open, potentially creating a source of pollution to the storm sewer system. Dumpster stalls, and their immediate vicinity had collections of discarded material, car parts, and barrels placed nearby. For this site, a cleanup and assessment of storage procedures is recommended. The area and the subwatershed would benefit from modifications to waste management procedures including attention to placement of material into dumpsters and expeditious removal of discarded items such as car parts. A car wash capture system would also eliminate another source of direct input of pollution to the storm drain system.

Figure 7-13: Excess Water from Washing Flowing Toward Storm Drain Inlet

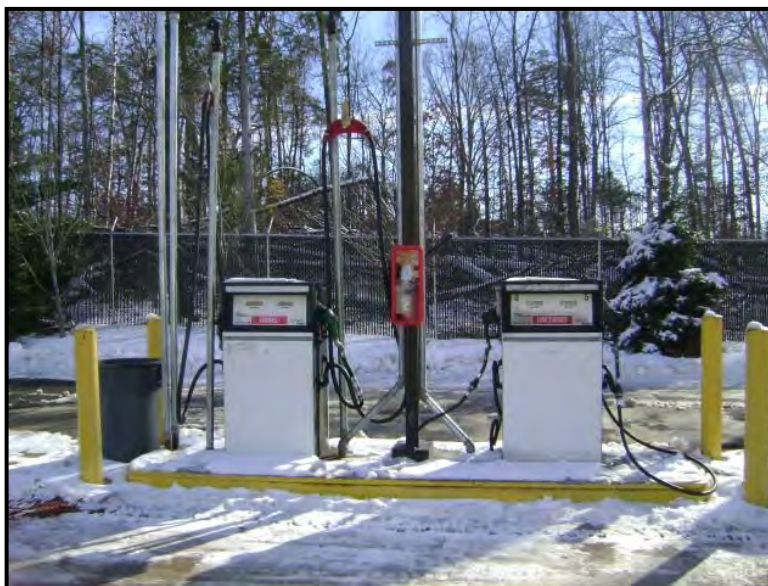
At a vehicle maintenance business in a business park, field staff identified several housekeeping issues in the back equipment lot. The company manages, stores, and repairs a fleet of vehicles and construction equipment and has a fueling station on the property. The fueling station does not have a canopy cover and is located within close proximity to a storm drain inlet (Figure 7-14). Staff also documented discarded material, such as an open bin of used tires. The rear lot also serves as a transfer area for dirt, gravel, and waste rubble, all of which is open to the elements and increases the storm drain system's and stream network's exposure to polluted and sediment-laden runoff. Other liquid material in barrels is stored outside without the benefit of secondary containment. Dumpsters placed near storm drain inlets were found to be overflowing.

Figure 7-14: Uncovered Fueling Station

The contribution by the business to polluted runoff could be reduced by placing material and conducting activities under canopy covers or shelters. Bulk waste, such as the bins of tires, should be removed quickly so that metals such as zinc are not accumulated and washed to the storm drain system. Bulk material, such as dirt, should be protected from the elements by using, at the very least, tarps. Training of employees, along with modification of waste management, equipment repair, and fueling procedures, would go a long way toward reducing this business' contribution of pollutant and sediment load to local streams.

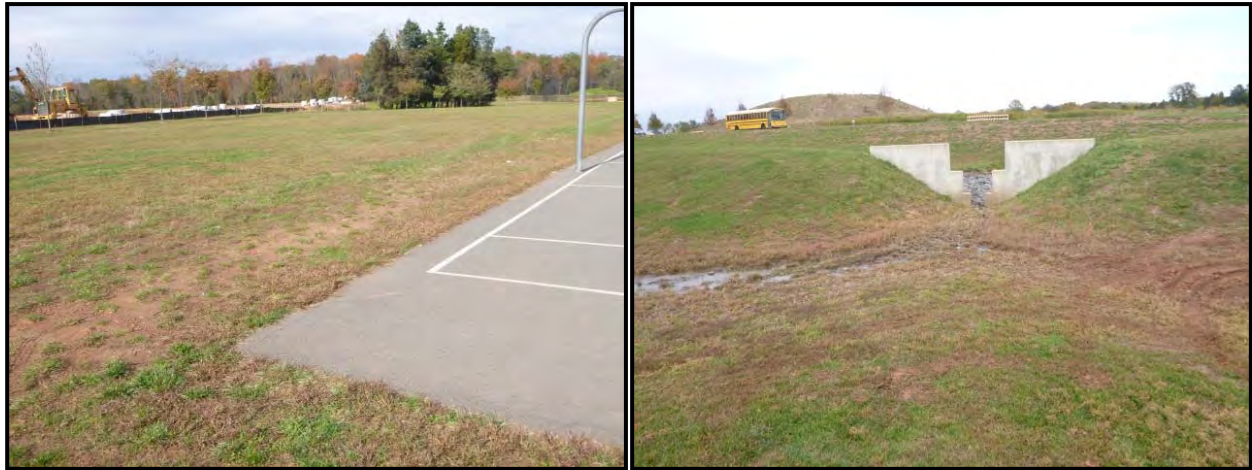
As is the case with all schools surveyed in the Upper Broad Run watershed, ISI-003 provides many opportunities for watershed restoration. Visibility of the watershed restoration measures is an added bonus since examples for environmental education are readily available. Adjacent to athletic fields are many opportunities for tree planting to convert unused or under-utilized grassy areas to forest canopy. Tree planting on the property would provide a much-needed contrast to the prevailing lack of trees in the immediate area. The property currently features bioretention areas adjacent to parking lots as pretreatment of stormwater. Stormwater treatment onsite could be further enhanced by installation of bioretention at strategic locations around the building and along a drainage swale between the back drive and the athletic fields. Bioretention servicing the faculty parking lot to the southwest could be expanded to infiltrate and treat a larger portion of the lot. This type of pretreatment reduces chemical and temperature pollution of stormwater effluent from the lot. Berms could be installed at the upstream end of the culvert that travels the width of the rear athletic area near the rear drive. These berms would capture and infiltrate sheetflow from athletic fields and points up-gradient. Lastly, the dry stormwater facility on the east side of the property can be converted to a wet pond to better settle out pollutants (Figure 7-15). Trash dumpsters located on the southwest portion of the school were found to be leaving stains on the impervious surface. Such staining is evidence of pollutants leaching from the dumpster and ultimately reaching storm drain inlets. A waste management training session for school staff would improve waste handling and reduce the possibility of pollution transport to the storm drain system.

Figure 7-15: Tree Planting (left) and Dry Pond Conversion (right) Opportunities at ISI-003

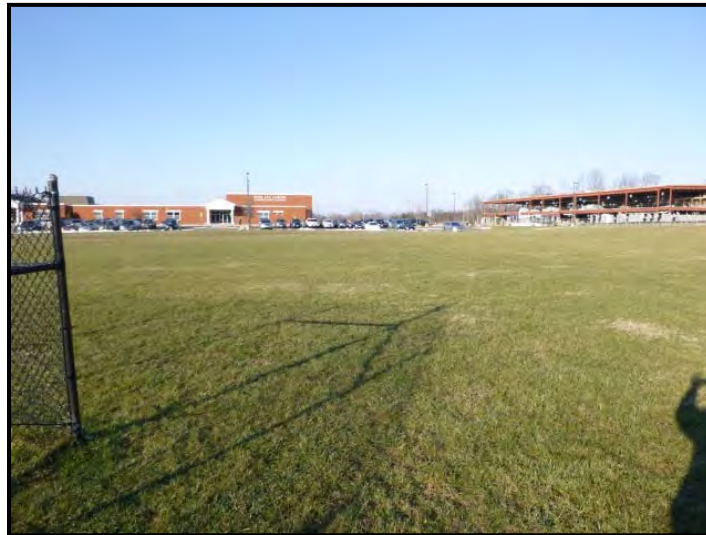
At ISI-009, a large expanse of grass was found immediately in front of the school building and adjacent to the roadway (Figure 7-16). The grassy area provides an excellent opportunity for reforestation. A drainage swale that runs through the grassy zone could be converted to bio-retention to provide an extra measure of stormwater treatment and infiltration. A tree planting, outreach, and education effort could be undertaken to restore the buffer along Broad Run, which forms the western border of the school. Approximately 300 feet of buffer has been eliminated due to sanitary sewer line construction; areas outside of the sanitary sewer line easement can be planted. Other areas near ballfields could also be planted with trees to extend the buffer. Waste management could also be improved through staff training. On the east side of the school, a dumpster was found to be leaking contents onto the impervious surface in near proximity to a

Figure 7-16: Tree Planting Opportunity at ISI-009

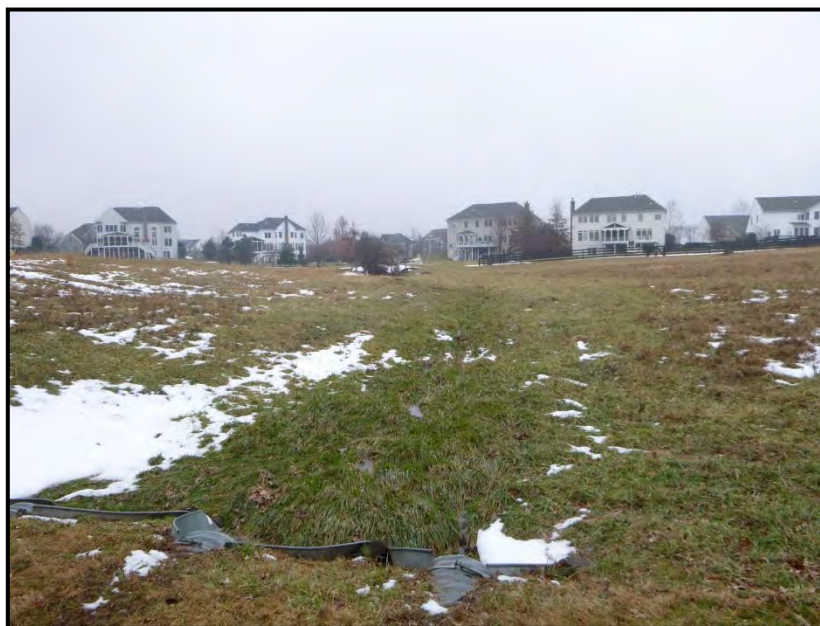
Figure 7-21: Grassy Field that Conveys Stormwater Runoff from Impervious Surfaces within NSA-9 to the Local Stream

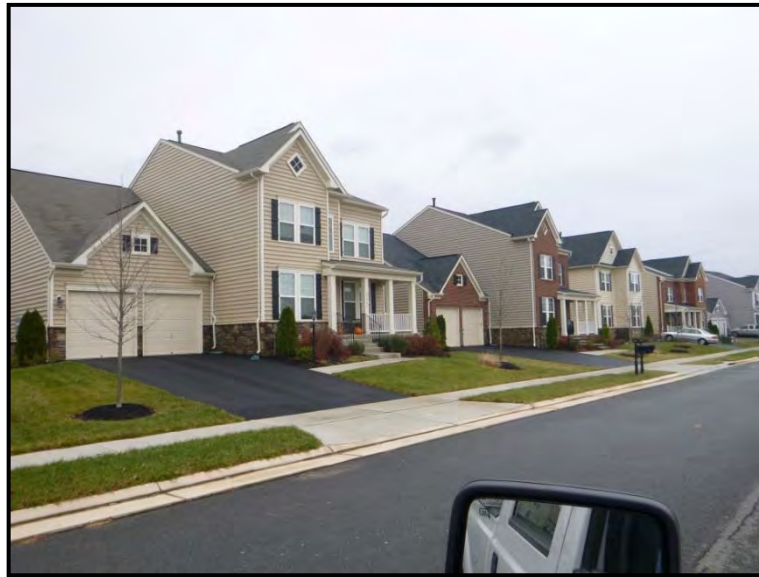
Figure 7-24: Typical Downspouts and Front Yards in NSA-5 with an Opportunity to Redirect Downspouts to Pervious Area

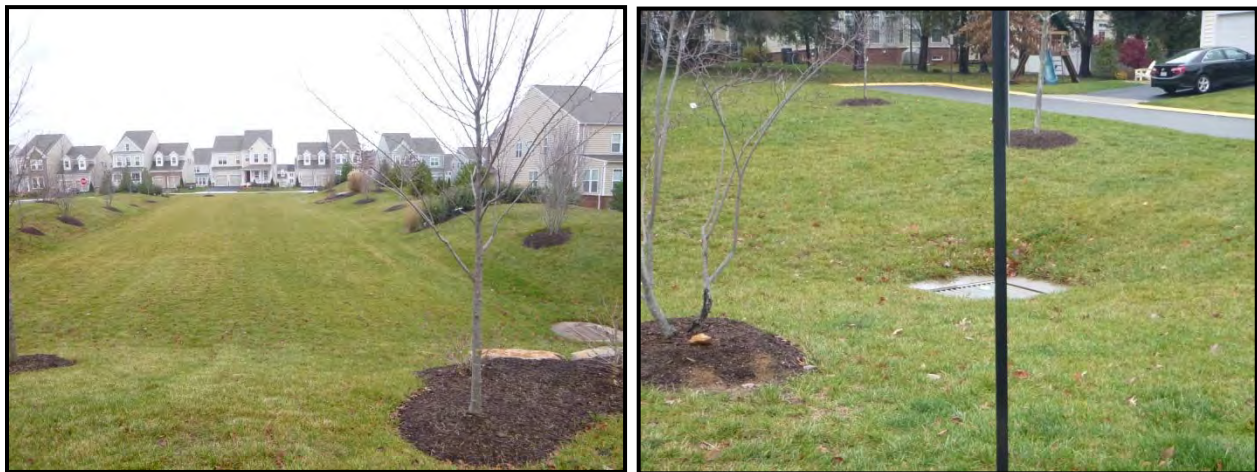
Figure 7-25: Rain Garden Installation Opportunity in NSA-5 (left) and NSA-4B (right)

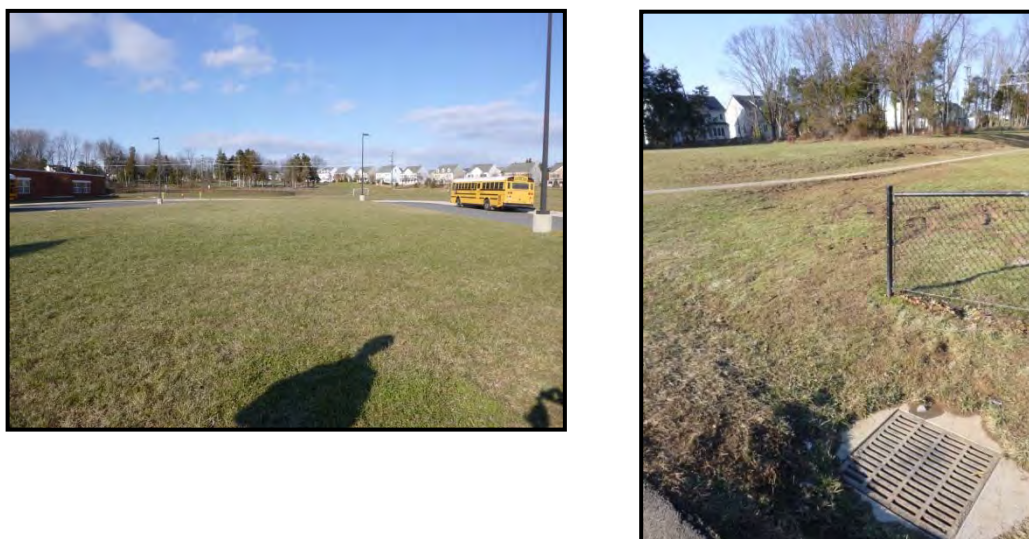
Restoration and opportunities to communicate and learn about them are plentiful at ISI-008. Field staff noted substantial grassy square footage that could be converted to more stormwater-friendly tree stands. Field staff noted areas on the southeast periphery, in the center of the bus turnaround drive, and adjacent to and between athletic fields. Further, an area at the north corner of the property has not been cleared for construction and which should be preserved and augmented with additional trees. These tree planting measures, if taken, would increase the forest canopy coverage at the school from 25% to nearly 50%. Tree planting would promote stormwater infiltration as well as reduce maintenance costs involved with mowing and maintaining turf areas around the school. Where trees would not be appropriate, conservation planting could be used instead. Adding to stormwater management opportunities around the school are areas where sheetflow from grassy and athletic areas are causing erosion problems. The southwest corner of the baseball diamond is such an example. Installation of bioretention in conjunction with terraces along the impacted hillside would reduce transport of sediment to the nearby storm drain inlet (Figure 7-26). Like many schools, the staff could benefit from waste management training so that pollutants are not transported from dumpsters to storm drain inlets.

Figure 7-26: Tree Planting Opportunity in Bus Turnaround Area (left) and Bioretention Opportunity (right)

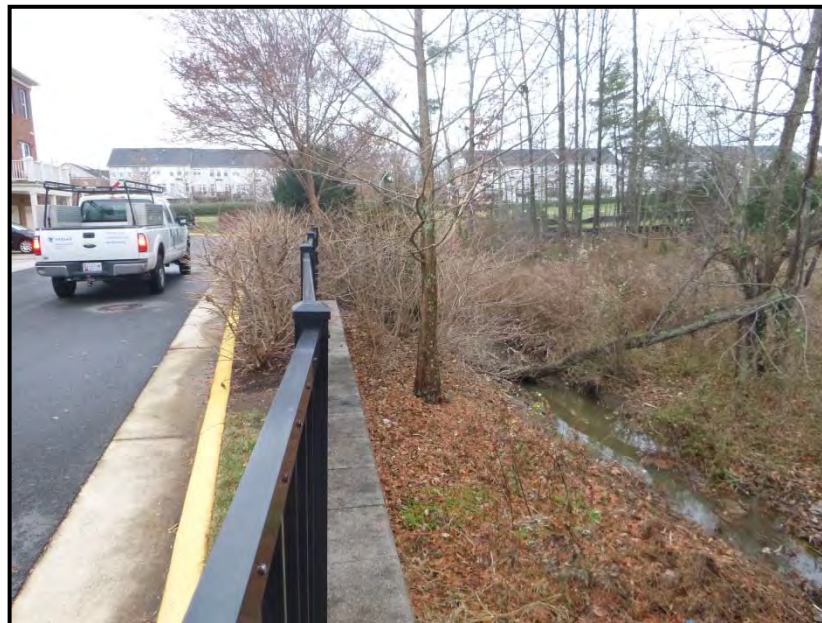
Figure 7-29: Stream Buffer Encroachment in NSA-20

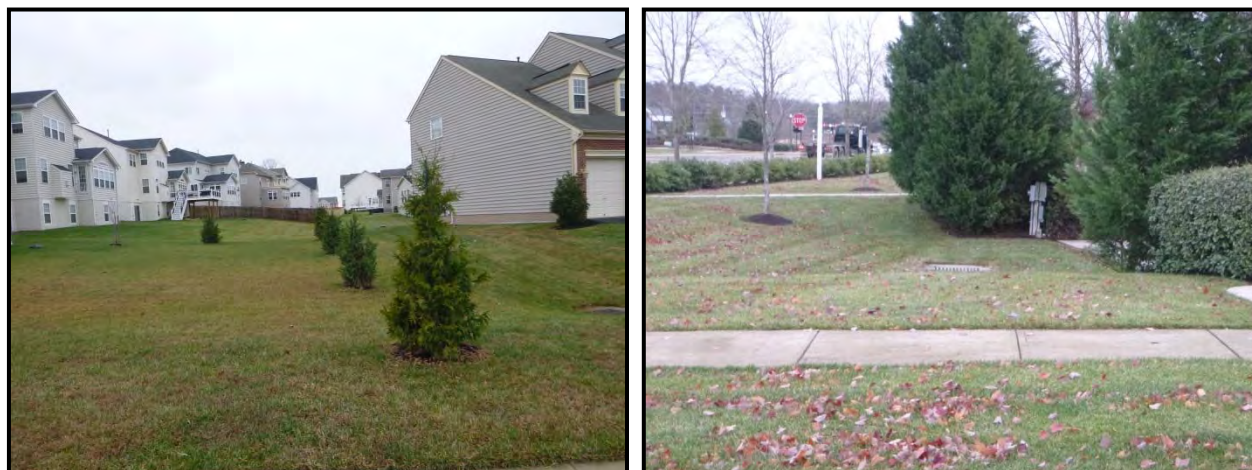
Figure 7-30: Opportunity for Rain Garden Installation within NSA-22 (left) and NSA-18 (right)

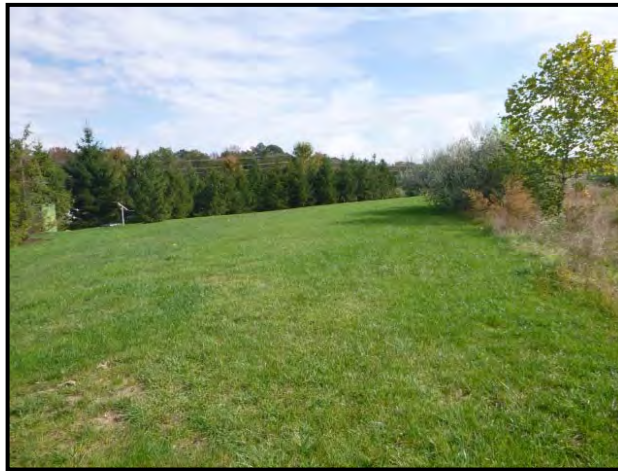
Figure 7-31: Tree Planting Opportunity

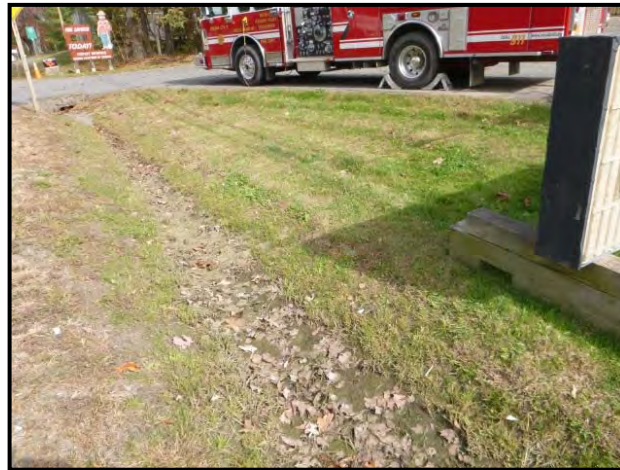
In contrast to ISI-001, ISI-002 is an older institution with stormwater management challenges characteristic of older facilities. The site features older impervious surface (a portion of the parking lot is breaking up) and in topography it slopes gradually toward Gum Spring Rd. General measures to improve stormwater infiltration on the site include the addition of bioretention in front of and to the side of the maintenance building and in a zone adjacent to Gum Spring Road. At present, the only stormwater treatment offered on the site is a grassy swale along Gum Spring Road (Figure 7-32). Bioretention would increase infiltration of stormwater runoff and reduce the net impervious footprint of the fire station. A further measure to increase stormwater infiltration would be the installation of rain barrels on downspouts. The risk of polluted stormwater would be lessened by implementation of waste management training. Field staff noted the presence of a rusted and overflowing dumpster and a collection of discarded equipment stored on impervious surfaces on the property. Lastly, extending the forested portion of the property to a grassy area behind the main building would further improve onsite stormwater infiltration and provide additional shade to the building.

Figure 7-32: Bioretention Opportunity at ISI-002

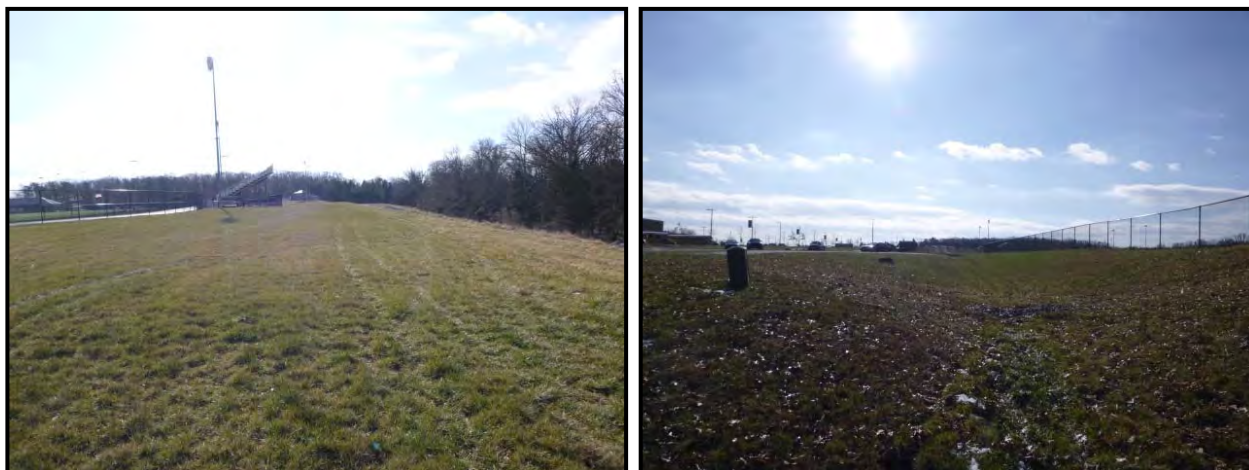
ISI-006 is an extensive school facility that provides ample opportunities for watershed restoration. Field staff noted that the main student parking lot is already provided with modern stormwater treatment in the form of a sand filter and bioretention. The stormwater facility, however, is in need of maintenance due to washout of gravel on the east edge of the lot by runoff originating from a culvert under a nearby roadway. Pervious asphalt is also provided on the northwest faculty parking lot. Potential restoration measures that can improve upon onsite stormwater management include installation of bioretention at a yard drain off the northwest corner of the student lot. A curb cut would divert stormwater runoff in the parking lot to the treatment area. Additionally, a grassy swale running east-to-west along a recently removed road could be converted to linear bioretention to both (a) treat and infiltrate stormwater runoff and (b) mitigate an erosion issue developing on the western edge of the property. Tree cover could be increased on the school campus by utilizing current mowed grass areas along the northern and southern peripheries (Figure 7-33). The trees would partially shade the athletic field complex, improve infiltration of stormwater that currently sheets off compacted, grassed areas, and provide habitat for animal populations. Construction of a sanitary sewer right-of-way off the southwestern edge of the property has encroached on a first order stream buffer as well as the South Fork of Broad Run. Replanting the buffer on both sides of the stream (but outside of the sanitary sewer easement) as well as along tributaries near the southern and northern borders of the high school property would improve water quality by promoting stormwater infiltration, providing bank stability, and improving instream habitat by increasing shading.

Figure 7-33: Tree Planting (left) and Bioretention Opportunity (right) at ISI-006

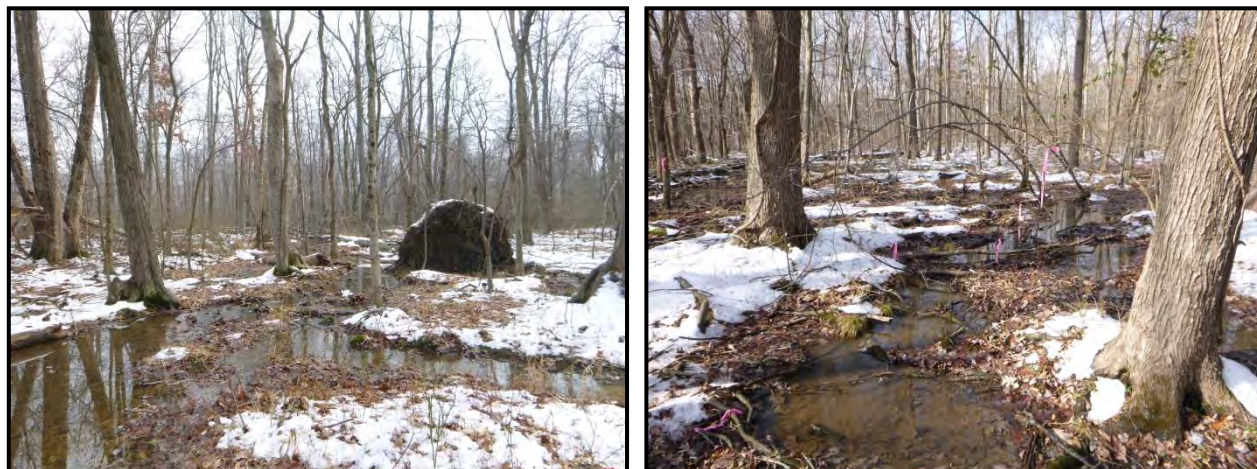
South Fork Broad Run's headwater area was recommended for stream corridor preservation (Figure 7-34). This headwater stream was broken into many small, braided channels connected directly to, or only inches above, the floodplain. Little flow was present here, and almost no bank erosion existed. Most of the upper area possessed broad, forested nontidal wetland buffers; though some recent land clearing activity was encroaching on these buffers in certain areas. The forested buffers possessed moderately large, second-growth deciduous trees, consisting of mainly of pin and white oaks, red maple, and boxelder. Spicebush, cinnamon fern, and Virginia chain fern were the principal species in the shrub and herbaceous layers.

Figure 7-34: Downstream Section (left) and Upstream Section (right) of Stream Corridor Recommended for Preservation within South Fork Broad Run

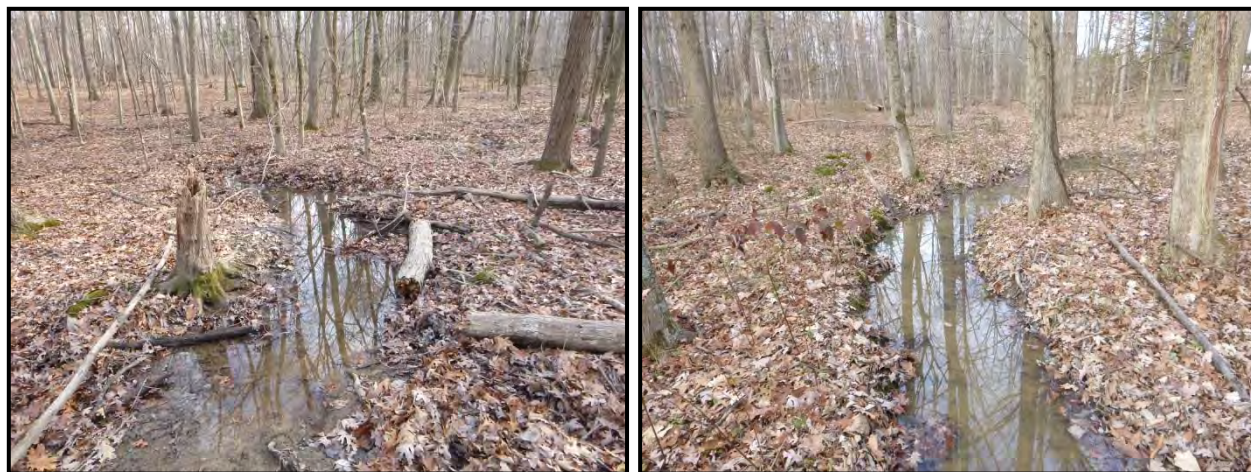
Upper North Fork Broad Run's headwater area was recommended for stream corridor preservation (Figure 7-37). This headwater stream was broken into many small, braided channels connected directly to, or only inches above, the floodplain. Little flow was present here, and almost no bank erosion existed. Most of the upper area possessed broad, forested buffers; some of the forest here was wider than 300 feet on each bank. The forested buffers possessed moderately large, second-growth deciduous trees, consisting of pine, white, and willow oaks, red maple, boxelder, and green ash. The shrub and herbaceous layers were relatively sparse, likely owing to the generally dense tree canopy, but spicebush and sensitive fern were the principal species. Several areas with particularly low topographies along the braided channels comprised forested nontidal wetlands.

Figure 7-37: Upper North Fork Broad Run Stream Corridor Recommended for Preservation

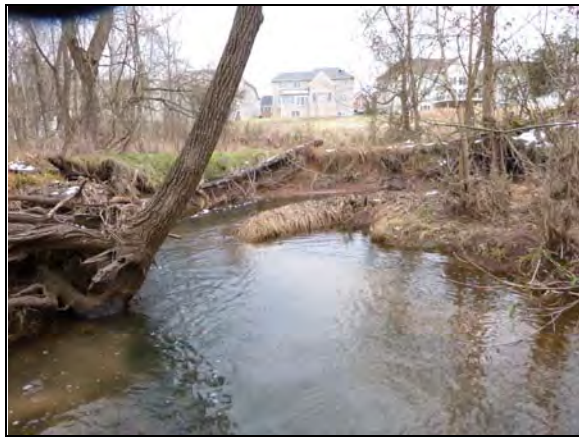
Within highly impervious catchment. Bank erosion is undermining trees along stream bank and several are close to falling into the stream. Within a narrow, wooded area with residential housing to the south and Loudoun County Parkway to the north.

Tree falling over into stream

Proposed Action: Stabilize stream bank and reconnect with floodplain

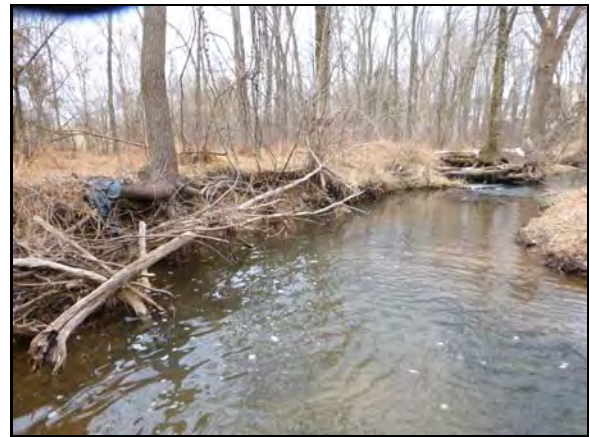
Bank erosion undermining several trees along stream channel

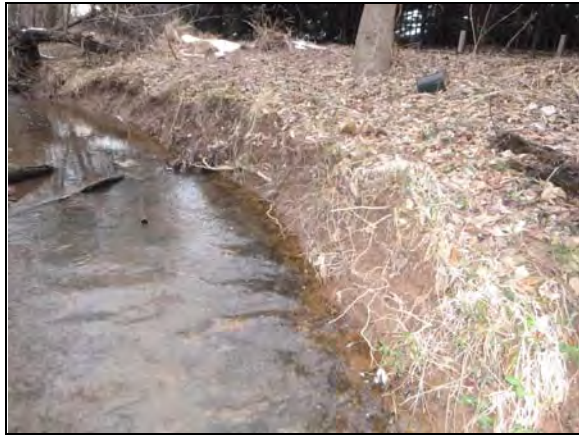
Within a narrow, wooded corridor. Residential yards close to eroding stream bank. Heavy deposition on opposite bank.

Stream bank erosion

Proposed Action: Stabilize stream bank and reconnect with floodplain

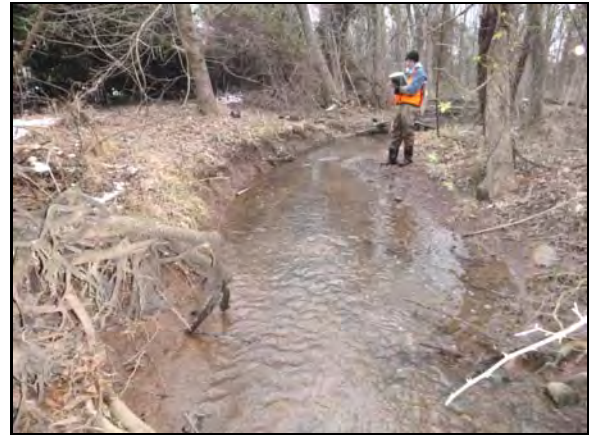
Deposition occurring on bank opposite of eroding bank

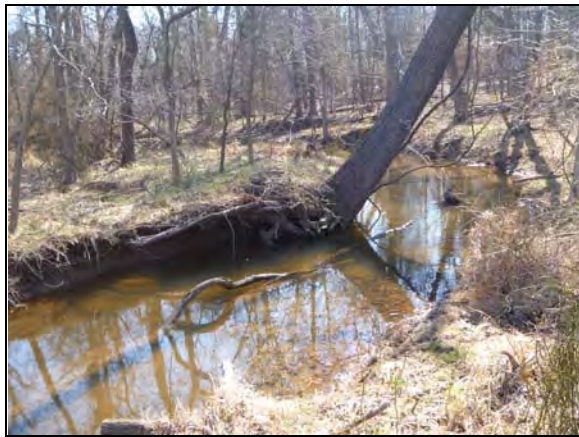
Eroded channel downstream of large regional pond. Fairly dense housing throughout upstream catchment. No headwaters, all is piped.

Tree undermined by bank erosion falling over into stream

Proposed Action: Stabilize stream bank

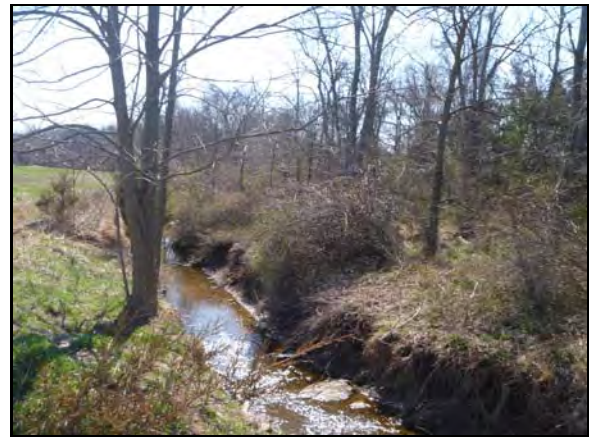
Bank erosion downstream of stormwater pond

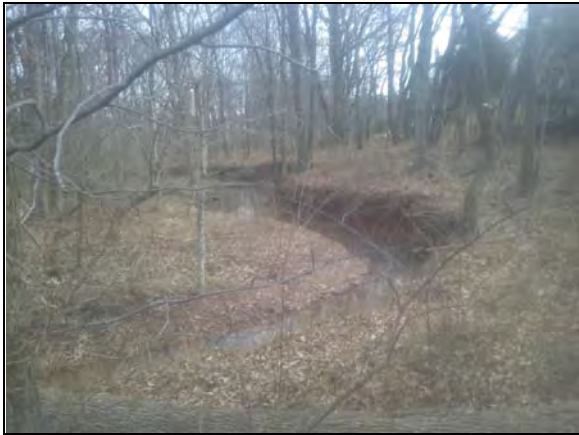
Stream with eroded banks beside stormwater pond. Site is downstream of a lot of recent and ongoing development, including Moorefield Station Elementary School.

Bank erosion occurring where stream runs along stormwater pond

Proposed Action: Stabilize stream bank

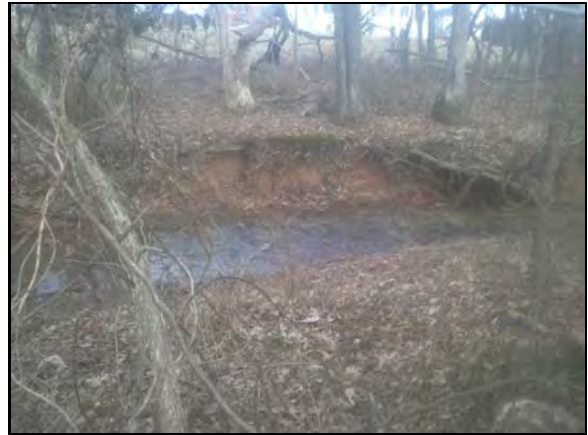
Very narrow, forested riparian buffer along eroding bank

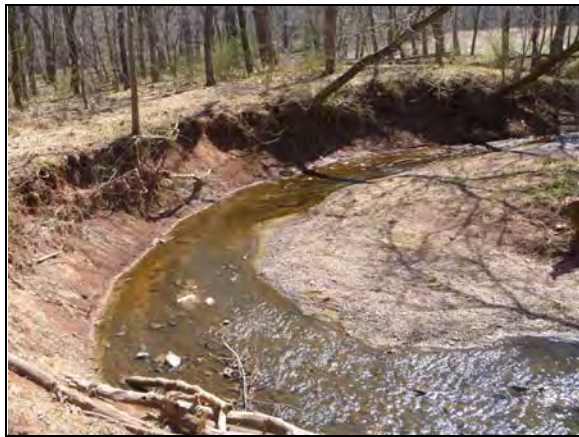
Pond within Lyndora Park. Restoration may include the inline pond, channels leading to the pond, and the outflow channel. Stream downstream of pond is very unstable.

Severe bank erosion

Proposed Action:	Take pond off-line, remove geese, convert upstream channels to bioswales, and stabilize downstream erosion
Benefits:	Improve stream stability, erosion, and instream habitat Improve floodplain connectivity and nutrient cycling functions Prevent property and structural loss Improve community usage Opportunity for public education

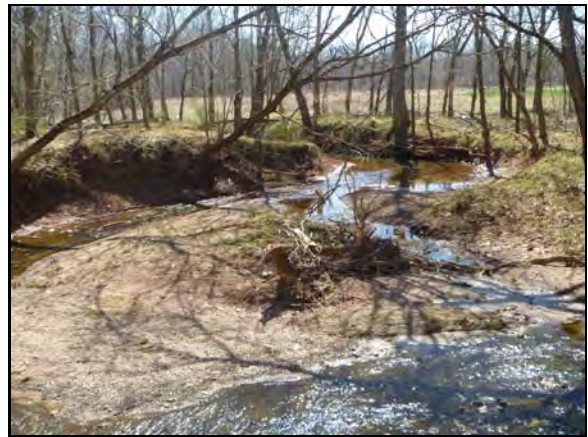
Bank erosion undermining trees causing them to fall over into stream

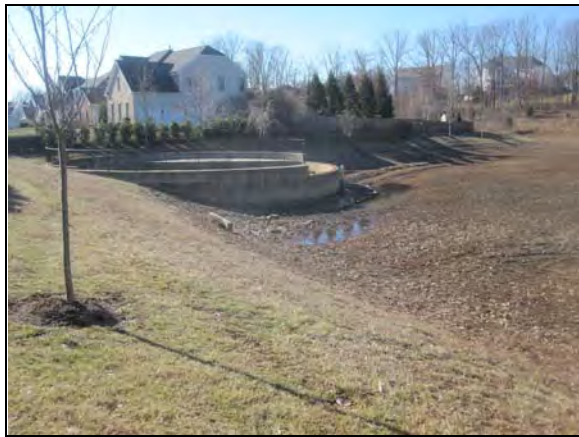
Inline dry ponds between Forest Manor Drive and Forest Run Drive. Most of the catchment is forested upstream of dry ponds.

Pond Structure ID JC5171 is one of the two inline ponds being recommended for restoration

Proposed Action: Take ponds offline

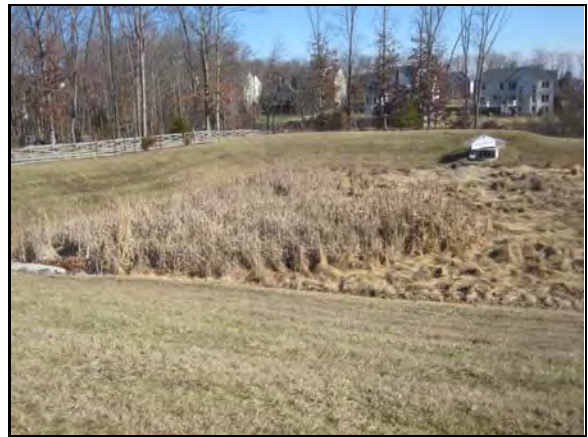
Pond Structure ID JC4796 is one of the two inline ponds being recommended for restoration

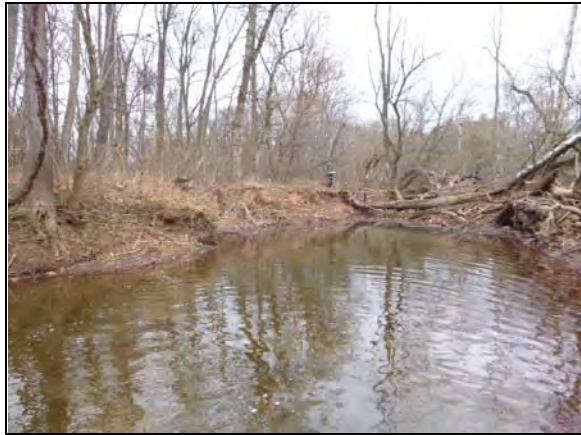
Severe erosion of right bank occurring where Loudoun County Parkway is proposed to cross Broad Run. Large debris jam downstream is causing erosion. Transmission line right-of-way on other side of stream.

Debris jam that is causing erosion

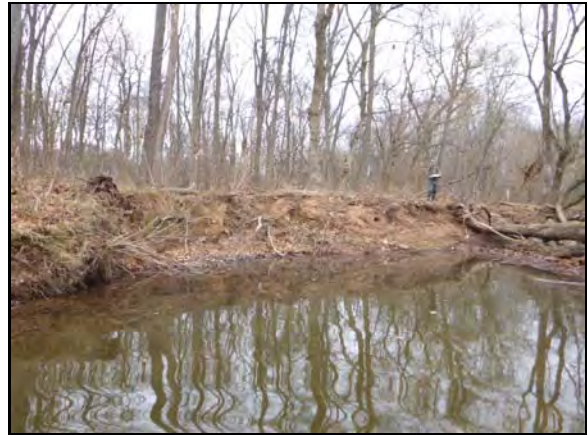
Severe stream bank erosion

Proposed Action: Stabilize stream bank

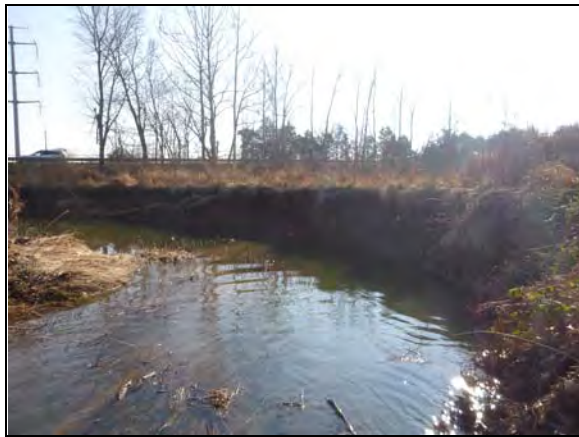
Along mainstem of North Fork Broad Run, adjacent to transmission line right-of-way and old crop field. Very little tree cover. Erosion is prevalent in the vicinity of this site. The stream banks are actively slumping.

Severe stream bank erosion

Proposed Action: Stabilize stream bank and reconnect with floodplain

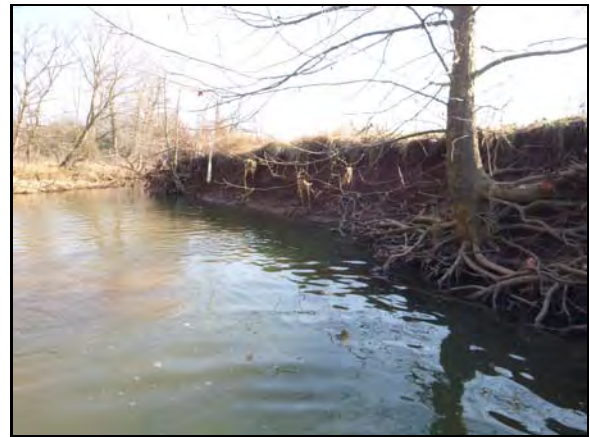
Bank erosion undermining trees along stream

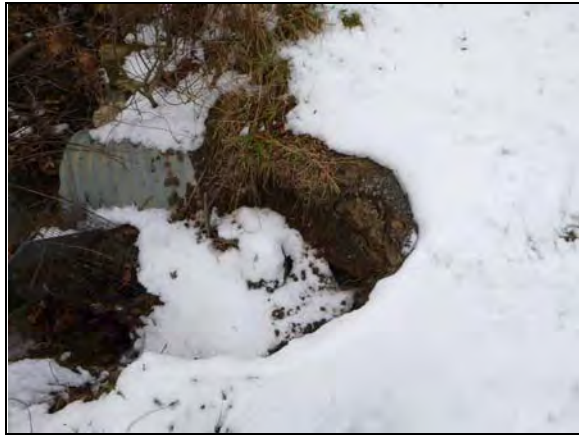
Headcut beside culvert that conveys stream under farm road. Upstream of site lacks riparian buffer.

Headcut occurring beside pipe culvert

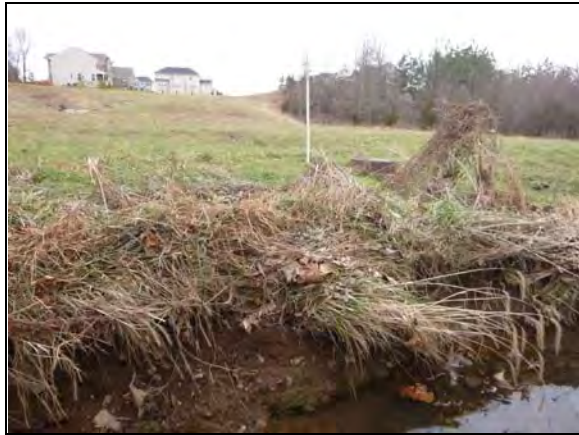
Some erosion occurring at sewer pipeline crossing. Site near end of Bishop Meade Place.

Bank erosion near sewer crossing, unforested riparian

Proposed Action: Stabilize stream bank

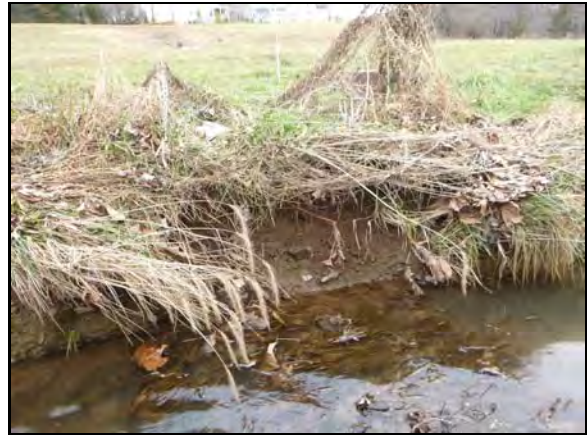
Close up of eroding stream bank beneath overhanging vegetation

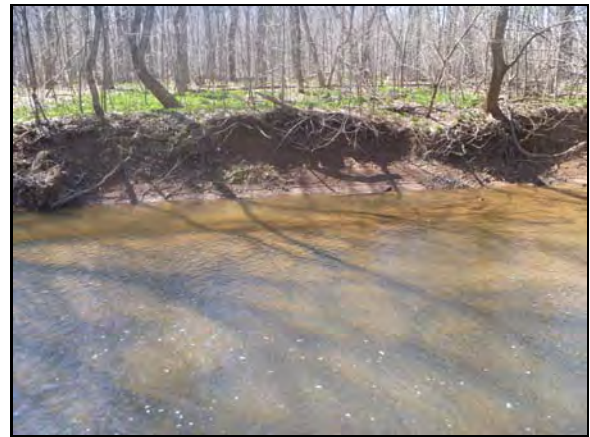
Bank erosion undermining trees and causing slumping

Proposed Action: Stabilize stream bank
