UPPER BROAD RUN WATERSHED MANAGEMENT PLAN

Prepared for
Loudoun County
Department of
Building and Development
1 Harrison St.
Leesburg, VA 20175

Nancy Roth, Mark Voli, Steve Schreiner,
Alexi Boado, Allison Brindley, Tom Jones,
Steve Harriott, Jodi Dew-Baxter, and
Mark Southerland
Versar, Inc.
9200 Rumsey Road
Columbia, MD 21045

September 30, 2014

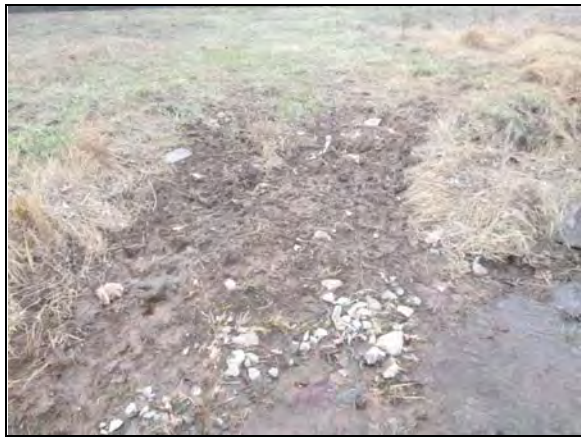
Grass next to stream trampled by livestock. Site located approximately 1000 feet upstream of Fleetwood Road.

Trampled stream bank

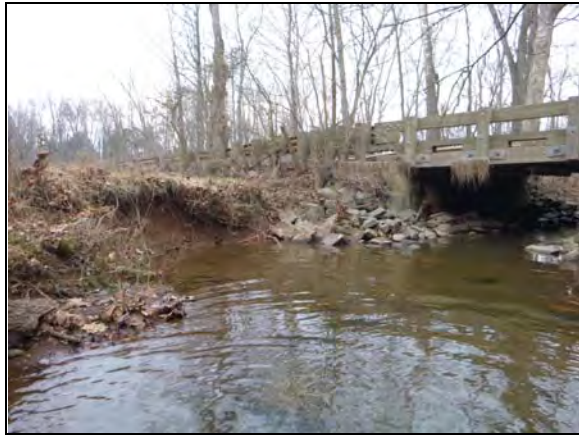
Bank erosion and slumping near road crossing

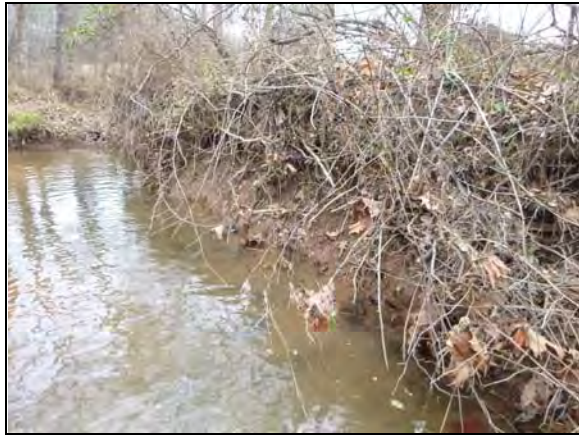
Stream banks trampled by livestock and also impacted by high flows. Site approximately 700 feet downstream of the proposed location of Lenah Loop Road.

Severe bank erosion

Proposed Action: Add fencing and stabilize stream bank

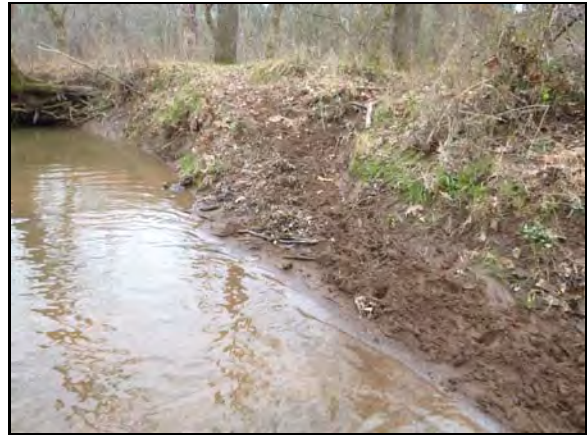
Trampled stream bank where cattle access stream

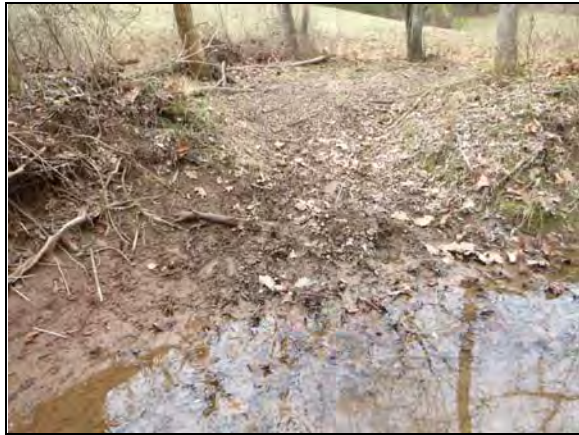
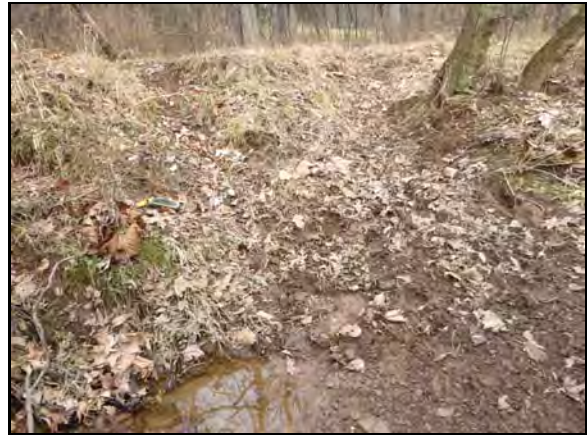
Stream banks trampled by livestock. Site is approximately 250 ft. downstream of proposed location of Lenah Loop Road.

Trampled stream bank where cattle cross stream

Proposed Action: Add fencing

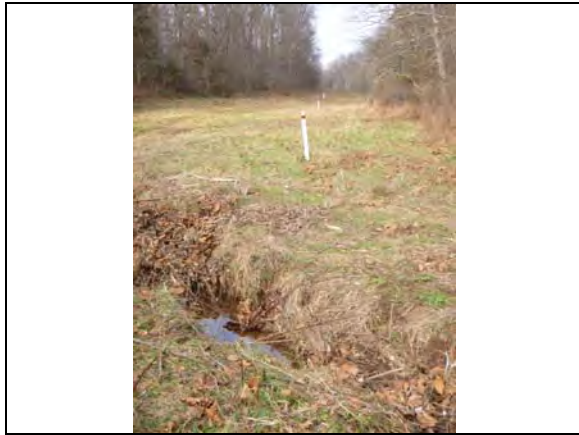
Stream channel is within gas pipeline right-of-way. Dense forest on both sides of right-of-way.

Pipeline that crosses stream bed

Proposed Action: Stabilize stream bed

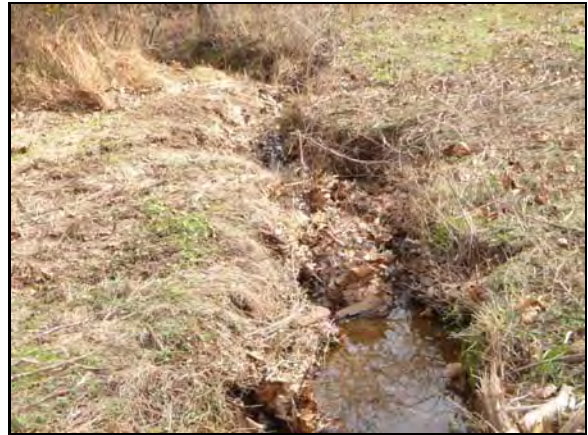
Unstable stream channel

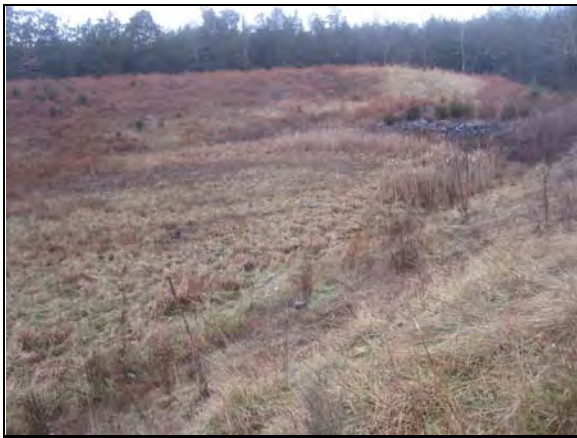
Dry pond with one major outfall entering it immediately adjacent to a dewatering structure. Lots of trash, dumping of some tires and 55-gallon drums.

Existing dry pond facility

Proposed Action: Convert pond to wet pond/wetland

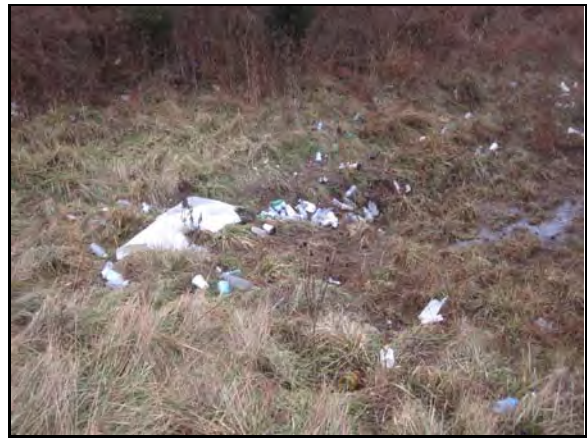
Trash and floatables accumulated in ponds

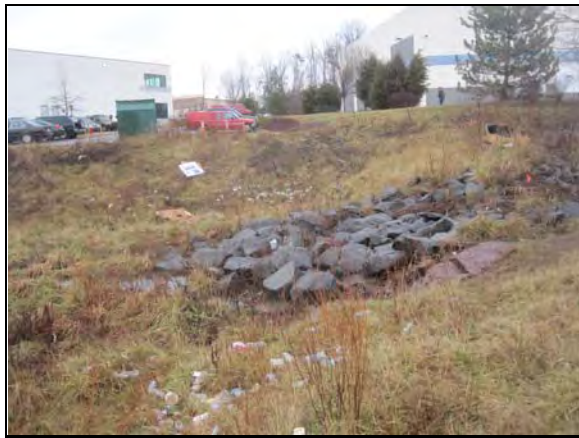
Riprapped channel from parking lot to pond where a bioswale is recommended

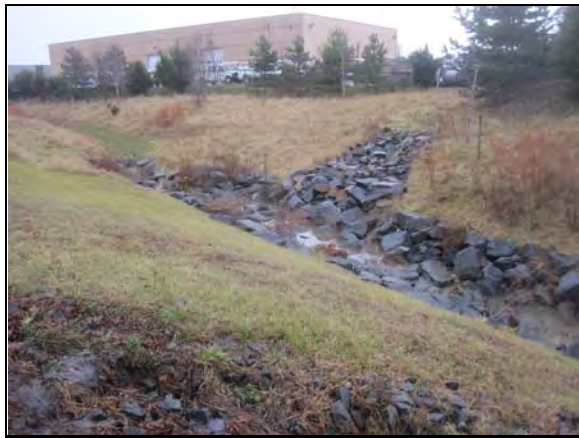
*Riprapped channel from parking lot to pond
where a bioswale is recommended*

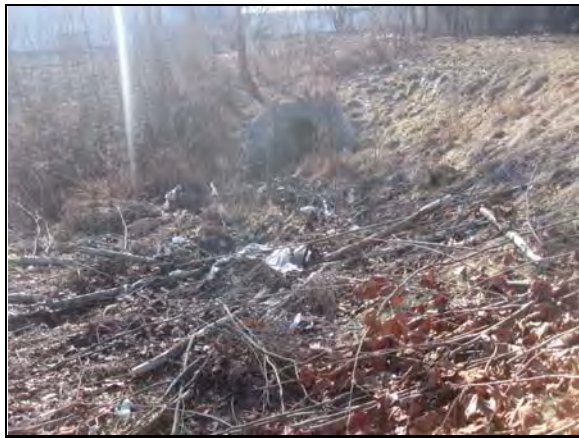
Large commercial area drains to existing pond.

Outfall draining to dry pond; accumulated debris in foreground

Proposed Action: Convert pond to wet pond/wetland

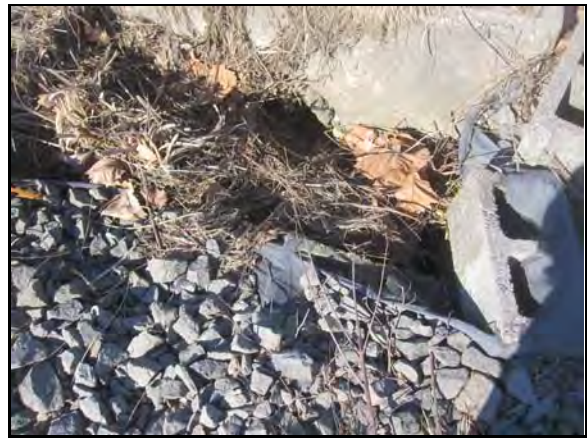
Damaged dewatering structure

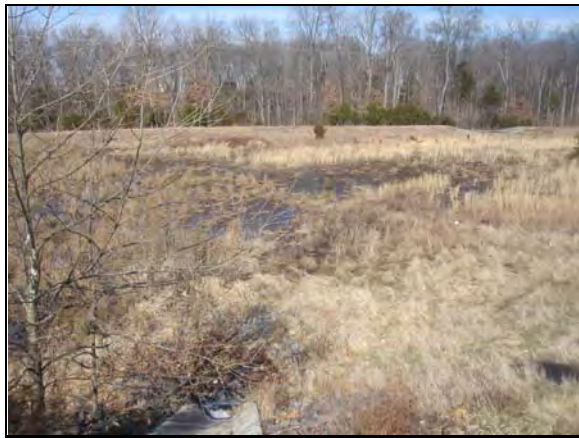
Large extended detention dry pond with two large, recessed outfalls and three additional surface outfalls. Pond has some de facto wetland areas due to a clogged dewatering structure. Area downstream seems to be relatively stable.

Existing stormwater management pond

Proposed Action: Convert to a wet pond/wetland

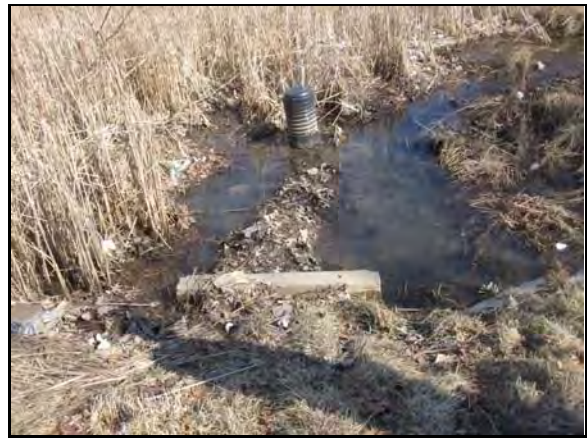
Dewatering structure clogged with sediment and debris

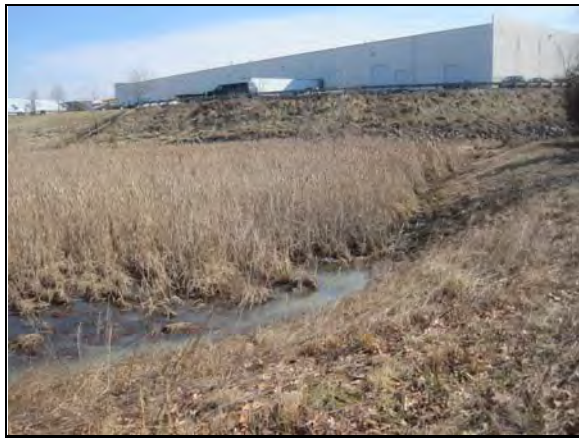
Portion of stormwater pond may have flow diverted with a berm and converted to a bioretention cell

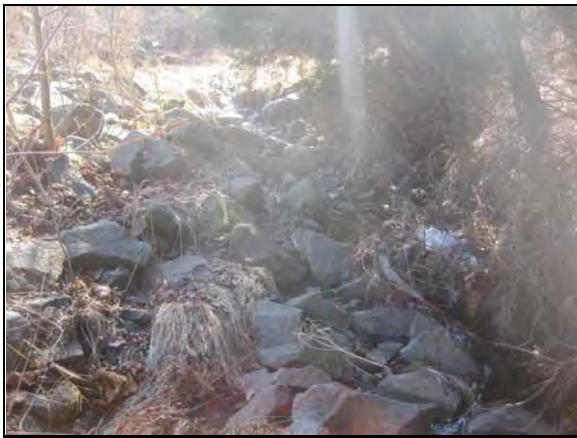
Riprapped flow path to pond that may be converted to a step pool conveyance

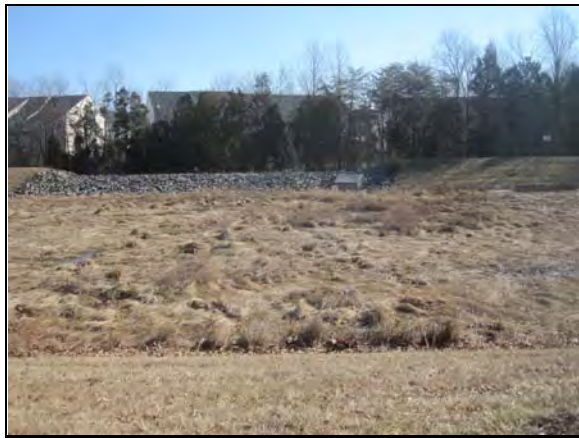
Extended detention pond. Area downstream of pond is in stable condition.

Existing extended detention dry pond

Proposed Action: Convert to a wet pond/wetland

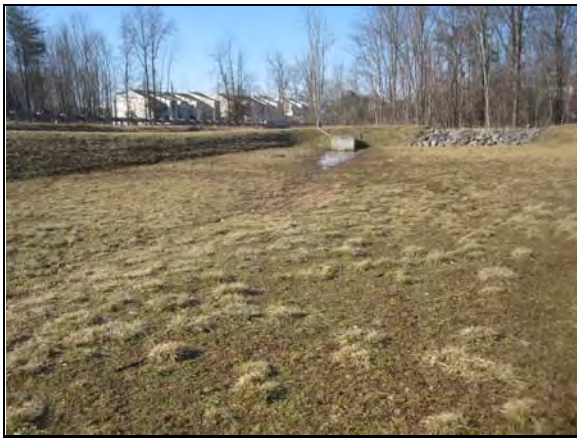
Existing dry pond is situated immediately adjacent to houses in neighborhood. Dewatering structure was underwater, possibly due to settling of structure and minor amount of elevation change.

Existing stormwater detention facility, with a small amount of water pooled in front of dewatering structure

Proposed Action: Convert to a wet pond/wetland

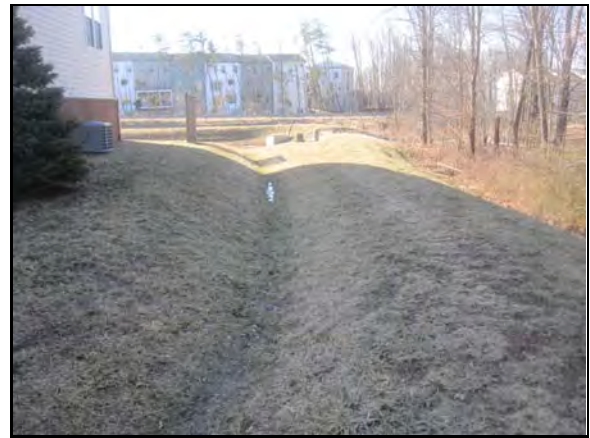
Grass swale leading between townhomes to the stormwater pond

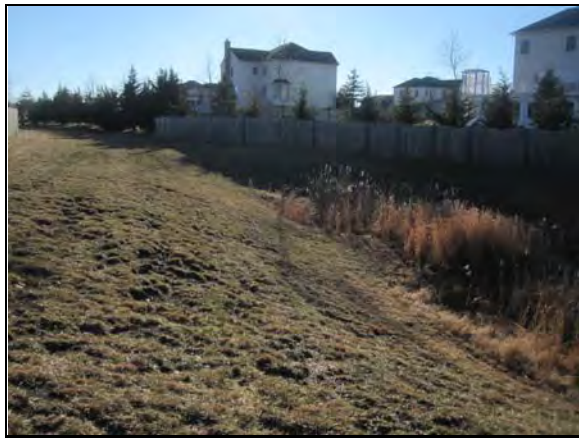
Modern extended detention pond with forebay. Three piped outfalls and one overland, riprapped swale. Area downstream of pond appears to be stable. There is room for expansion if utilities not present south of the pond.

Stormwater pond situated behind rows of townhomes

Proposed Action: Convert to a wet pond/wetland

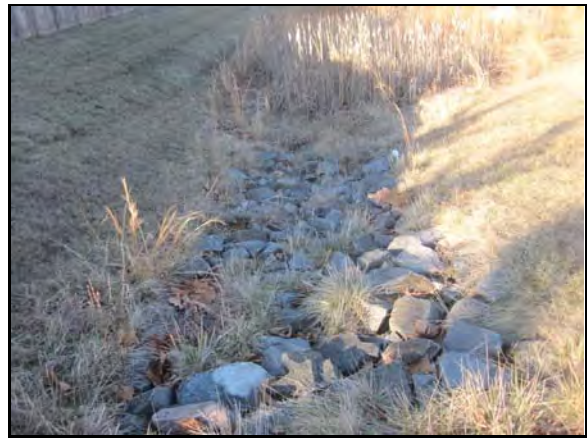
Riprapped swale leading to pond

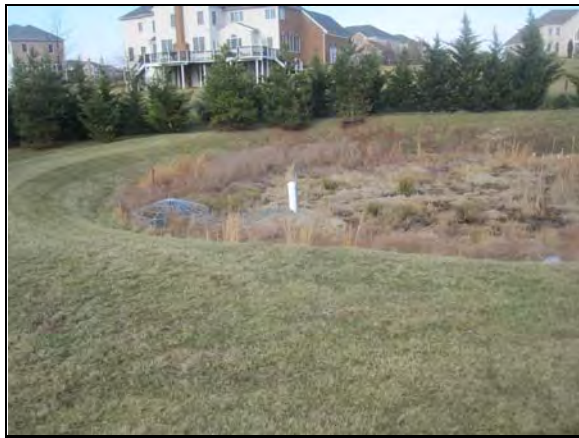
Existing facility is an extended detention dry pond; facility appears well-maintained and seems to be functioning properly.

Dry pond in excellent condition close to existing homes

Proposed Action: Convert to a wet pond/wetland or a bioretention with underdrain

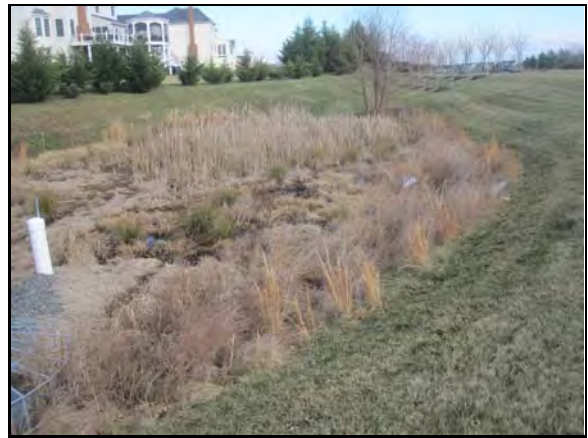
Trees planted along flow path leading to pond

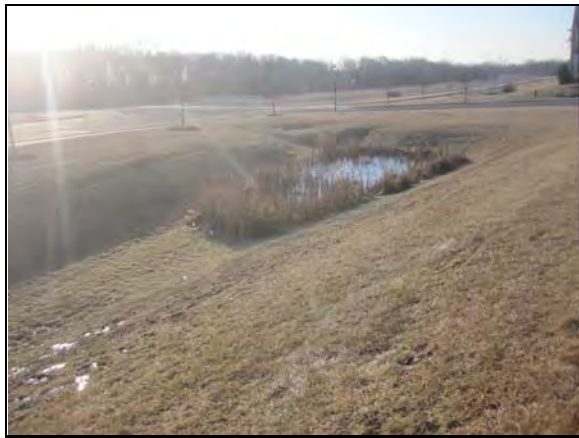
Existing flood control/dry pond has morphed into wet pond/wetland.

Stormwater pond is adjacent parking lot

Proposed Action: Convert to a wet pond/wetland and install bioswale

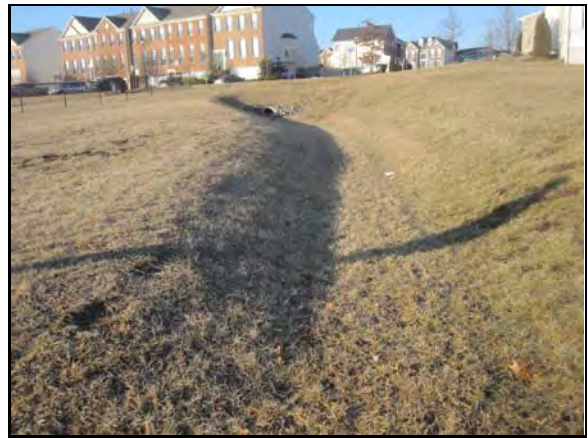
Existing drainage swales provide an excellent opportunity for conversion to bioswales

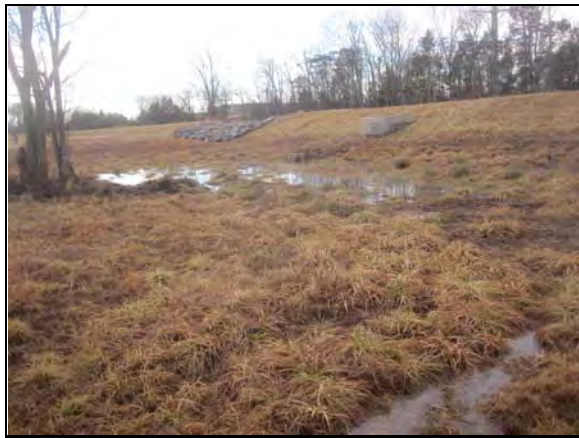
Existing dry pond has three outfall draining to it, two of which have made preferential channels to the dewatering structure. Plenty of space available for additional treatment, however the soils are a poor.

Stormwater management facility

Proposed Action: Convert to a wet pond/wetland

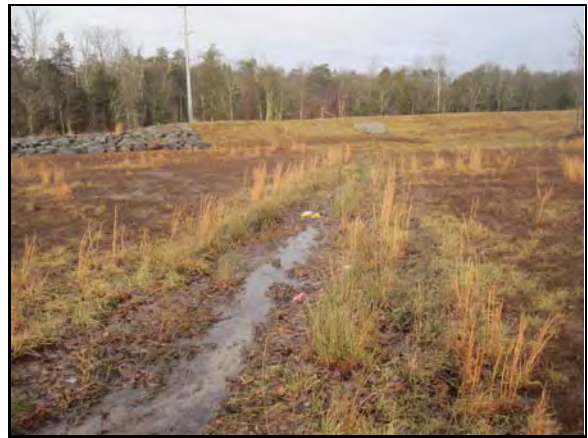
Flow path being created between outfall and dewatering structure

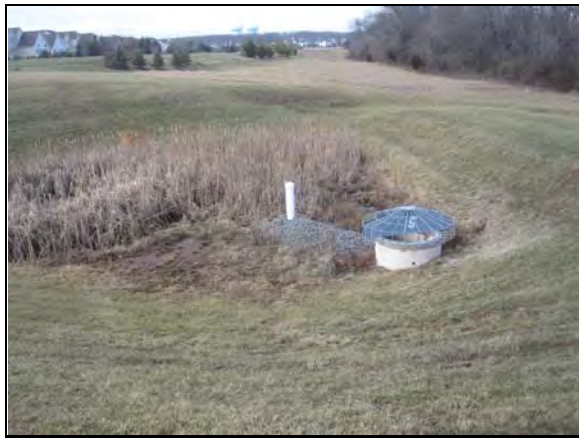
Existing facility is an extended detention dry pond and appears to be well-maintained and functioning properly.

Existing extended detention dry pond

Proposed Action: Convert to a wet pond/wetland or a bioretention with underdrain

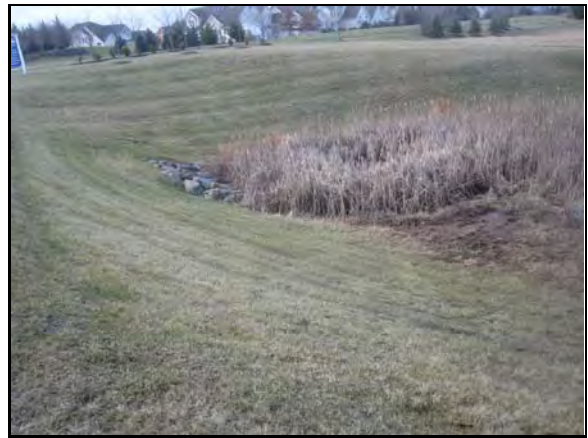
Outfall enters a vegetated area of pond

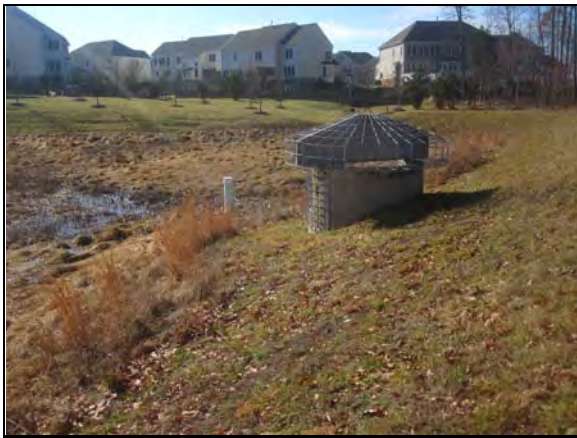
Extended detention dry pond with two piped outfalls and a long swale along tree line from the south carrying overland flow. Pond seems to be well-maintained and functioning properly; area downstream appears to be stable.

Existing stormwater pond with nearby houses in the background

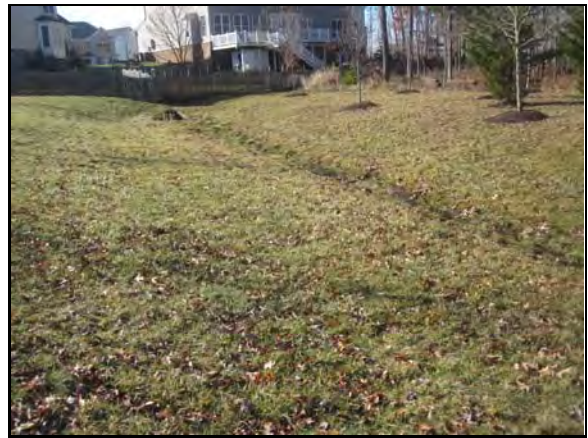
Pipe outfall draining to pond

Proposed Action: Convert to a wet pond/wetland or install a bioretention with underdrain

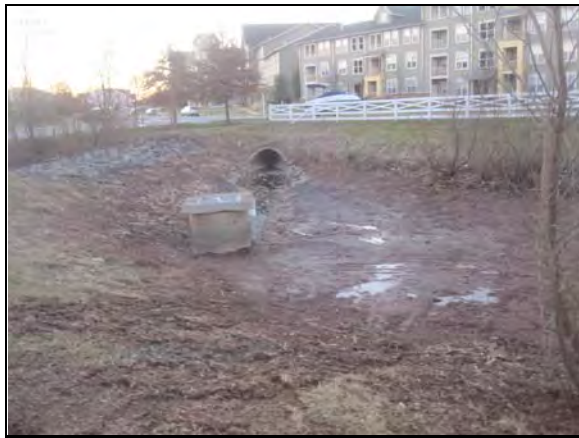
Existing extended detention pond - treatment is somewhat short-circuited due to primary outfall being located in front of dewatering structure. Pond also receives runoff from Community Center parking lot to the east.

Pipe outfall enters pond directly in front of dewatering structure

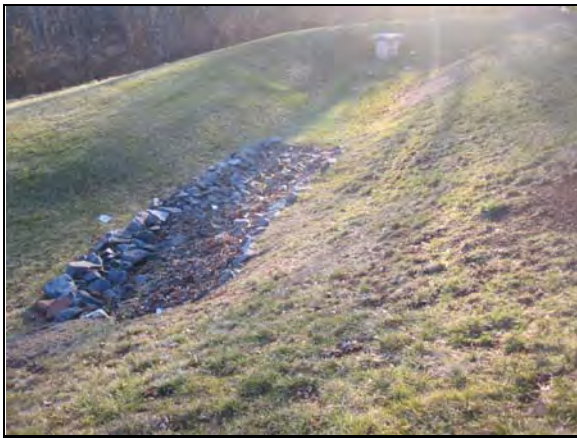
Existing simple dry pond with one pipe outfall and one riprap swale. Channel downstream of pond is stable.

Small neighborhood stormwater management pond

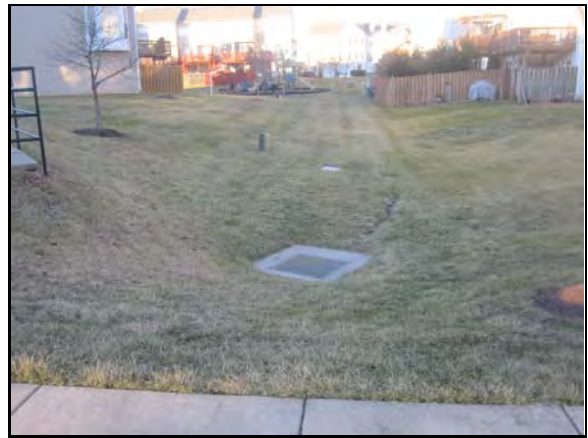
Swale between townhomes enters grate inlet before entering pond

Proposed Action: Convert to a wet pond/wetland

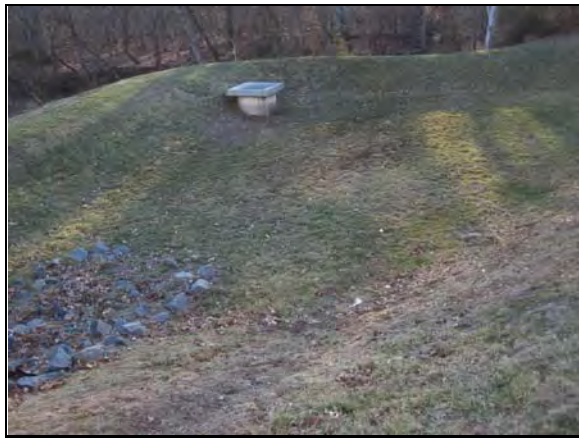
Existing facility is a simple dry pond. Area downstream of pond is relatively stable.

Small stormwater pond behind townhomes

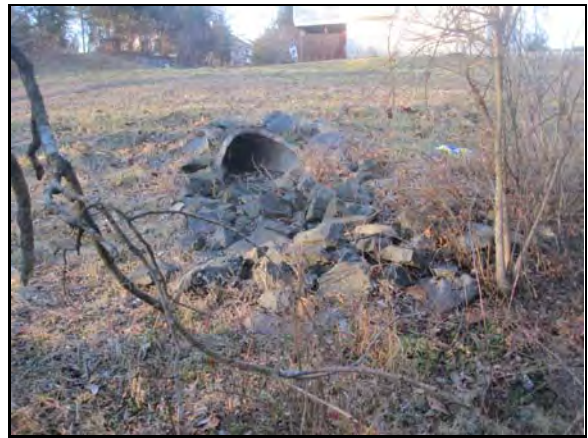
Pipe outfall draining to pond

Proposed Action: Convert to a wet pond/wetland or a chamber system under parking lot with sand filters

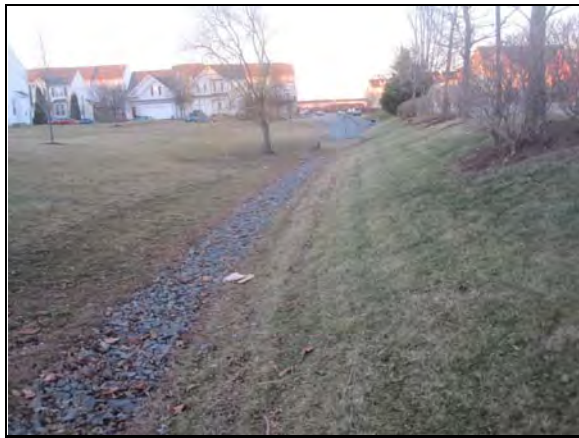
Existing dry pond with two pipe outfalls. Facility drains directing into MS4. There is no room available above this facility for swales or rain gardens.

Elongated dry pond situated between houses and a road

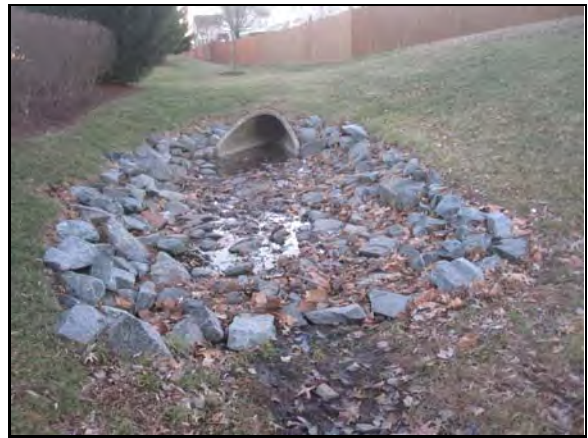
Riprapped pipe outfall entering pond

Proposed Action: Convert to a wet pond/wetland

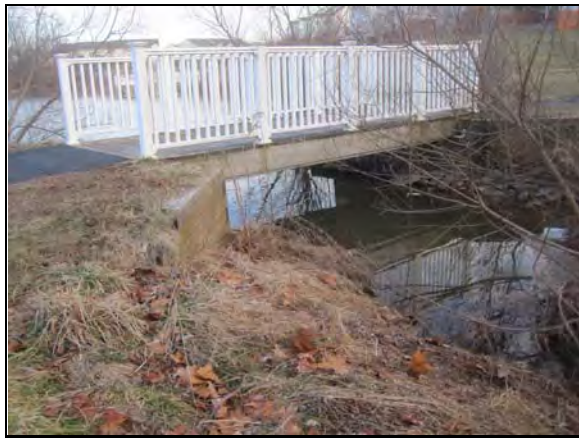
Large residential neighborhood served by large inline wet pond. The inline stream is very poor condition, such that it is threatening some homes and sidewalks and contributing sediment to pond. Downstream channel is very unstable with high bank erosion.

inline pond facility passing under a footbridge

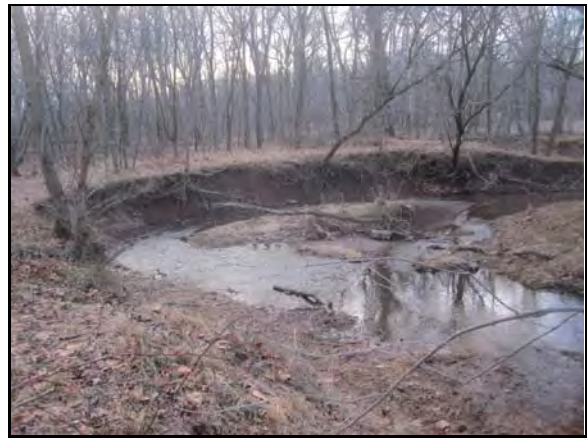
Eroding stream channel downstream of inline pond

Proposed Action: Convert pond to an offline structure

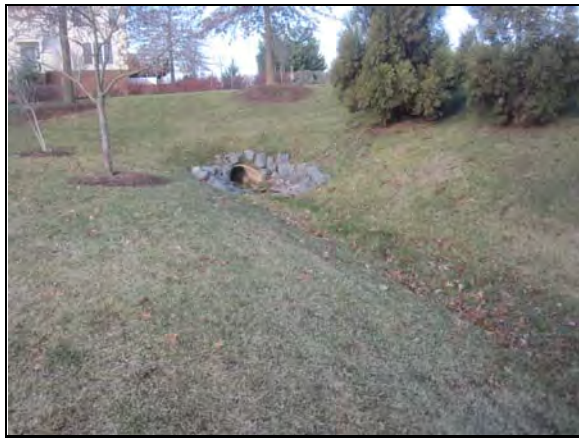
Opportunity at a pipe outfall for installing bioswales

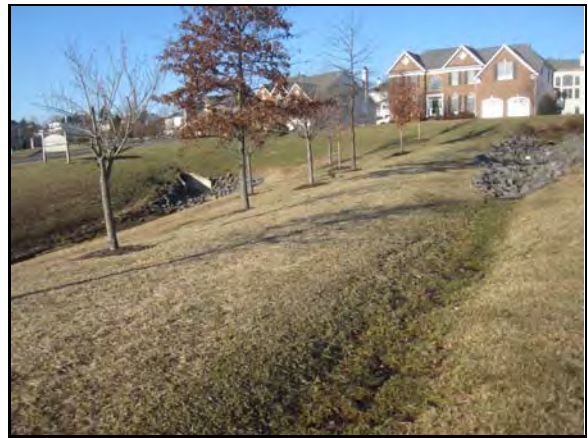
Additional opportunities in the neighborhood for converting riprap and grass swales to bioswales

Proposed Action: Install bioswales

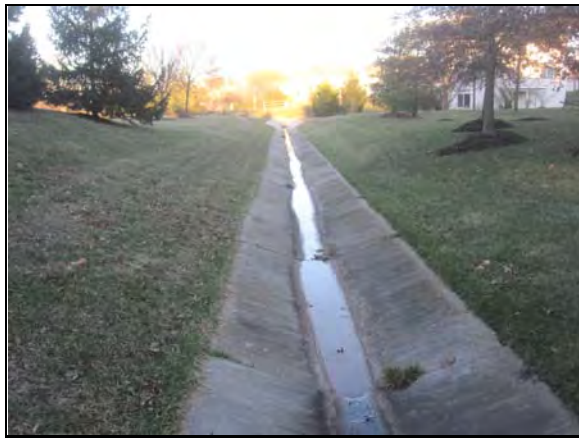
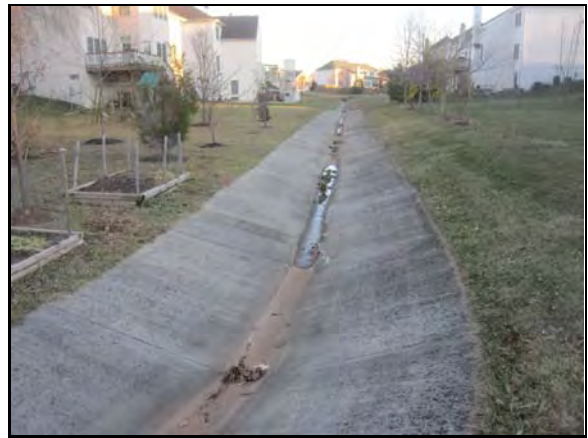
500 foot concrete channel within a residential development leading to existing aerated wet pond with two piped outfalls and riprap spillway. Channel carries drainage from backyards and roads.

Concrete swale

Proposed Action: Convert to bioswale

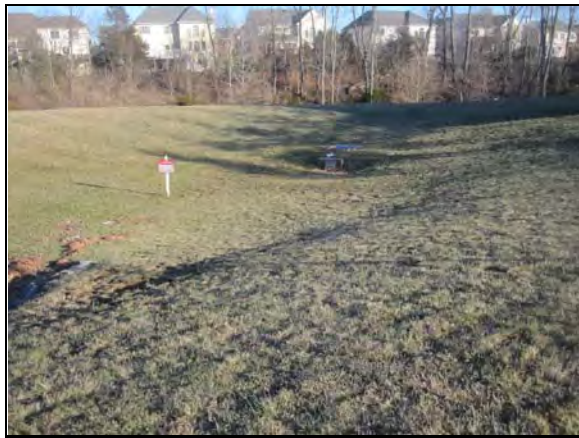
Small extended detention dry pond with one outfall draining to it. Area downstream of pond is in stable condition.

Existing stormwater pond facility

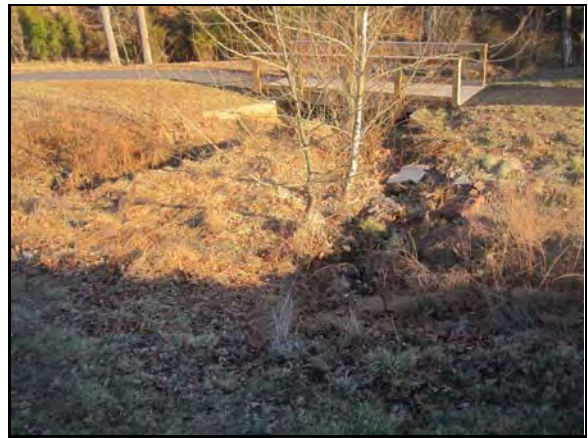
Area downstream of stormwater pond

Proposed Action: Convert to a wet pond/wetland or install a chamber system

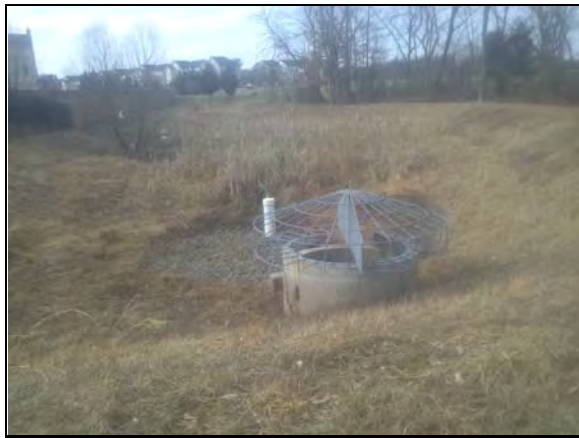
Existing new extended dry detention pond with opportunistic wetland in bottom. The stream channel in the vicinity of the pond is eroding and unstable.

Existing stormwater pond

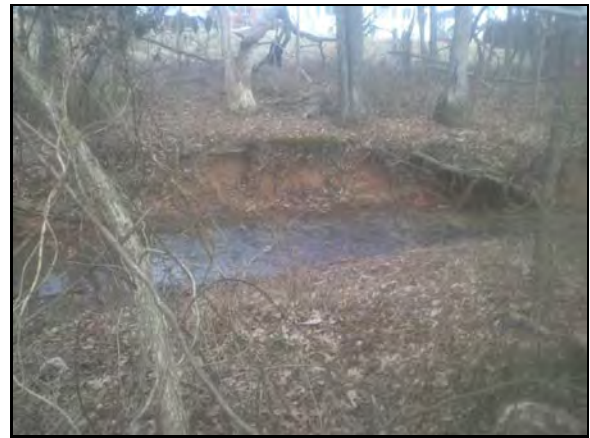
Eroding stream channel downstream of stormwater pond

Proposed Action: Convert to a wet pond/wetland or install bioretention

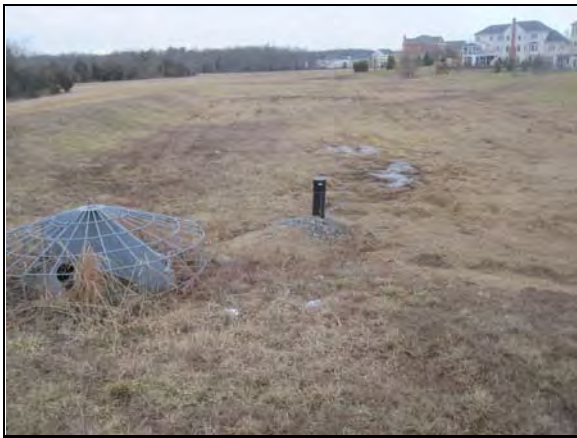
Large, flat extended detention dry pond had two outfalls. One is proximate to dewatering structure.

Existing stormwater dry pond

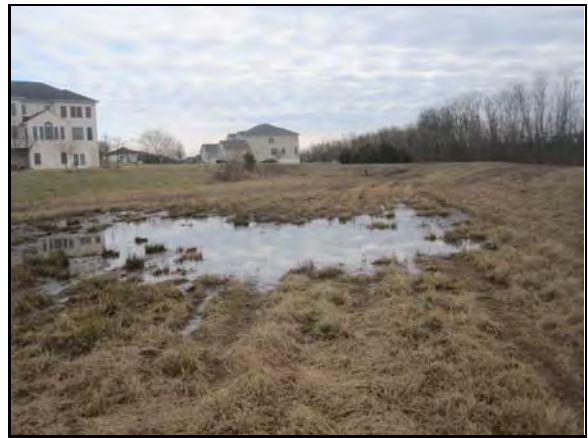
Standing water in the dry pond

Proposed Action: Convert to a wet pond/wetland or install bioretention systems with underdrains

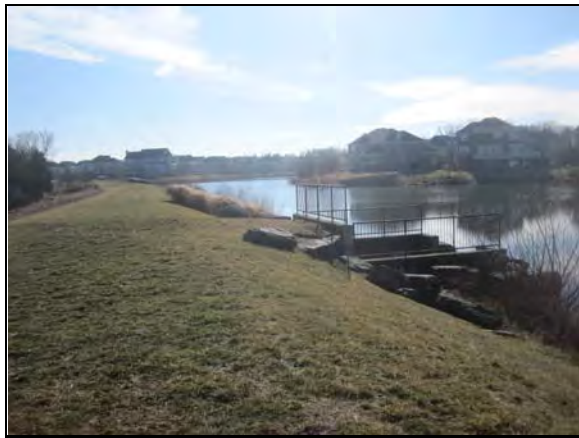
Large wet pond designed primarily for flood control. Fourteen formal outfalls into pond and overland flow from forested areas. Downstream condition is poor due to constrained flow path; stream channel incised for the first 200 feet below the pond.

Extensive wet pond provides flood control for large neighborhood

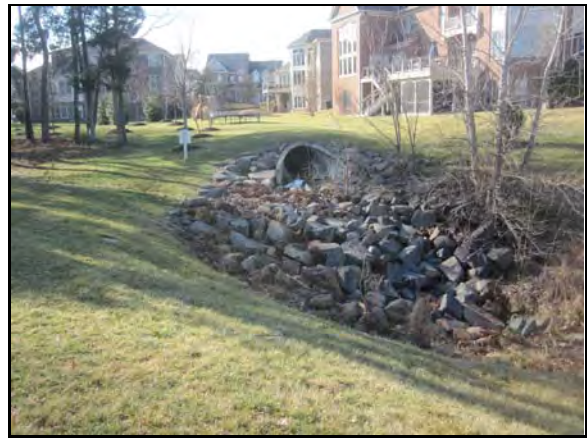
One of the many pipe outfalls that discharge to the wet pond

Proposed Action: Install a step pool conveyance or bioretention

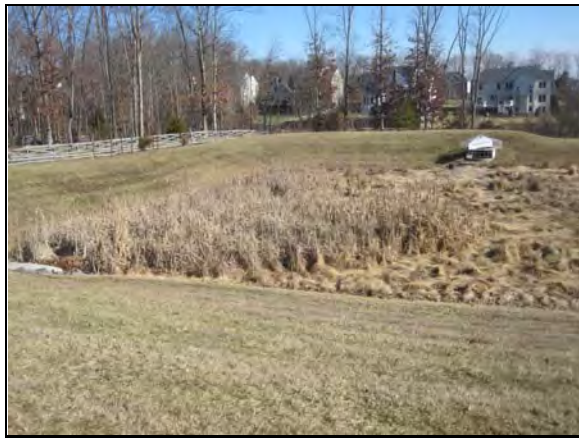
Existing extended detention dry pond is in great condition; it appears to be well maintained and is functioning properly. There is not enough space for pre-treatment in pond. Pond receives stormwater from residential area but probably also from nearby for

Existing pond is in very good condition and seems to be functioning well

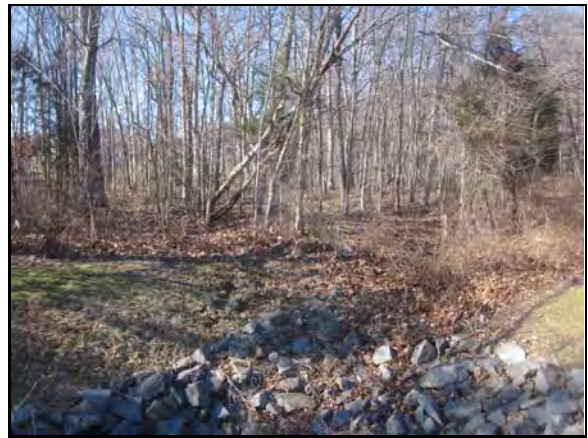
Channel downstream of pond is in stable condition and has little erosion

Proposed Action: Convert to a wet pond/wetland

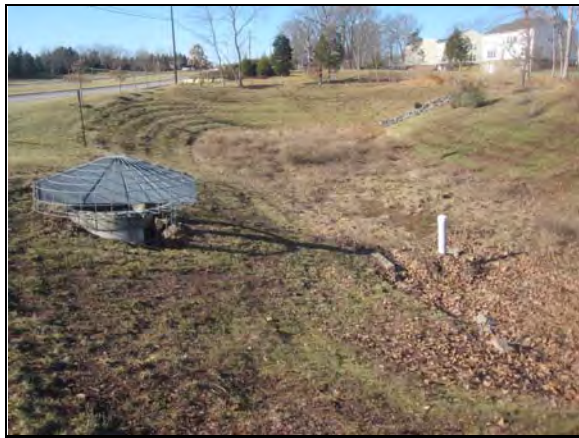
Existing extended detention pond is in fine working condition; two outfalls drain to this facility.

Existing stormwater management facility

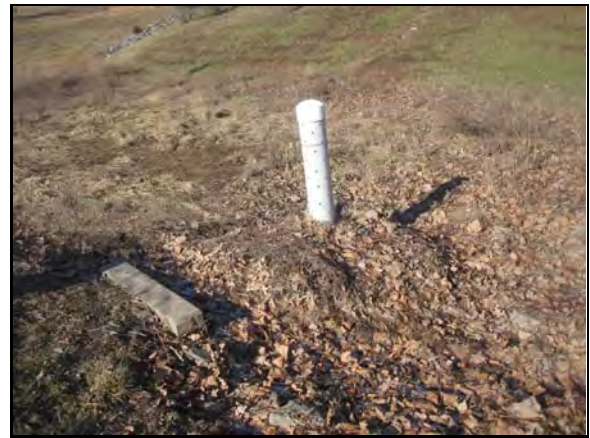
Stormwater pond dewatering structure

Proposed Action: Convert to a wet pond/wetland

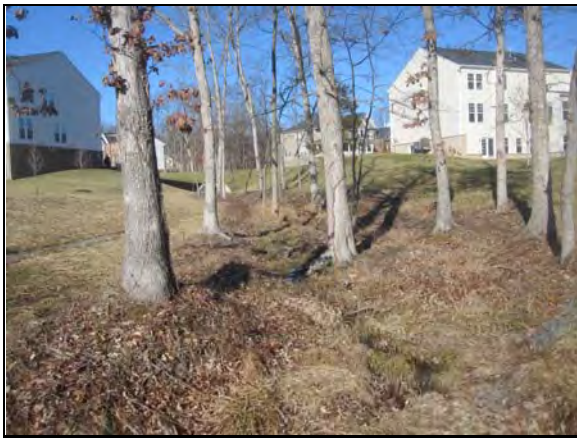
Potential path for bioswale

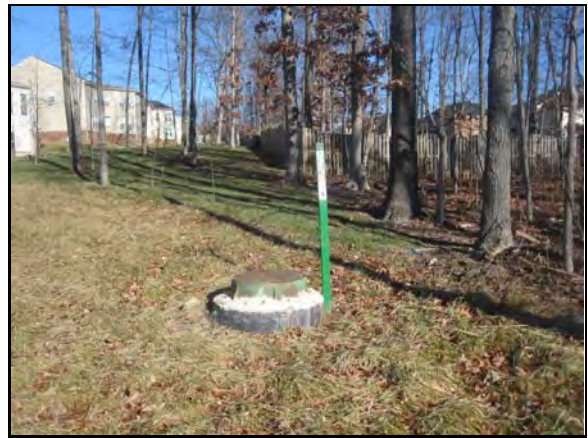
Sewer and gas pipelines may restrict where restoration takes place at this site

Proposed Action: Install bioswale

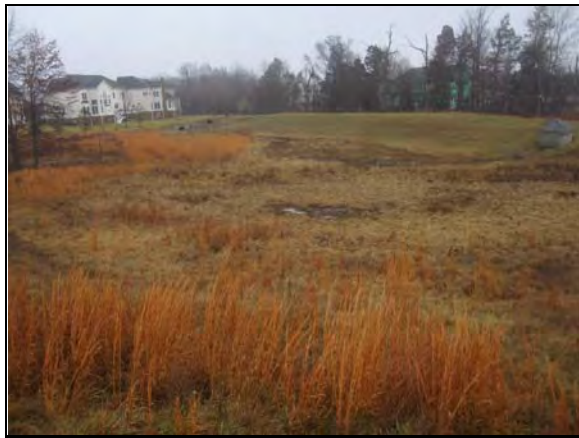
Dry pond draining cul -de-sac and a grouping of large-scale homes. No preferential flow path within basin and downstream area is relatively very stable.

Fairly flat dry pond structure

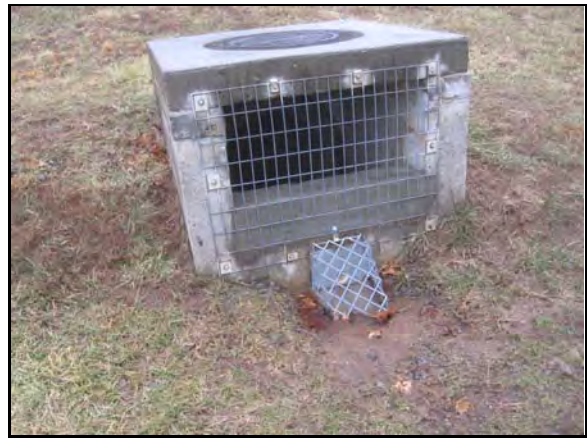
Dry pond control structure

Proposed Action: Convert to bioretention or extended detention dry pond

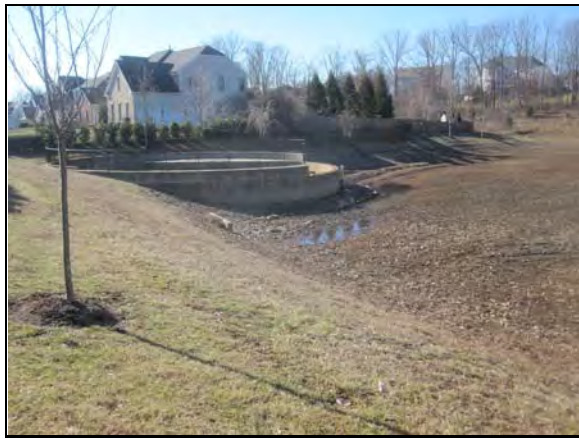
Complex structure; existing large dry pond designed for flood control with four outfalls draining to it, one of which received dry weather flow. Area downstream of pond seems to be stable.

Large flood control pond

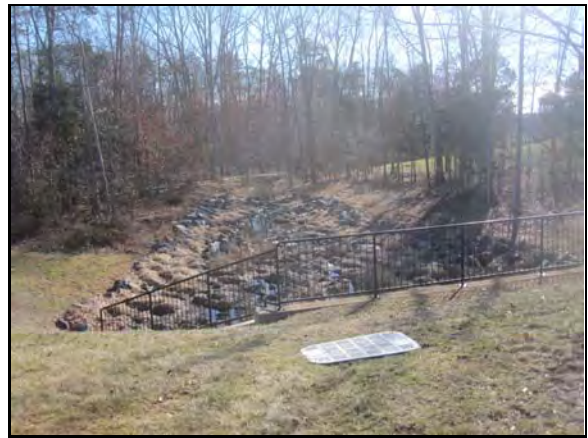
Area downstream appears to be stable

Proposed Action: Convert to a wet pond/wetland and installation of bioswales

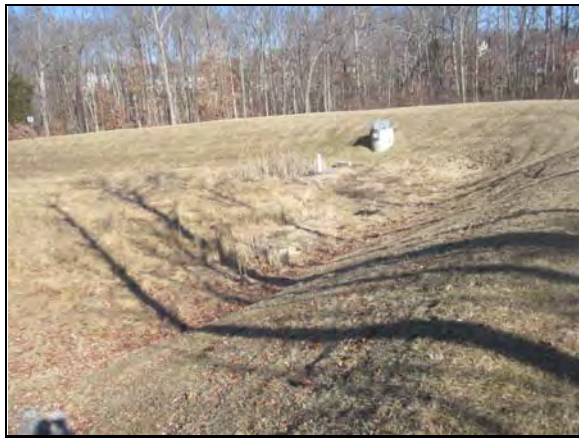
Existing extended detention dry pond drains a large residential neighborhood; it appears to be well-maintained and functioning properly.

Existing stormwater pond facility

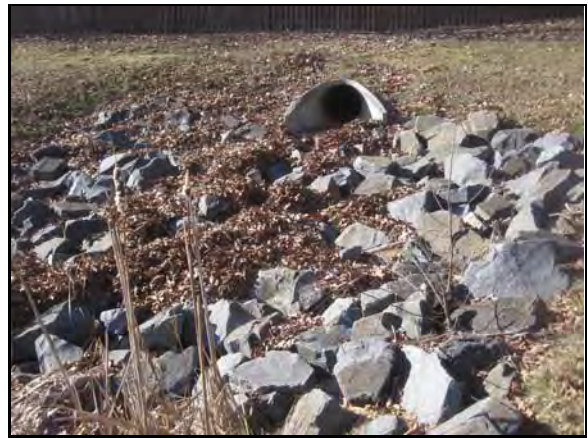
Pipe outfall that discharges to pond

Proposed Action: Convert to a wet pond/wetland and install bioswale

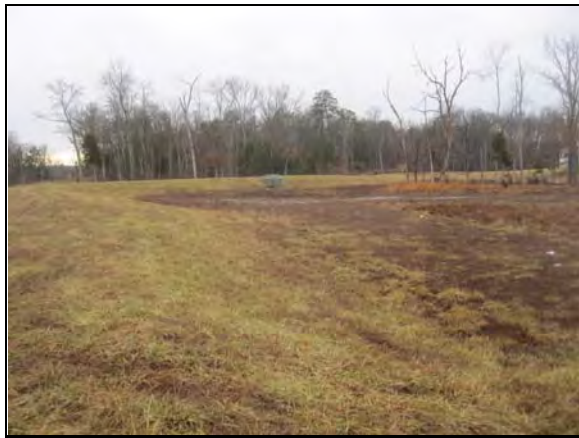
Large detention pond draining residential neighborhood. Facility accepts drainage from two pipe outfalls.

Existing stormwater detention pond

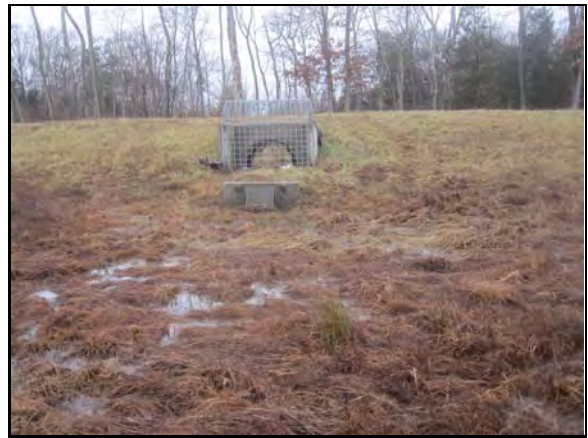
Control structure for existing dry pond

Proposed Action: Convert to a wet pond/wetland or a bioretention with underdrains

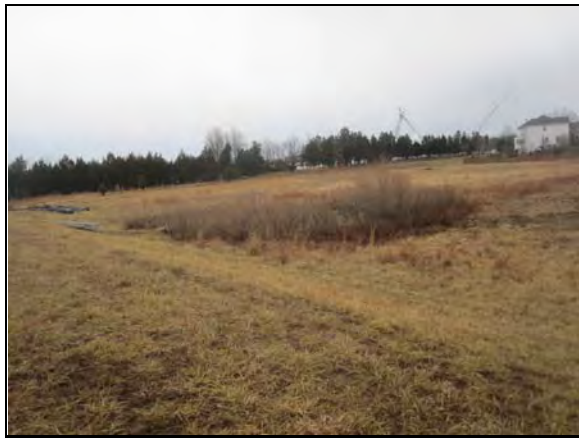
Treatment of dry pond facility is being short-circuited; one outfall is draining proximate to pond's dewatering structure. Plenty of unused surface area within pond provides room for additional treatment. Beaver pond has been built downstream.

Existing stormwater pond

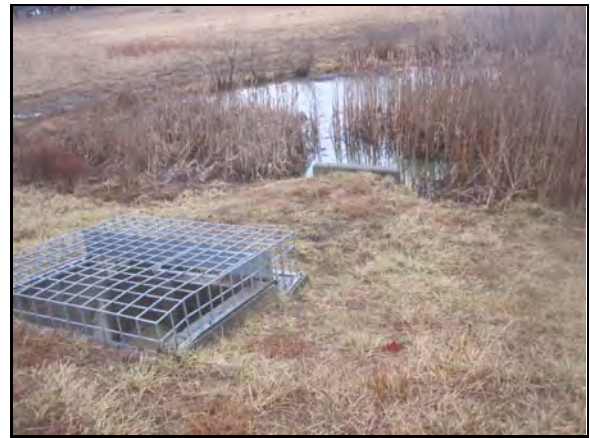
Dewatering structure for existing stormwater pond

Proposed Action: Convert to a wet pond/wetland

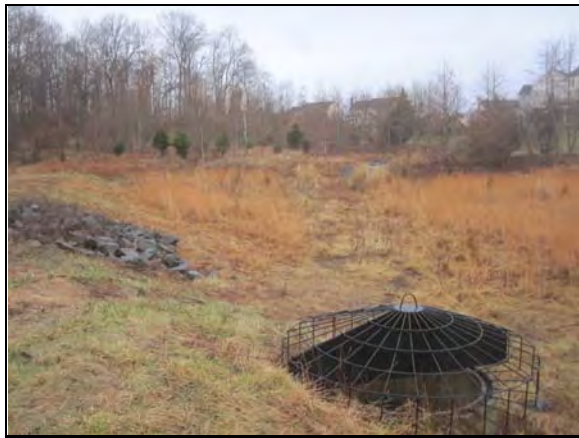
Dry pond appears to be very well-maintained and functioning properly. Very little evidence of channelization or flow from outfall; pond seems to receive very little flow even on rainy days. Area downstream of pond seems to be very stable.

Existing stormwater dry pond

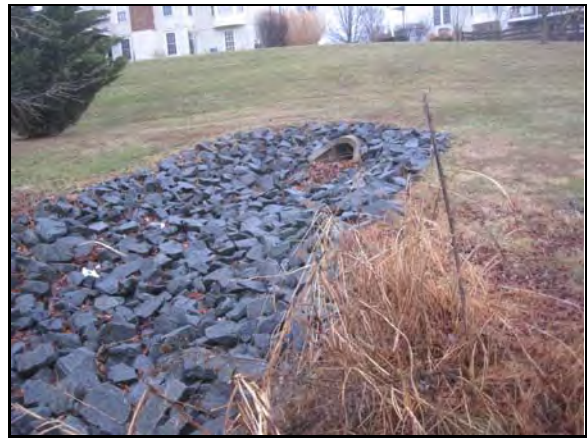
Drainage path carrying flow to dry pond

Proposed Action: Convert to bioretention/infiltration or wet pond/wetlands

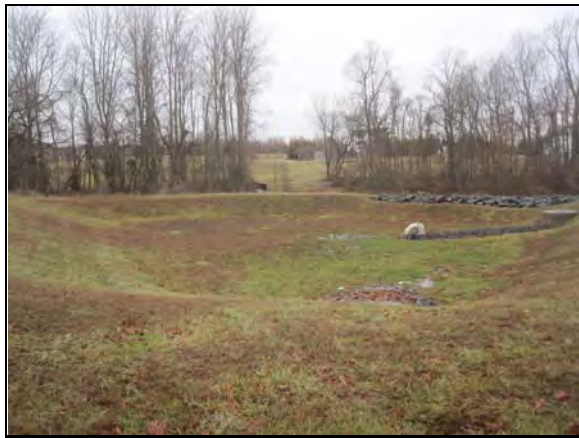
Existing extended detention dry pond appears to be well-maintained and functioning properly; area downstream of site appears stable. Large-scale home lots drain to this small pond. Pathway for local residents is adjacent to pond.

Existing stormwater dry pond

Proposed Action: Convert to bioretention or wet pond/wetland

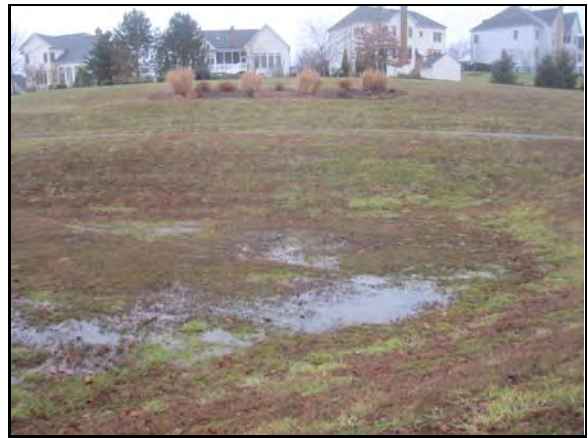
Residential neighborhood that drains to pond in background

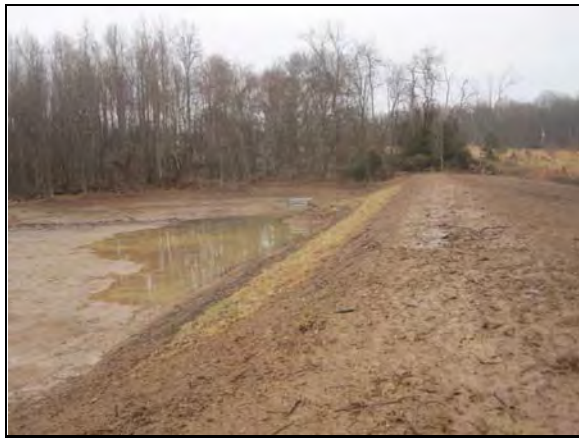
Existing dry pond is completely destabilized, though it looks recently built. Embankment is bare soil and pond bottom is muddy. Long conveyance via open soil channel from roadway and large-scale houses nearby contributes sediment to pond. Algae present.

Pond with bare soil embankments and a muddy bottom

Proposed Action: Stabilize banks of pond, install bioswales and possible convert to wet pond/wetlands

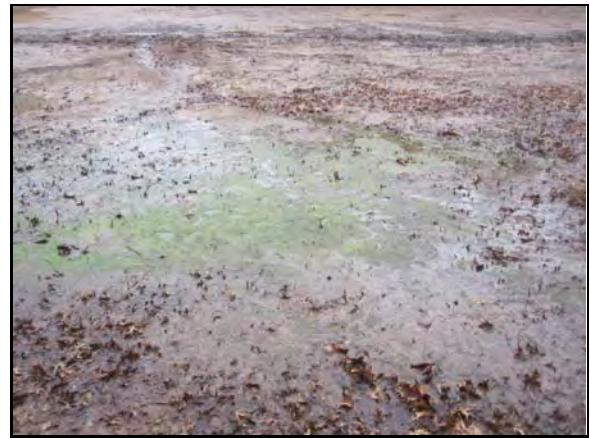
Channel cutting a path through sediments in bottom of pond

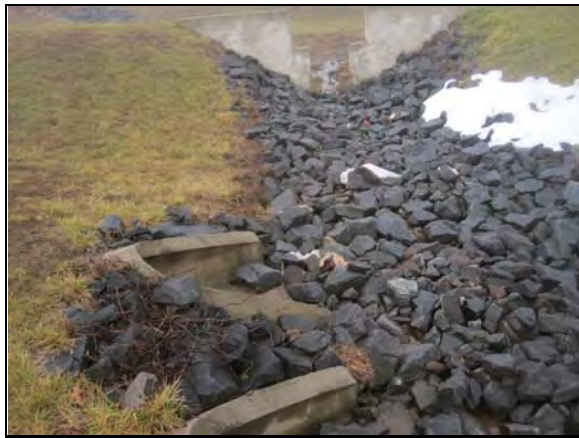
Two bioretention cells from school drain from the south into this dry pond. Playing fields and some landscaped areas drain into the pond from the north and west.

Small stormwater management facility treating drainage from multiple areas of school property
