UPPER BROAD RUN WATERSHED MANAGEMENT PLAN

Prepared for
Loudoun County
Department of
Building and Development
1 Harrison St.
Leesburg, VA 20175

Nancy Roth, Mark Voli, Steve Schreiner,
Alexi Boado, Allison Brindley, Tom Jones,
Steve Harriott, Jodi Dew-Baxter, and
Mark Southerland
Versar, Inc.
9200 Rumsey Road
Columbia, MD 21045

September 30, 2014

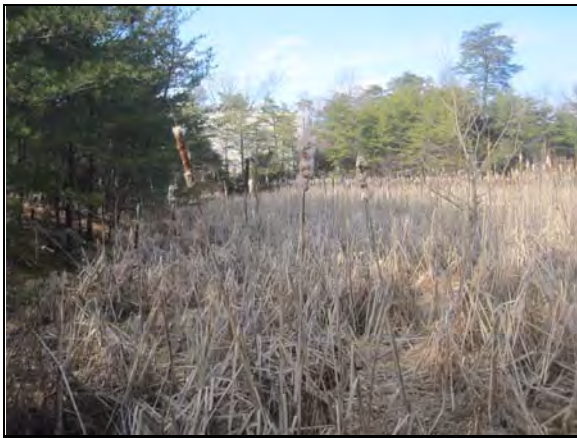
Dry pond turned into de facto wetland draining headwaters. Area downstream of pond appears to be very stable.

Stormwater pond currently filled in with cattails

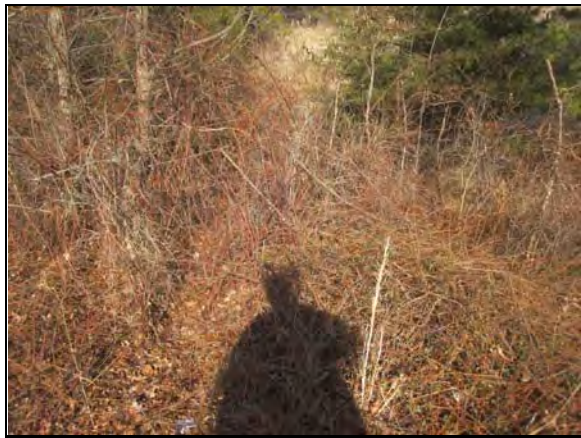
Dry pond turned into de facto wetland draining headwaters. Area downstream of pond appears to be very stable.

Current flow path to pond recommended for step pool conveyance

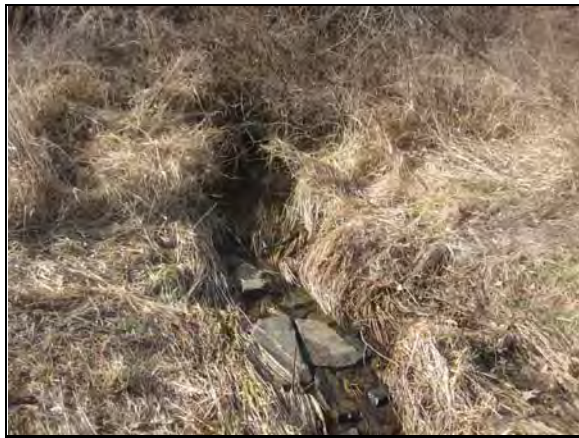
Dry pond turned into de facto wetland draining headwaters. Area downstream of pond appears to be very stable.

*Current flow path to pond recommended for
step pool conveyance*

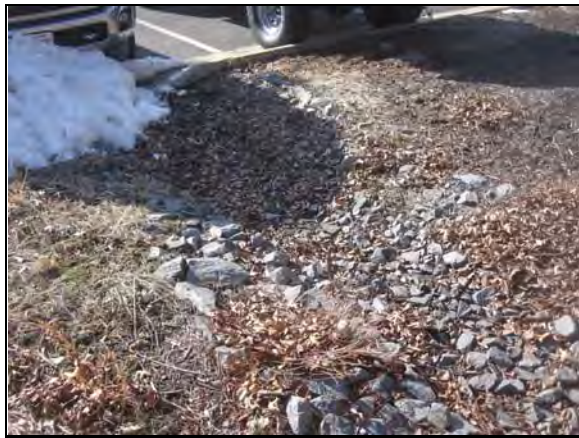
Dry pond turned into de facto wetland draining headwaters. Area downstream of pond appears to be very stable.

*Riprapped channel from parking lot to pond
where a bioswale is recommended*
