## *DEPARTMENT OF ENVIRONMENTAL QUALITY*

### MEMORANDUM

Re: IR# 2019-N-2076  
Gable Farm, Gable Farm Lane, Hamilton, VA  
Evaluation of Fill Material - February 22, 2019

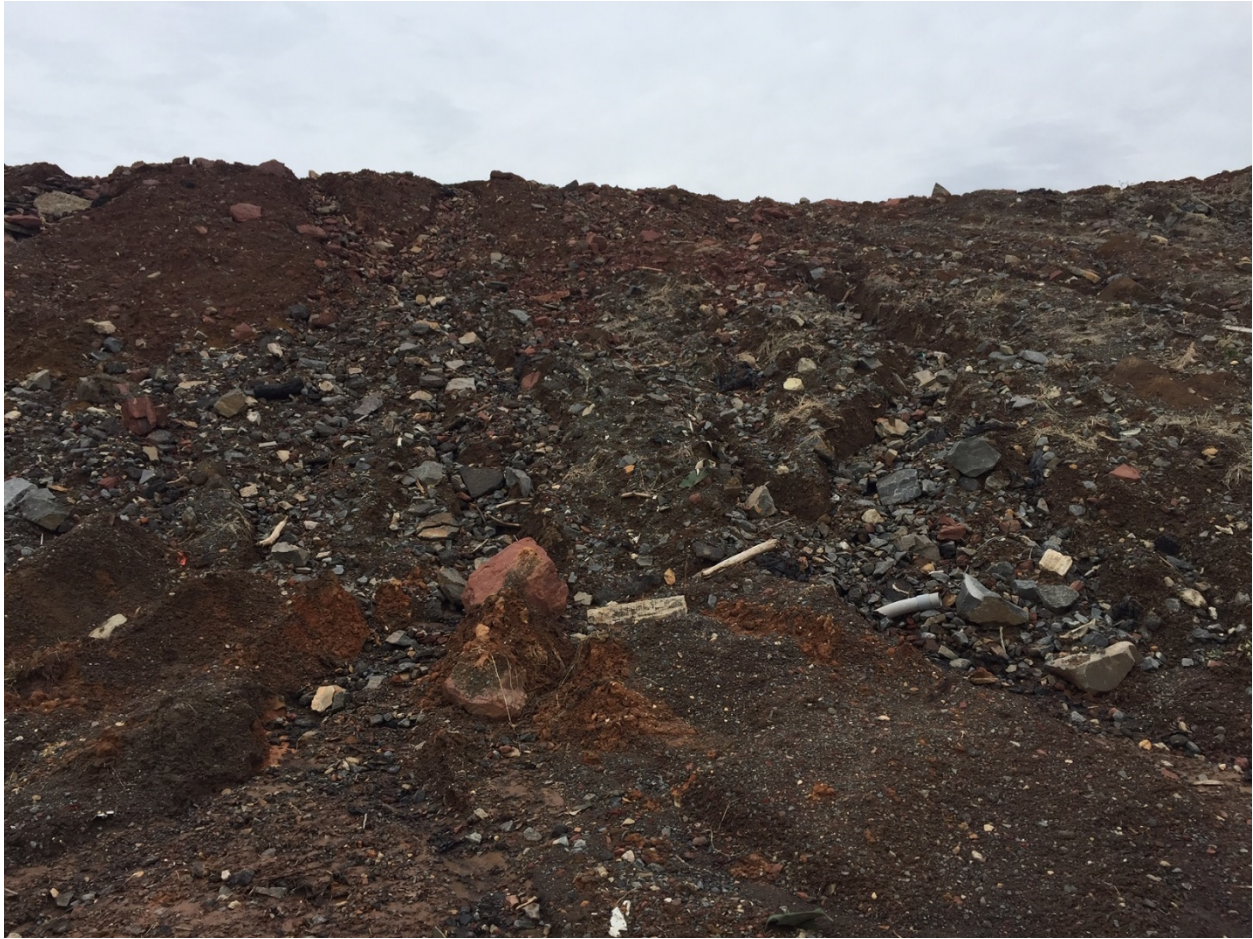
<b>Site Name:</b>	Gable Farms (IR# 2019-N-2076)	<b>Date:</b>	Feb. 22, 2019
<b>Address:</b>	Gable Farm Lane, Hamilton, Virginia	<b>Taken by:</b>	Richard Doucette
<b>County:</b>	Loudoun County	<b>Photo #:</b>	1 of 4

Photo 1. Back slope of fill along Gable Farm Lane. Facing Northeast.

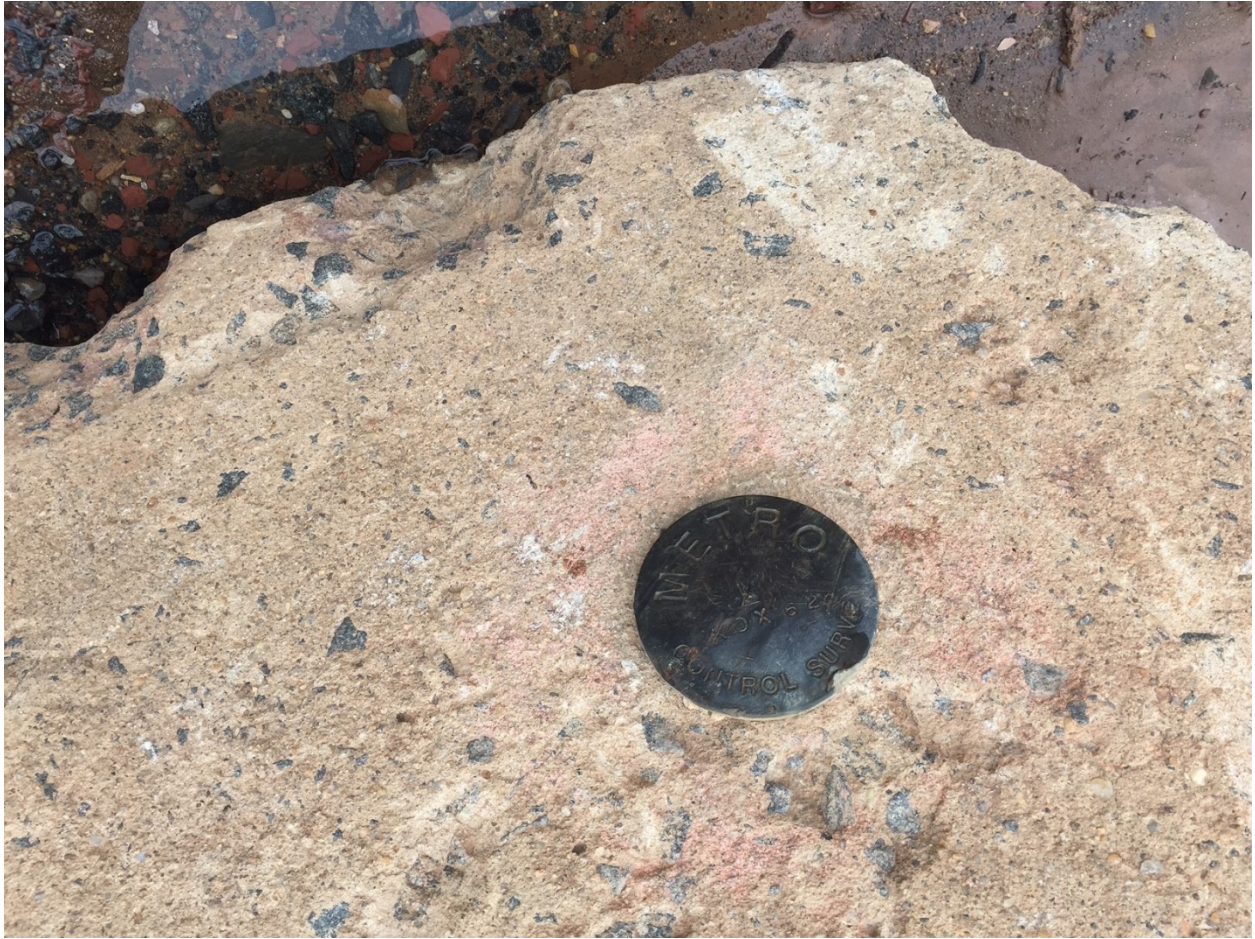
<b>Site Name:</b>	Gable Farms (IR# 2019-N-2076)	<b>Date:</b>	Feb. 22, 2019
<b>Address:</b>	Gable Farm Lane, Hamilton, Virginia	<b>Taken by:</b>	Richard Doucette
<b>County:</b>	Loudoun County	<b>Photo #:</b>	2 of 4

Photo 2. Survey marker on a large block of concrete. Marker suggests that this block originated from a Metro Project.

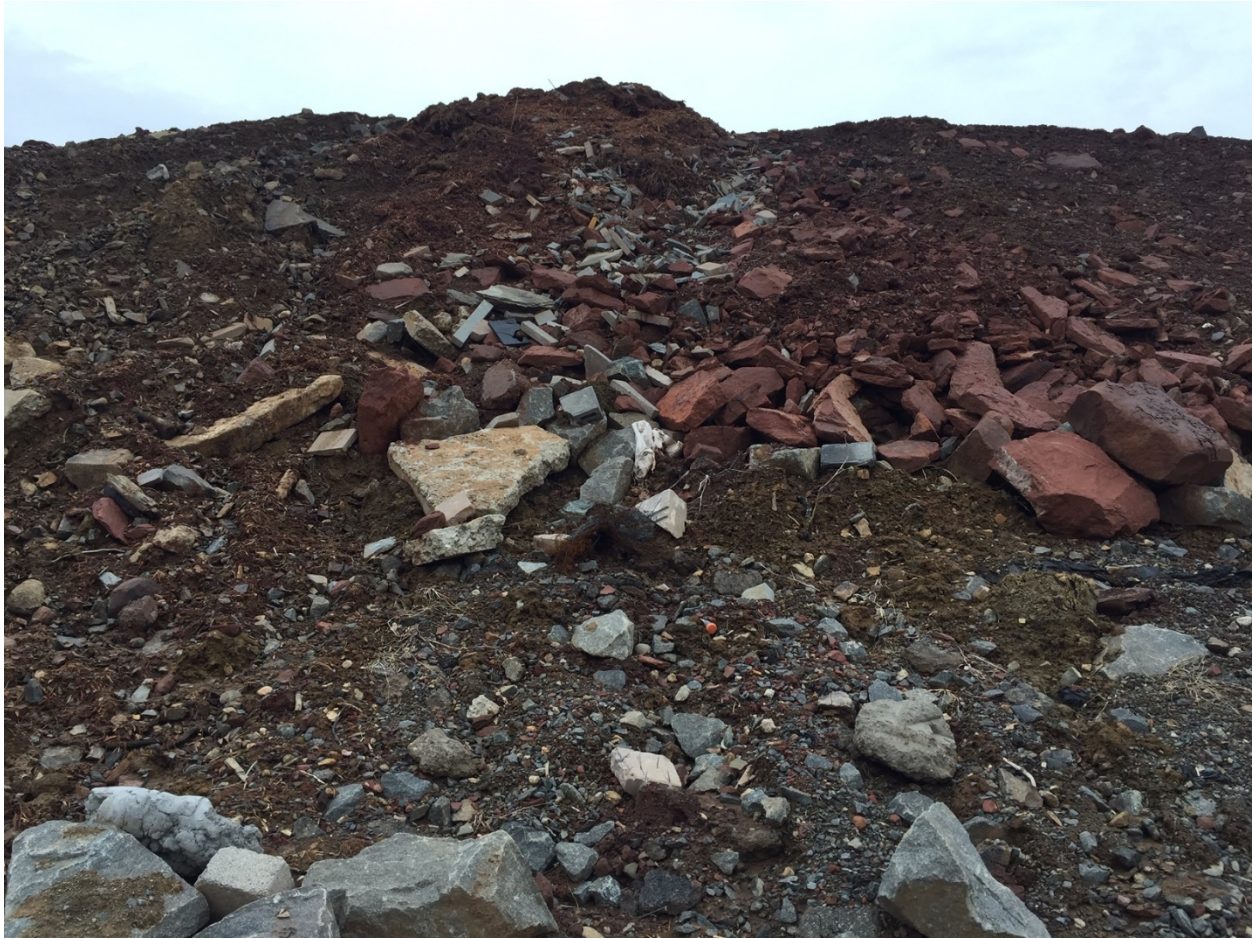
<b>Site Name:</b>	Gable Farms (IR# 2019-N-2076)	<b>Date:</b>	Feb. 22, 2019
<b>Address:</b>	Gable Farm Lane, Hamilton, Virginia	<b>Taken by:</b>	Richard Doucette
<b>County:</b>	Loudoun County	<b>Photo #:</b>	3 of 4

Photo 3. Back slope of fill along Gable Farm Lane. Facing Northeast.

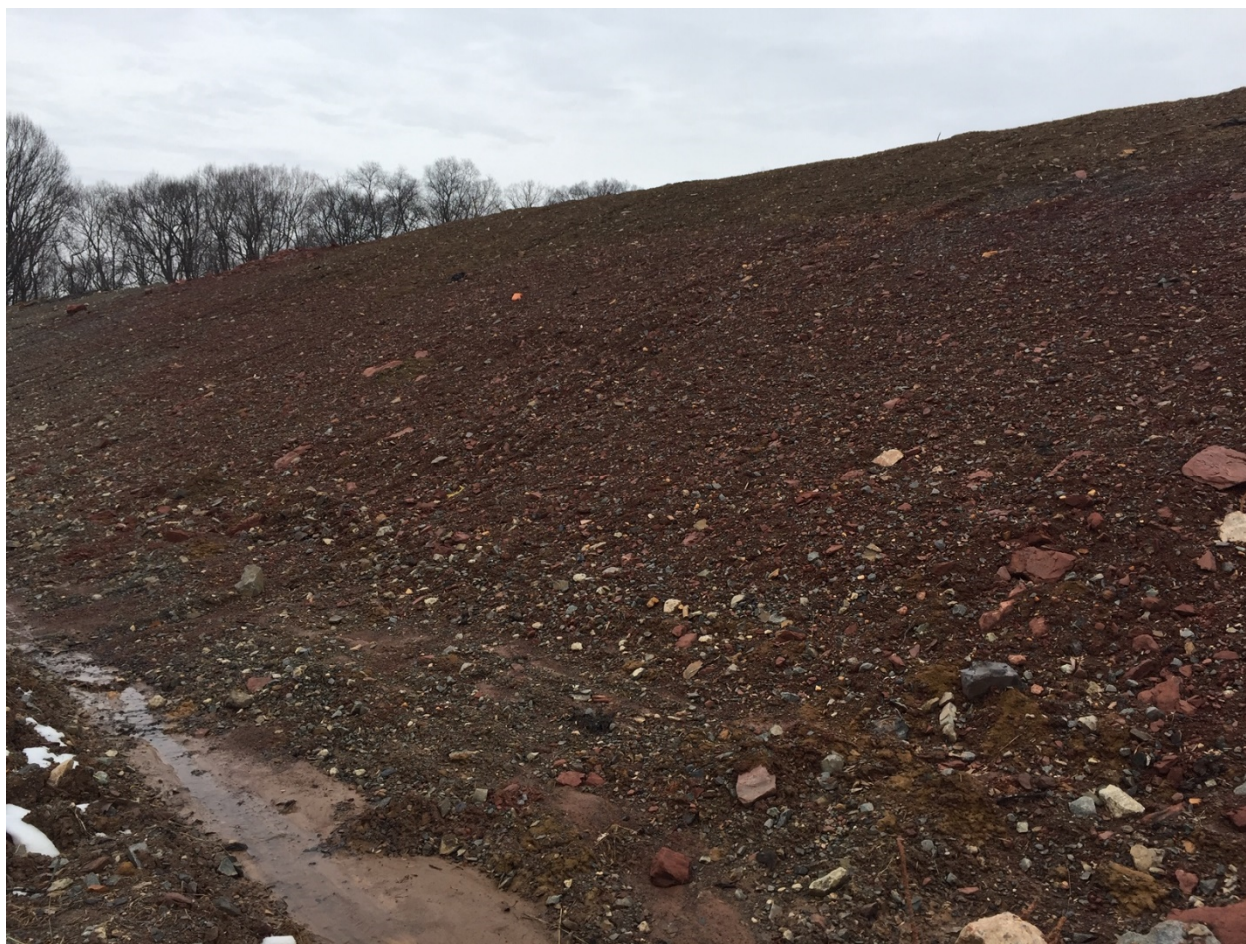
<b>Site Name:</b>	Gable Farms (IR# 2019-N-2076)	<b>Date:</b>	Feb. 22, 2019
<b>Address:</b>	Gable Farm Lane, Hamilton, Virginia	<b>Taken by:</b>	Richard Doucette
<b>County:</b>	Loudoun County	<b>Photo #:</b>	4 of 4

Photo 4. Back slope of fill along Gable Farm Lane. Facing Northeast.
