# Loudoun County

## Philomont Fire Station

Philomont Volunteer Fire Department

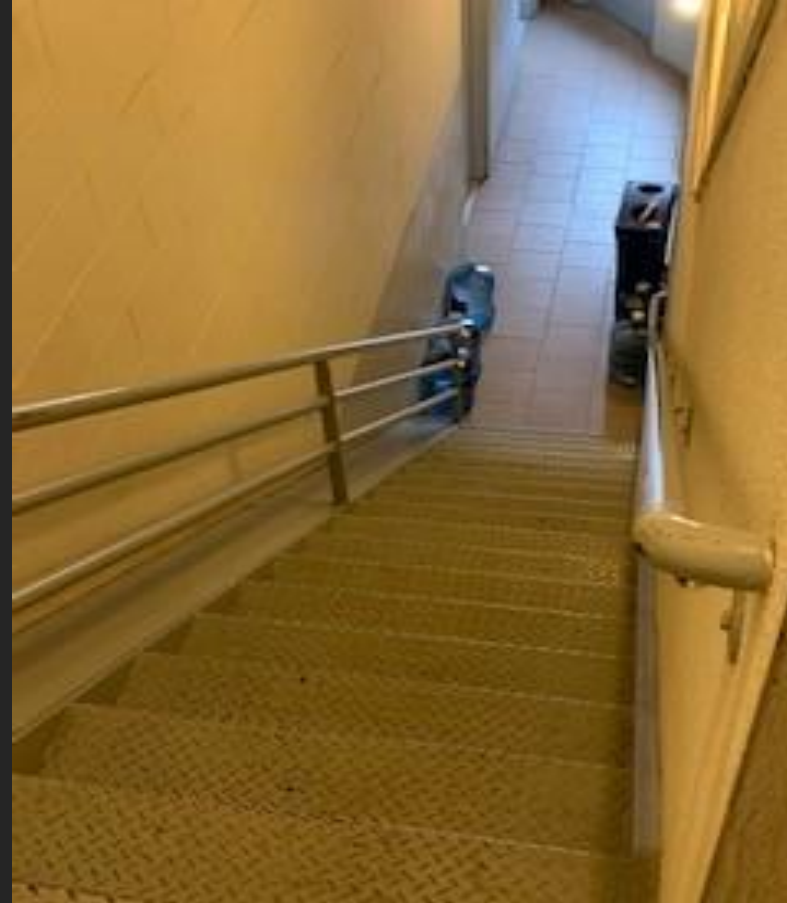
- The picture on this slide depicts the steep, narrow stairwell that personnel descend when responding to emergency incidents from sleeping and kitchen/dining areas of the station.

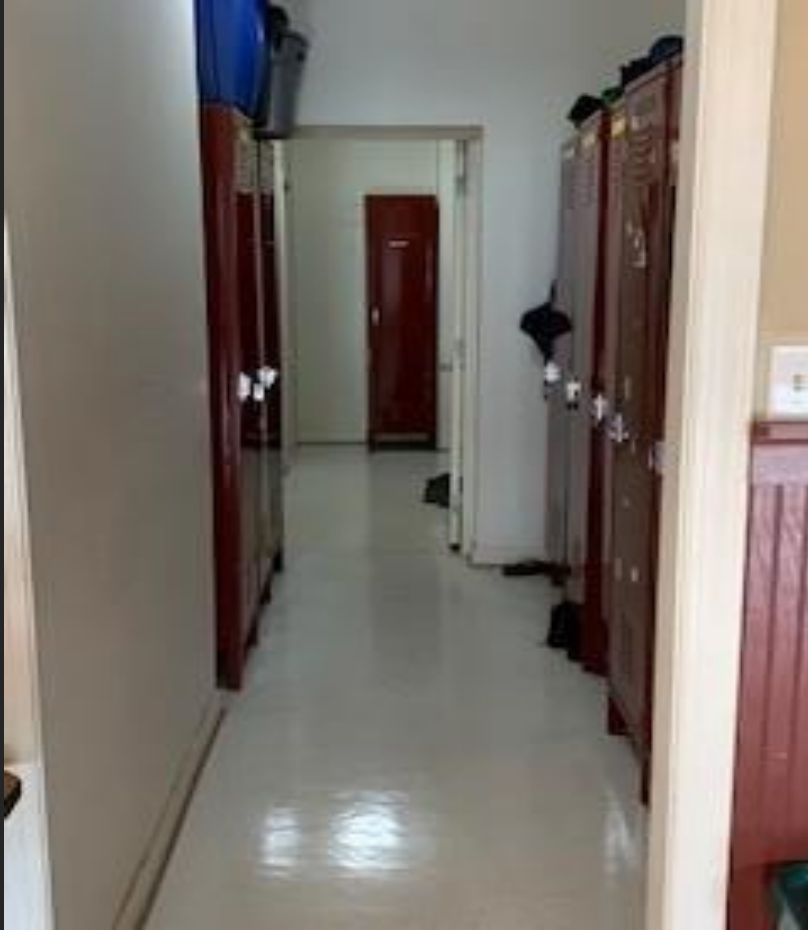
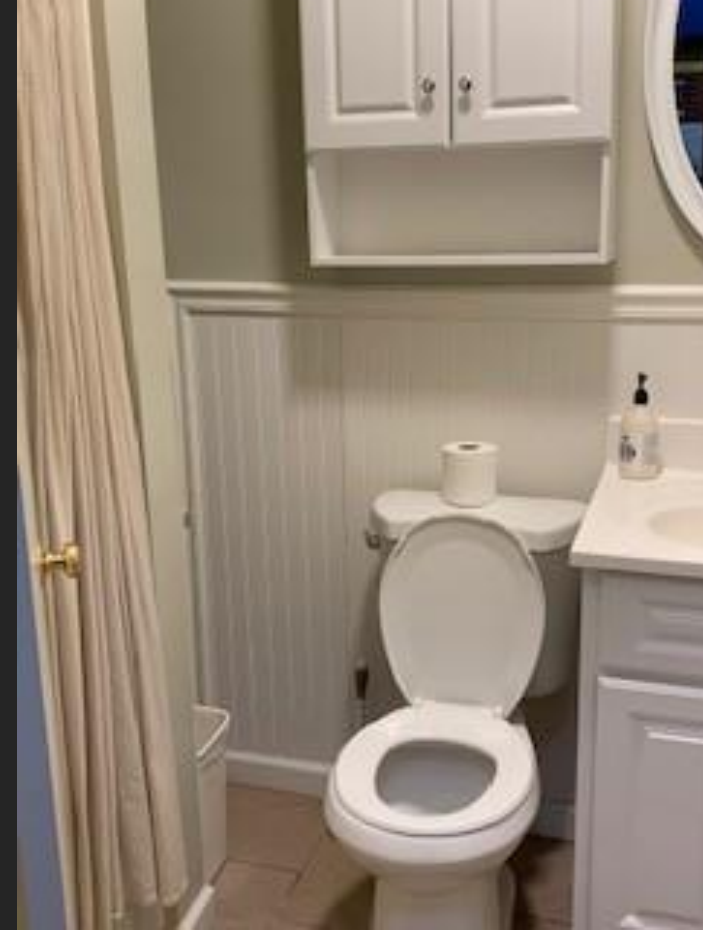
# Locker/Shower Rooms

- The current station was never designed to accommodate dedicated locker and shower rooms for men and women assigned to the station. Lockers have been configured in a co-ed arrangement located in a hallway on the second floor.
- This arrangement does not afford staff any privacy for changing. Staff are required to grab their personal/uniform items and go to a restroom in order to change.
- Typically, uniform changes happen for the entire staff simultaneously (shift change, incident return, bedtime, etc.)

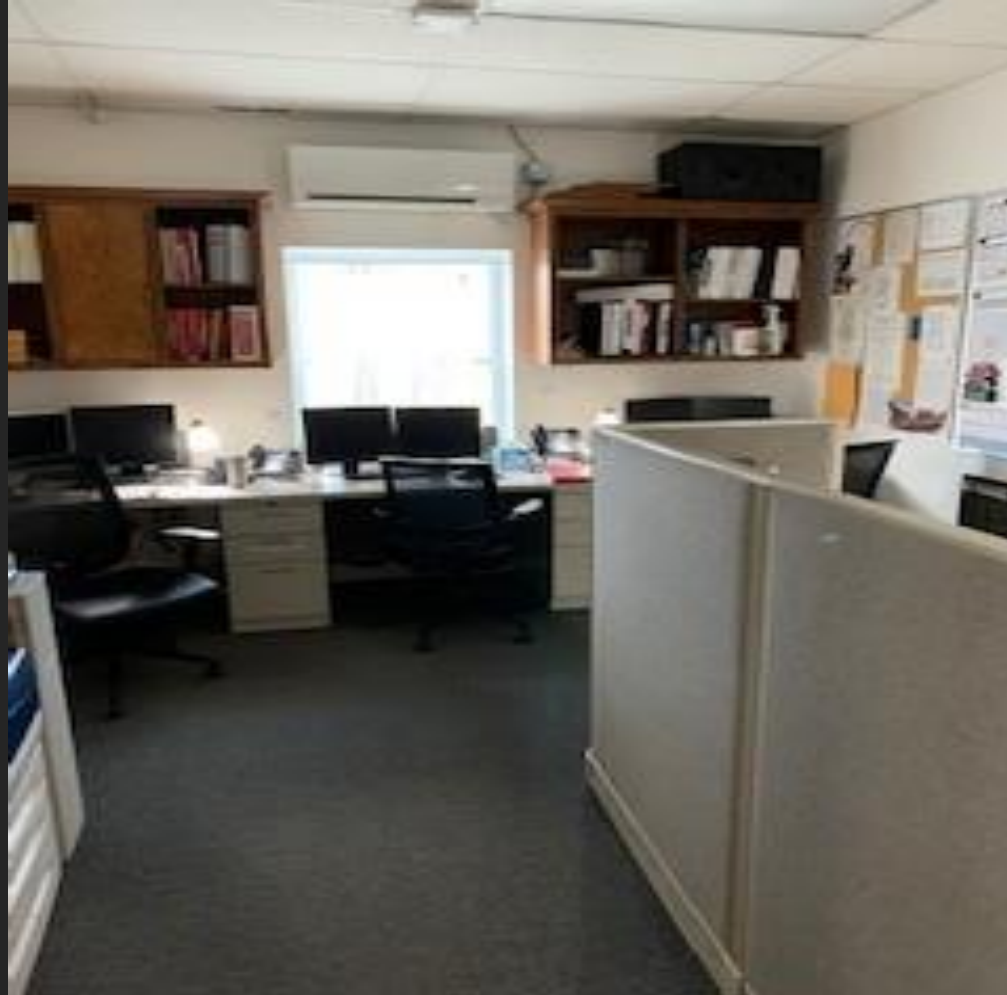
# Inadequate Administrative Office Area

- The current station was not designed to accommodate administrative offices and dedicated training areas needed to support assigned staff.
- An existing office was converted and is shared by all assigned staff. While this arrangement provides for four (4) computer workstations, the space is small, cramped and does not provide privacy needed when addressing employee coaching/counseling or studying.
- There is no dedicated training room. The community hall located on the second floor serves as the training room, meeting room and dining room.

- There is limited storage space available for training aids, manuals and station supplies.
- There is no ability to provide additional administrative areas in the event that service is expanded requiring additional daily staffing.
- The volunteers no longer have an office for administrative activities/storage. Volunteer file cabinets are presented housed in apparatus bay areas.

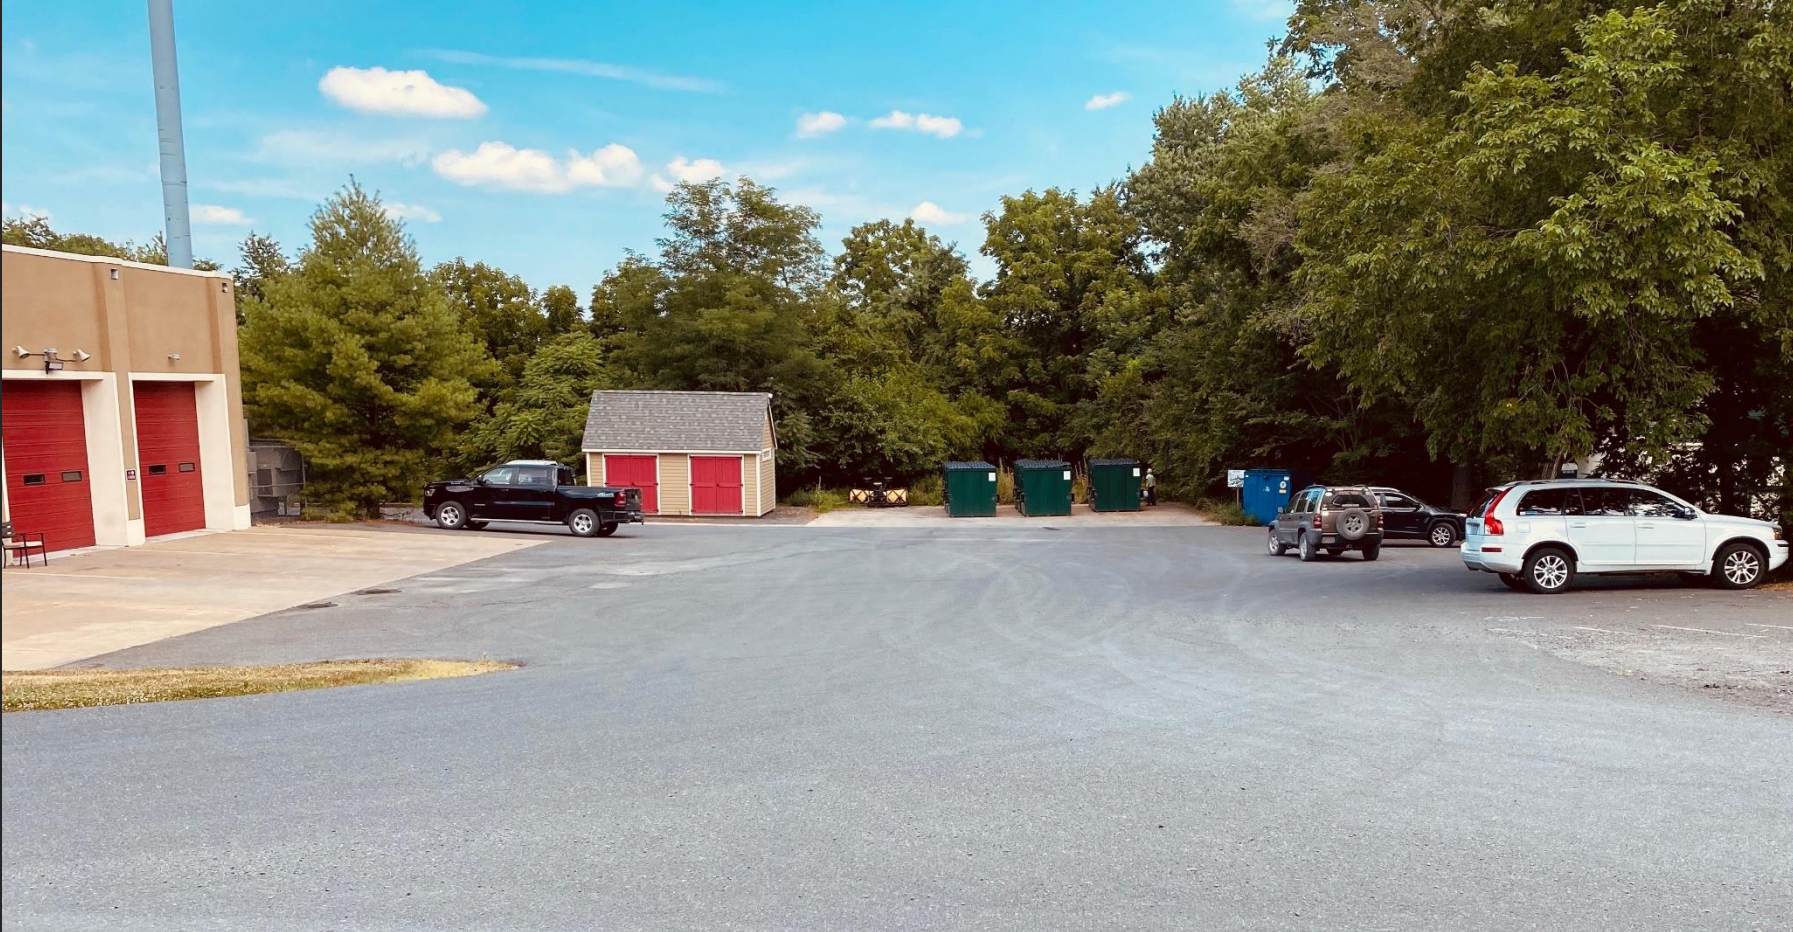
# Station Emergency Vehicle Response Route

- The station's entrance from Jeb Stuart Road serves as the primary egress path for emergency response and is shared with the Philomont Community Center (child daycare) and a recycling center.
- Parking for station staff and visitors is also shared with the Philomont Community Center.
- Current station design standards require a dedicated entrance for emergency response vehicles and a separate staff and visitor entrance to ensure unimpeded response of apparatus and to reduce the potential of injuries and accidents with pedestrians and civilian traffic.

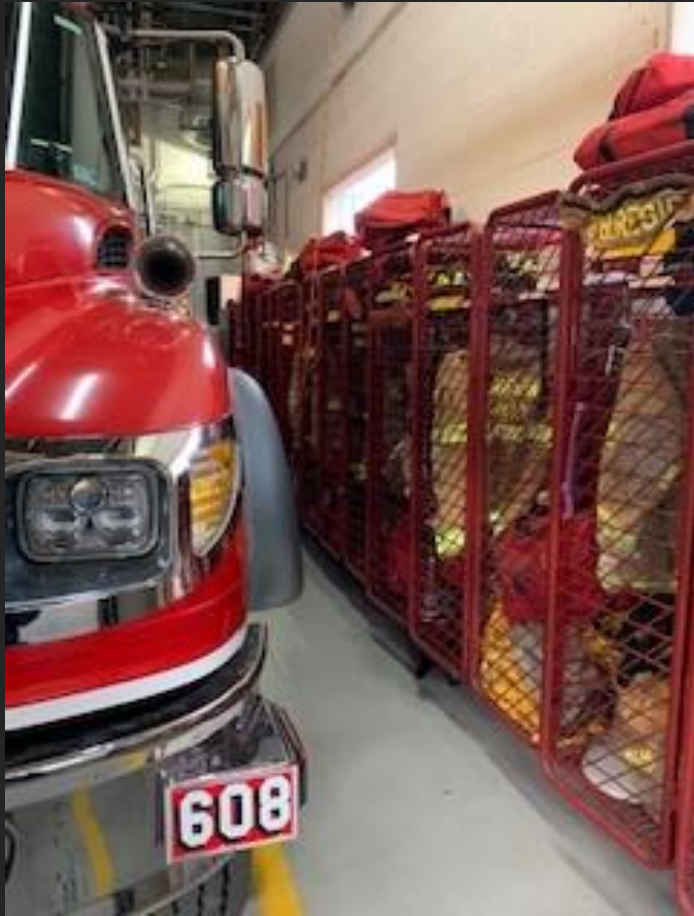
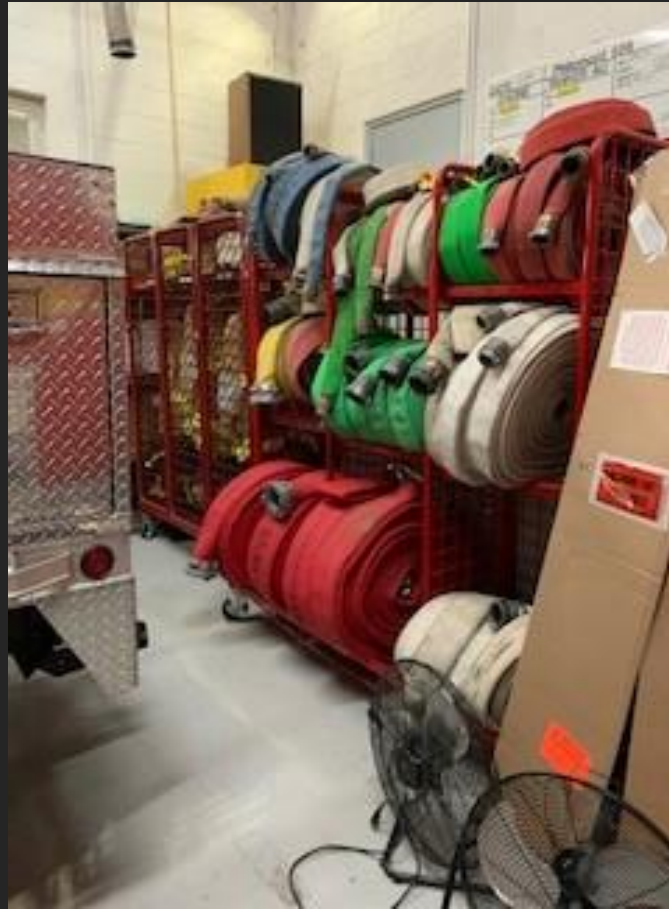
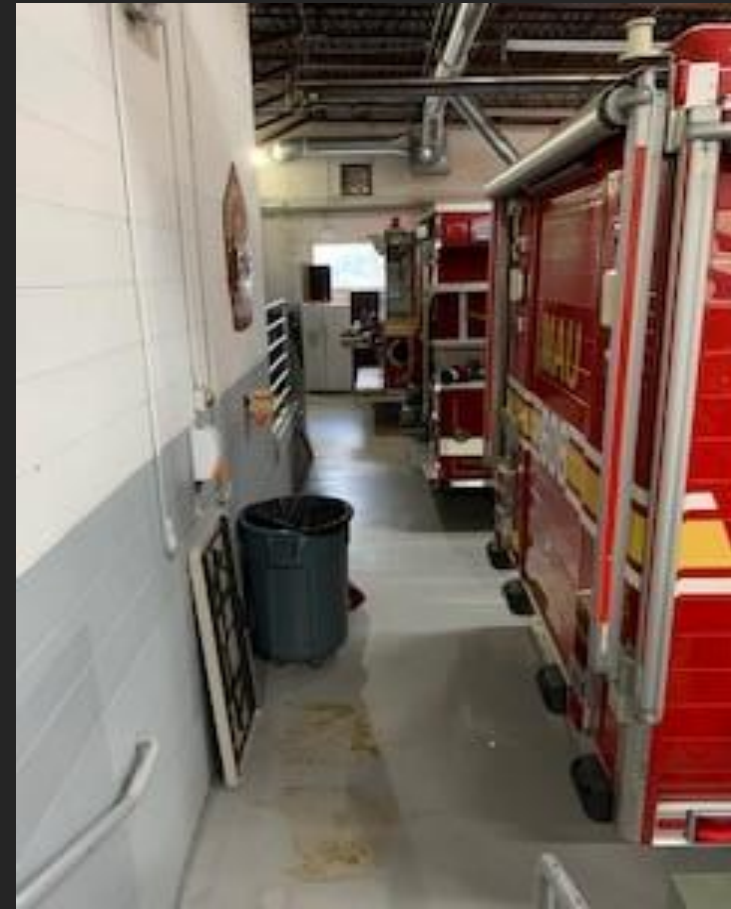
# Support Areas for Equipment and Gear Storage

- The station lacks dedicated support and storage areas for personal protective gear, equipment, shop space, supplies, and decontamination areas.
- Currently, firefighter/EMT's personal protective gear and equipment is stored in the apparatus bay. This exposes personal protective gear and spare equipment to vehicle exhaust and the degrading effects of prolonged exposure to sunlight.
- Limited space forces supplies to be placed in inappropriate areas throughout the station

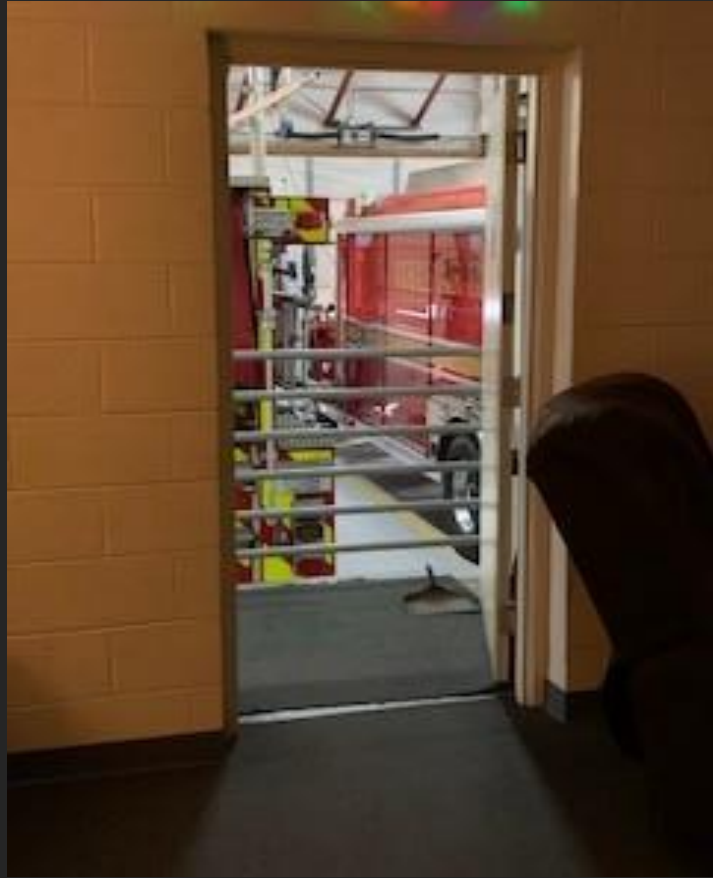
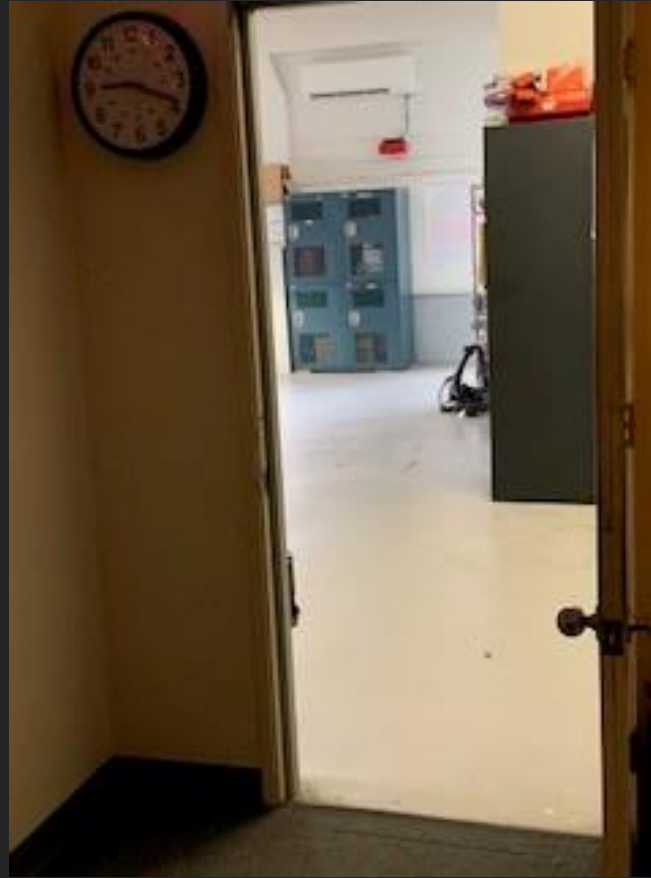
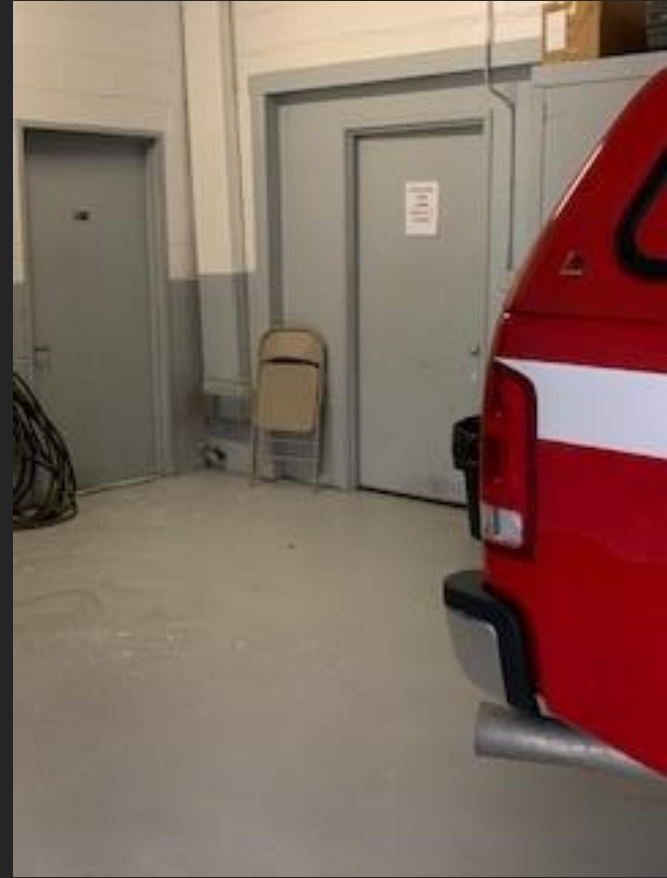
# Lack of Transition Zones

- The Philomont fire station was designed prior to our current understanding of the risks of cancer in the workplace.
- The apparatus bay hot zones are adjacent to the living areas
- The exercise room is located in the hot zone
- The washer and dryer used for personal uniforms and linens is located in the hot zone.

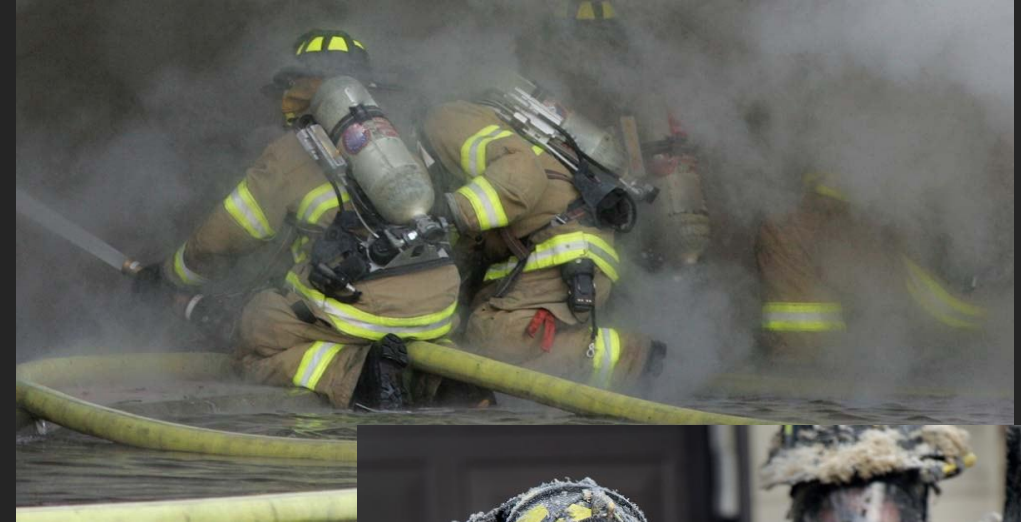
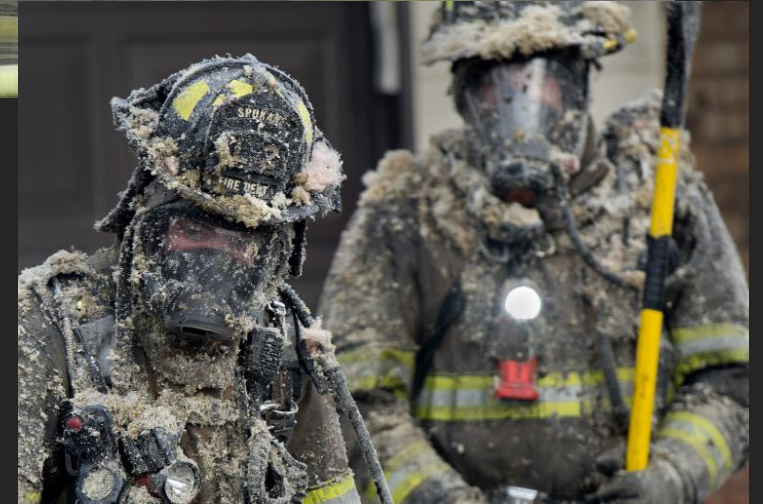
- To mitigate the risk of exposing firefighters to work induced carcinogens, National Standards recommend a zoned station design approach.

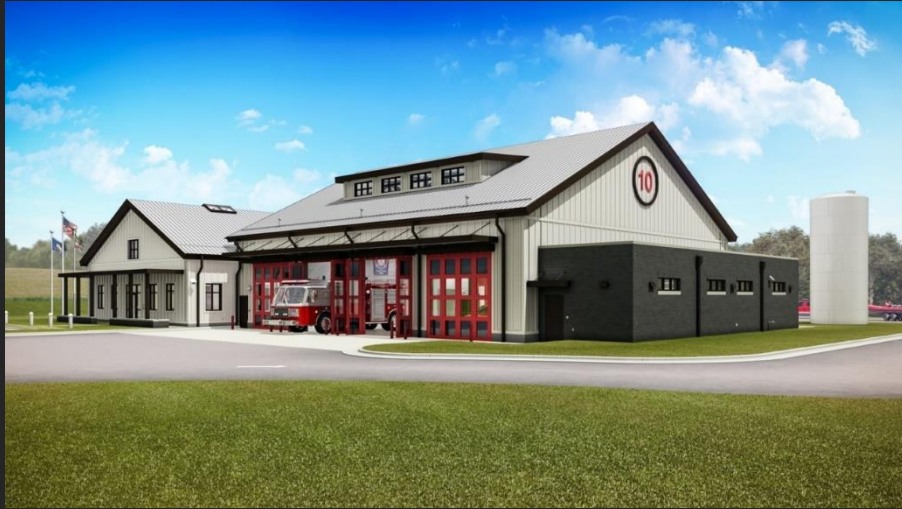
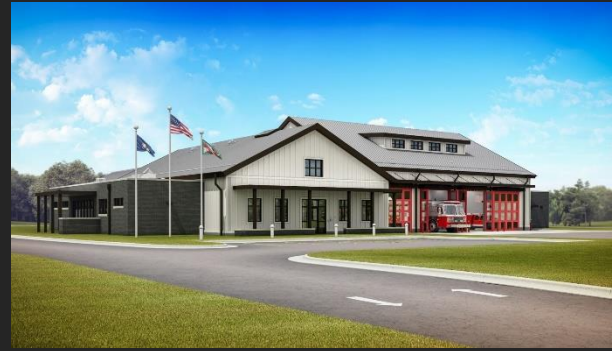
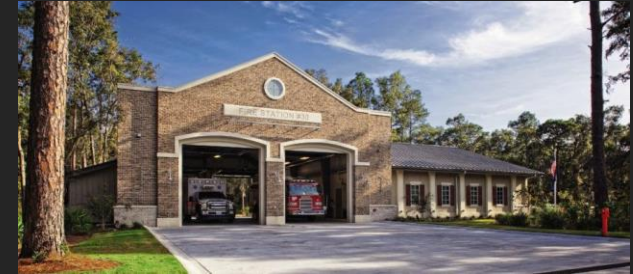
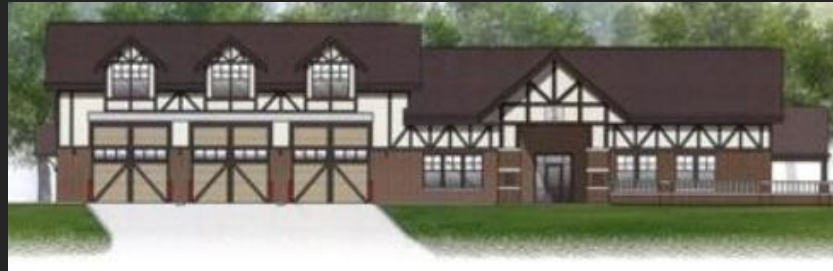
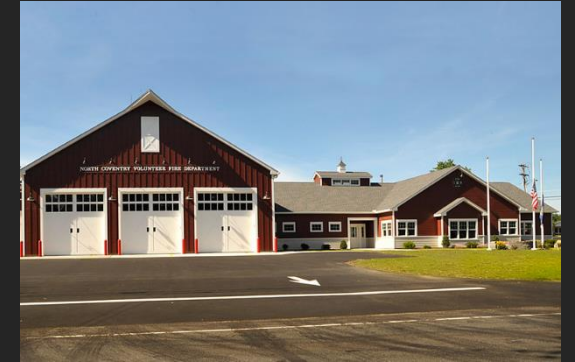
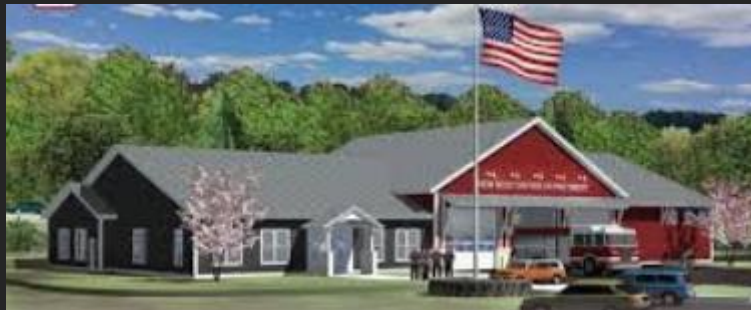
# Typical Rural Station Design

- Building exterior facades are selected to fit in the surrounding uses and neighborhood characteristics.
- Single story designs
- Landscape screening along neighbor property lines as needed
- Noise and light intrusion minimized
- Solar energy collection included in design
