UNISON COMMUNITY WATER AND WASTEWATER STUDY

Feasibility Study

DECEMBER 16, 2022

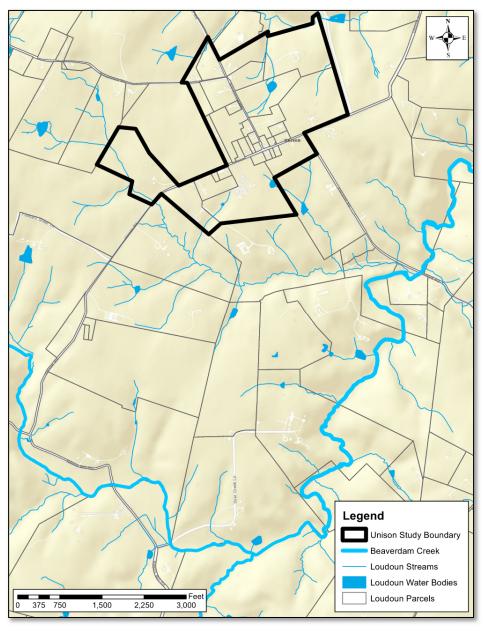
Figure 2-1 – Unison Village by Beaverdam Creek

Unison is a small historic community consisting of 34 lots total within the study boundary. The lots within the study boundary range in size from approximately 0.29 acres to approximately 25 acres. Unison is located near the Beaverdam Creek and its tributaries, as shown in **Figure 2-1**.

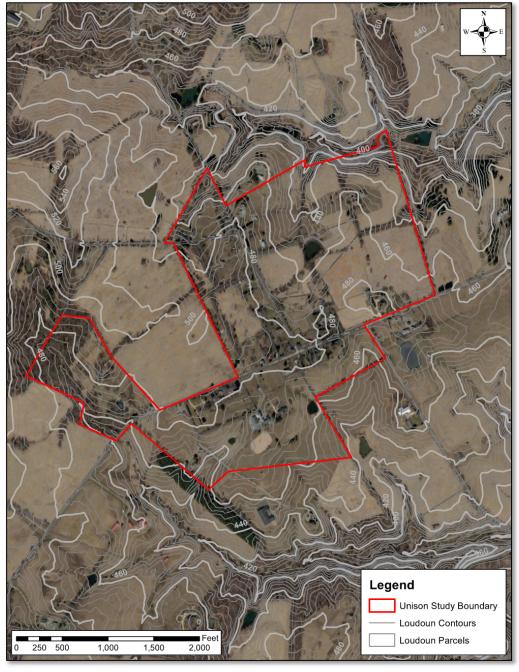
Figure 2-2 - Unison Topography

Unison has topography generally decreasing in elevation from the middle of the community moving both north and south throughout the community, as shown in **Figure 2-2**. A cluster of highpoints are located in residential parcels along Unison Rd in the center of the community and are approximately 480-feet above Mean Sea Level (MSL). The low points are located at stream tributaries at the southwestern corner of the community and at the northern end of the study boundary. The northern low point is approximately 420-feet above MSL and the southwestern low point is approximately 440-feet above MSL.

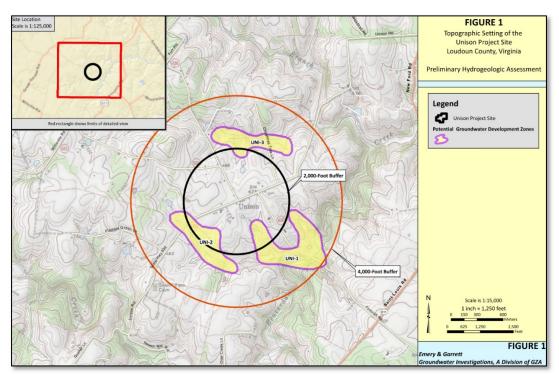
Figure 3-2 – Potential Groundwater Development Zones

As a result of the hydrogeologic assessment, EGGI identified three (3) potential Groundwater Development Zones, which are shown in **Figure 3-2** and identified as UNI-1, UNI-2, and UNI-3. According to EGGI, these Zones are considered the best candidate areas for developing potable groundwater resources for a community water system in Unison. These areas are priority ranked according to their overall hydrogeological favorability for yielding appreciable groundwater resources. Therefore, UNI-1 is considered more favorable for groundwater development than UNI-3.

Based upon the hydrogeologic data collected in Phase I, EGGI also recommends that the groundwater exploration program proceed to Phase II, which includes conducting geophysical surveys within the selected Groundwater Development Zones to aid in the selection of specific exploratory test well drilling targets/sites. The geophysical surveys should be conducted on selected land parcels where permission to gain access onto private or public property can be obtained and where it is technically feasible to conduct the surveys.

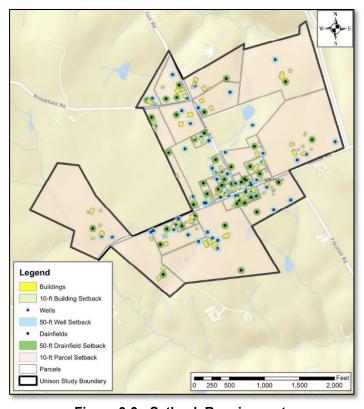
Figure 3-3 - Setback Requirements

Another solution to improve yield on a private property is to drill an additional well or wells. However, due to setback requirements and other permitting and regulatory requirements, this option may not be feasible. An additional challenge for individual properties may be lack of access for necessary drilling equipment due to small parcel size and density of structures. **Figure 3-3** illustrates the density of the existing wells, drainfields, and buildings within the Unison community along with minimum required setbacks for each. As shown in this figure, the majority of parcels within the community, particularly near the middle of the community do not have sufficient area to site new wells.

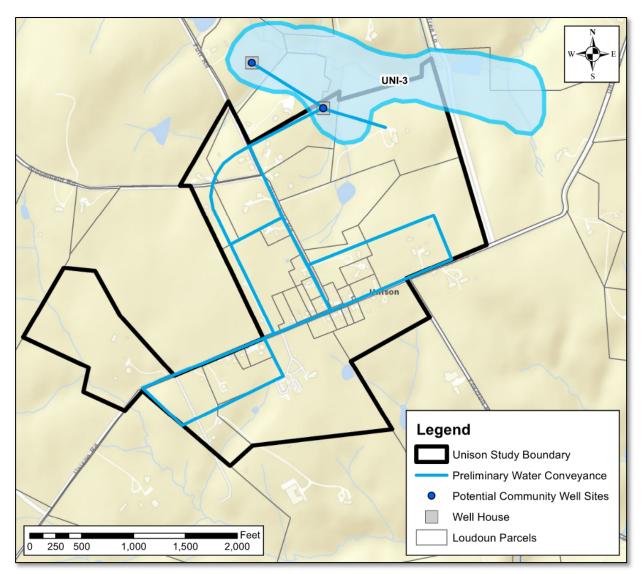
Figure 3-4 - Conceptual Water Main Layout

This alternative would also require that a conveyance system be installed to distribute water from the treatment facility to individual homes. A conceptual water main layout for the potential community water system is shown in **Figure 3-4**. It should be noted that the layout was arranged to convey water from UNI-3, which is a potential Groundwater Development Zone that was identified by Emery & Garrett in the Phase I Hydrogeologic review completed for this study (see Section 3.1.3). It was assumed that UNI-3 would be utilized instead of UNI-1 or UNI-2 due to the conflict with the preferred conceptual layout for the community sewer system. Furthermore, a baseline assumption for the size of the distribution piping is 6-inch ductile iron pipe (DIP), as the LW EDM requires that raw water lines be 4-inch and larger for a community system and that the material be DIP.

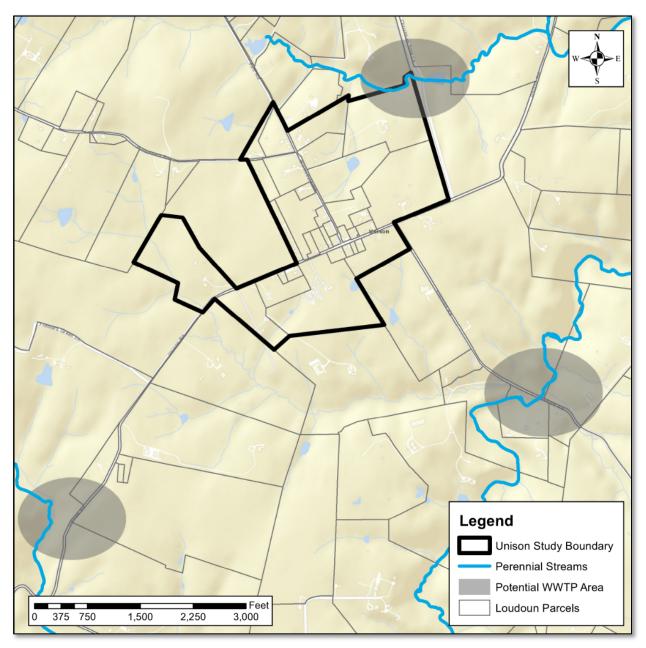
Figure 4-6 - Potential Discharge Locations to Beaverdam Creek

This alternative would require construction of a WWTP in or around Unison. Treated effluent from the WWTP would be discharged into the Beaverdam Creek, which is considered to be a perennial stream. **Figure 4-6** identifies three (3) potential discharge locations along the creek, which are located North, Southeast and Southwest of the Unison study boundary. The location of the effluent pipe would need to be determined in the preliminary stages of design and coordinated through VDEQ. An effluent pump station and force main may be required to convey treated effluent to an approved discharge location.

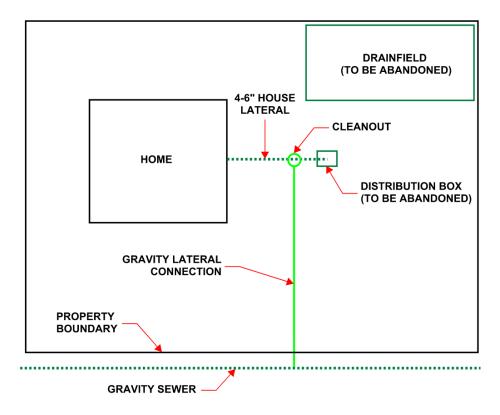
Figure 5-1 – Gravity Sewer System Lateral Connection

improvements were included in the capital costs. In the future the responsibility for these costs will need to be refined and potentially a portion distributed to property owners, depending on project funding. There is a cost associated with individual parcels including the installation of the grinder pump, modification to the house lateral connection (gravity and LPS), and construction of a 1.25-inch pressure service lateral or 4 to 6-inch gravity lateral. In addition, there will be costs associated with the proper abandonment of the existing systems. For the purpose of this feasibility study, the connection cost for each parcel includes the installation of the LPS equipment and/or gravity lateral. This includes the grinder pump and tank, valve assembly, and service line and lateral connection piping (gravity and LPS), and electrical components. A typical gravity system lateral connection and gravity lateral connection is shown in **Figure 5-1**.

The total cost estimated for these individual parcel improvements is approximately \$17,000 per parcel as shown in the summary above.

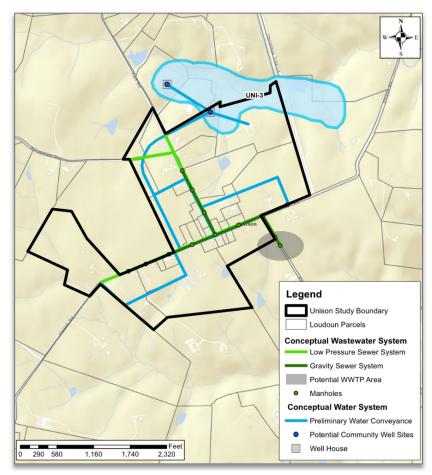
Figure 6-1 - Recommended Conceptual Water and Wastewater System Layouts

Figure 6-1 displays both the recommended water and wastewater conceptual layouts. It should be noted that no discussions took place with property owners regarding potential well sites or treatment plant sites. These sites are shown conceptually for the purpose of this feasibility study and to show potential infrastructure alignments. Some infrastructure may ultimately be located outside of the Unison study boundary. It should be noted that cost estimates assumed water and wastewater improvements will be built concurrently with only one roadway overlay, which was accounted for in the wastewater estimates.
