Loudoun County Carbonate Area with Mapped Sinkholes - Route 15 Corridor

Map Number: 2007-015
Date Generated: February 6, 2007
Map Prepared By: Department of Building and Development, Loudoun County, VA

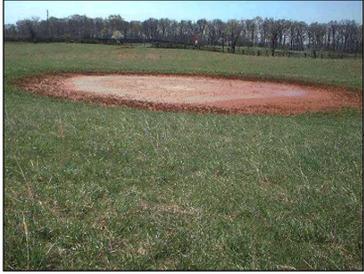
Selma Estates Subdivision (photograph date: April 14, 2003)
An old sinkhole that has formed a clay plug and collects water.

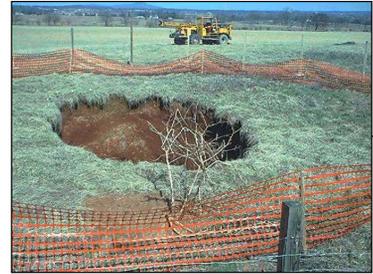
Selma Estates Subdivision (photograph date: March 27, 2003)
The sinkhole is approximately 30 feet in diameter and 30 feet in depth and opened approximately 100 feet from a well being installed.

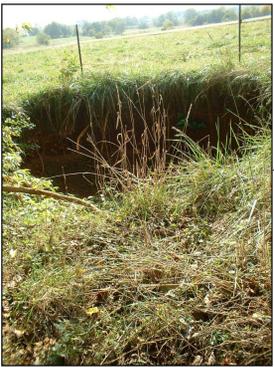
Raspberry Falls Subdivision
(photograph date: October 18, 2004)
The sinkhole is approximately 20 feet in diameter and 15 feet in depth.

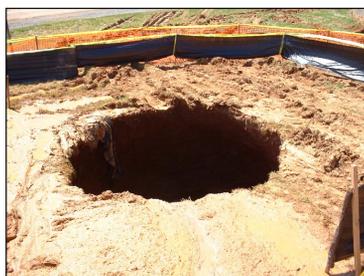
Leesburg Crossing Subdivision (photograph date: April 6, 2005)
The sinkhole is approximately 8 feet in diameter and opened during well installation.

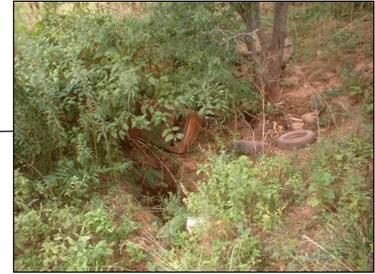
Zial Subdivision (photograph date: August 30, 2006)
Sinkhole with debris. Sinkholes have historically been used as a location for trash/debris collection.

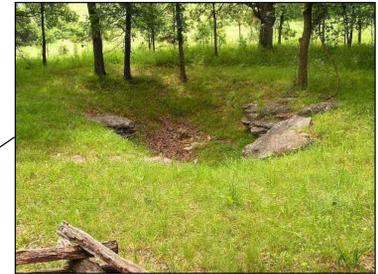
Morven Park
Older sinkhole beginning to heal over.

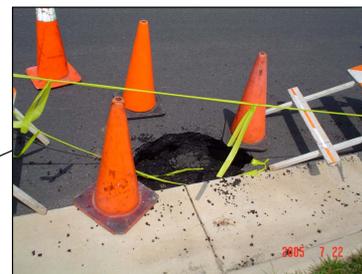
Route 15 Business near Dry Hollow Road (photograph date: July 22, 2005)
Sinkhole is approximately 3 feet in diameter and 6 to 8 feet in depth.

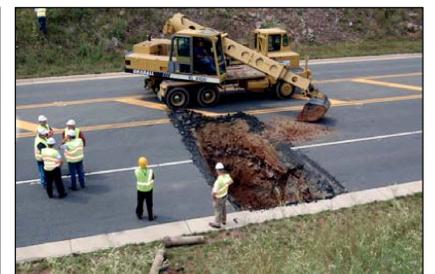
Approximately one year later, the sinkhole reopened at the same location. The sinkhole is approximately 20 feet in diameter and 15 to 18 feet in depth. (photograph date: June 28, 2006; source: Leesburg Today)

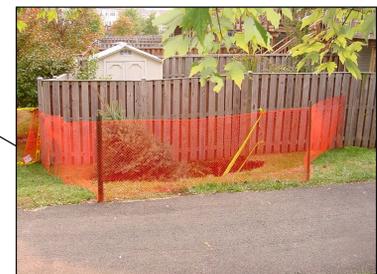
Exeter Subdivision (photograph date: January 10, 2002)
The sinkhole opened around a 24-foot spruce tree (6 feet exposed).
